Coastal Adaptation Study for Alexandrina Council

PORT ELLIOT

Report to be cited as: Western, M, Bourman, R., Hesp, P (2019) Coastal Adaptation Study for Alexandrina Council (Cell SF8 Horseshoe Bay) prepared by Integrated Coasts, South Australia.

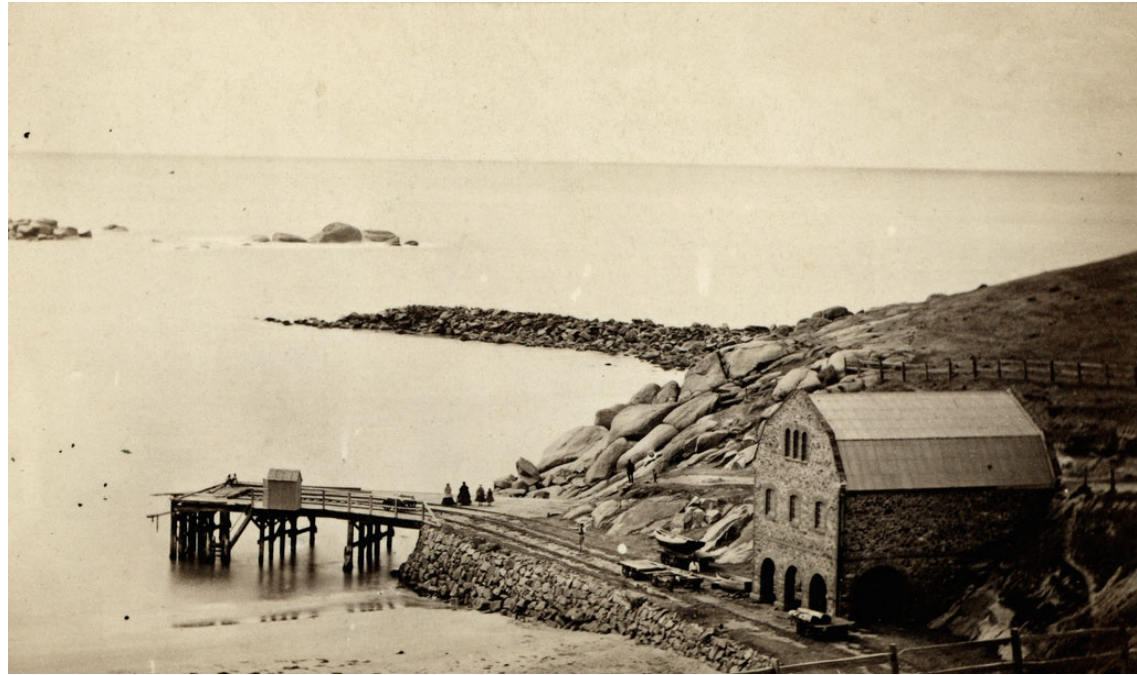
Figure 2: Earliest photograph of Horseshoe Bay in 1860

Note the abandoned cliffs and likely location of backshore when sea level was higher (Fig 2,3).

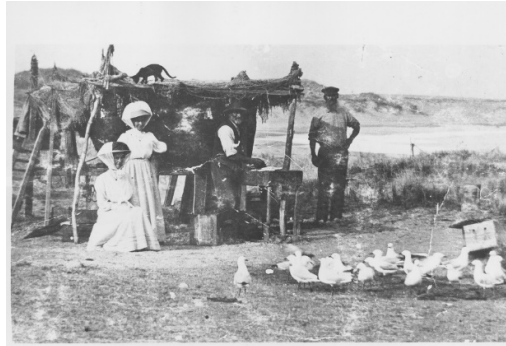
Figure 5: Fisherman's camp c.1908

The foreshore was sometimes used in the early 1900s as a 'fisherman's camp' (Fig 5).

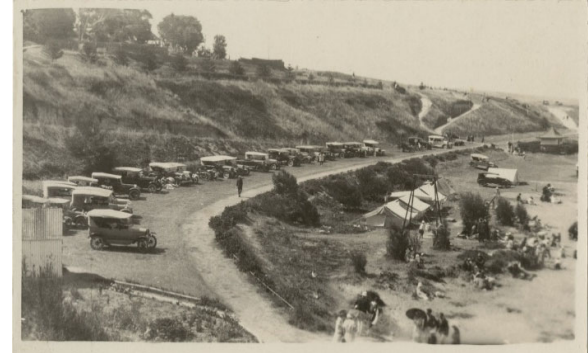
Fig 6: Note height and nature of the dunes in the mid-section of the bay. These dunes are also seen in Fig 4.

Figure 6: Horseshoe Bay c.1900

Initial recreational activities were concentrated on the south-western end of the bay where swimming was safer and the jetty in close proximity (Fig 6).

Note the distance between green and foreshore (Fig 6). Either the green has been repositioned or the coast has receded significantly (likely the former).

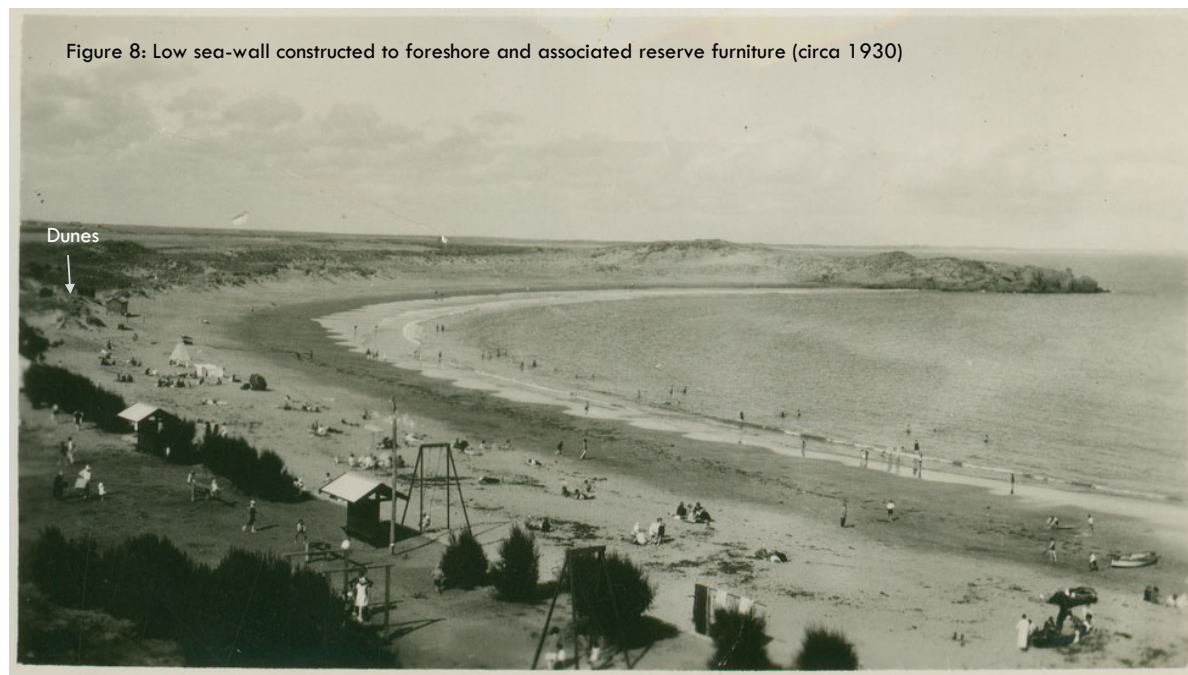
Fig 8: There appears to be a small dune system forward of the current line of dunes adjacent the bowling club (also a beach shelter or changing room).

Note the substantial dune system on the eastern end (now the location of the caravan park)

Figure 8: Low sea-wall constructed to foreshore and associated reserve furniture (circa 1930)

The sea-wall was installed to the western side circa 1930, most probably as a means to contain the reserve for public use rather than to act as any form of protection from actions of the sea (Figure 8,9).

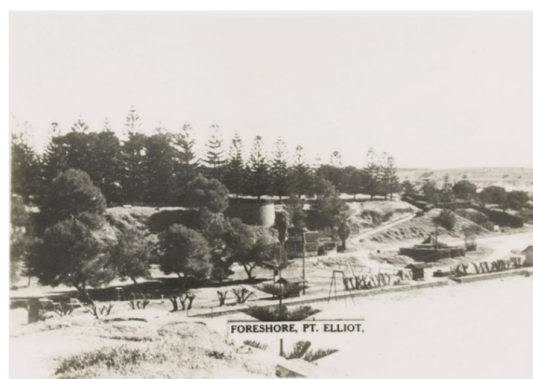
Figure 9: Photograph taken after Figure 7 (circa 1930)

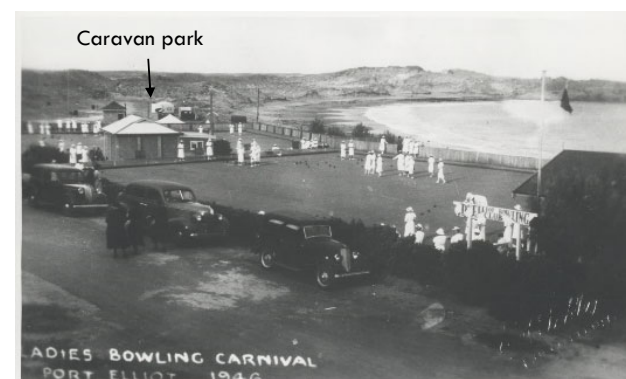
Figure 10: Second bowling green and caravan park

A second bowling green was constructed circa 1940 (Figure 10).

A caravan park was established to the north-east of the second bowling green (Figure 10). It is likely that the caravan park expanded slowly to the east transforming the former dune into a green space for camping.

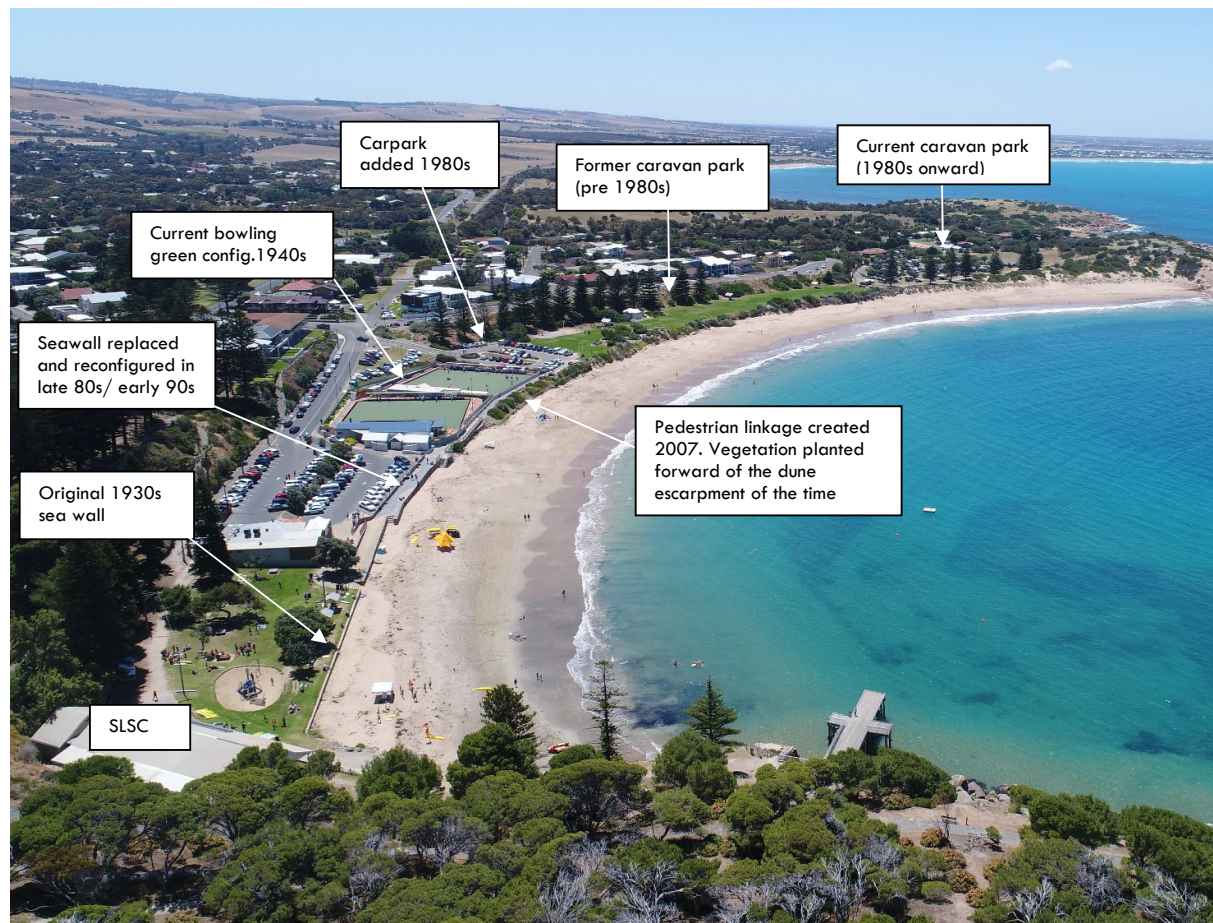
Figure 11: Horseshoe Bay in its modern form (2018). (Compare tidal lines and seaweed lines to Figure 8)

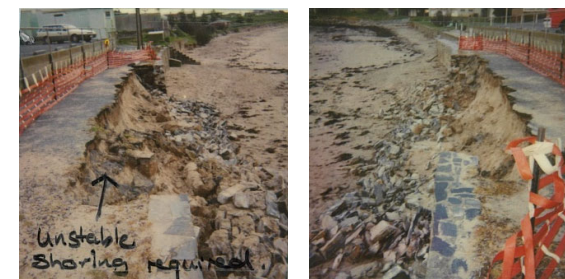
In 1989, a second section of wall in front of the carpark was damaged by storms. The cost to repair approximately 25m of wall was estimated at \$15600. CPB considered this excessive and only agrees to pay half (19890926). Council seems to have drawn up a master plan in 1981 repair and the existing plans are implemented (plans in file).

The replacement wall incorporated a revised entry point to the beach (steps heading west), and it is likely that the overall width of the promenade in front of the carpark was widened seaward.

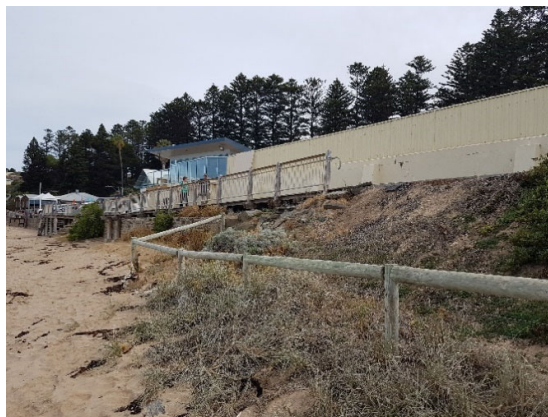
Figure 13: Small buffer between green and beach. (Photograph, M. Western, 2018)

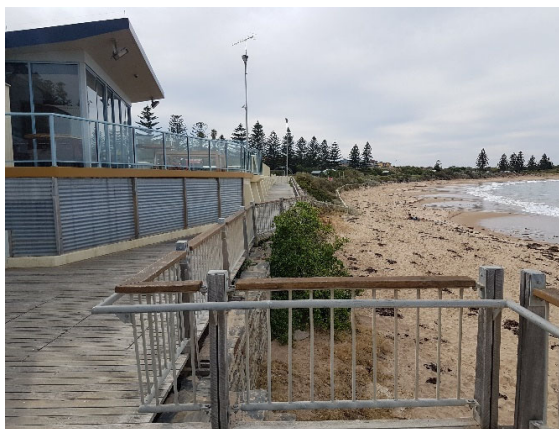
Figure 14: Boardwalk constructed adjacent bowling club circa 2007 (Photograph, M. Western, 2018)

Circa 2007 a boardwalk was installed seaward of the bowling club and amendments made to the area in front of the Flying Fish Café.

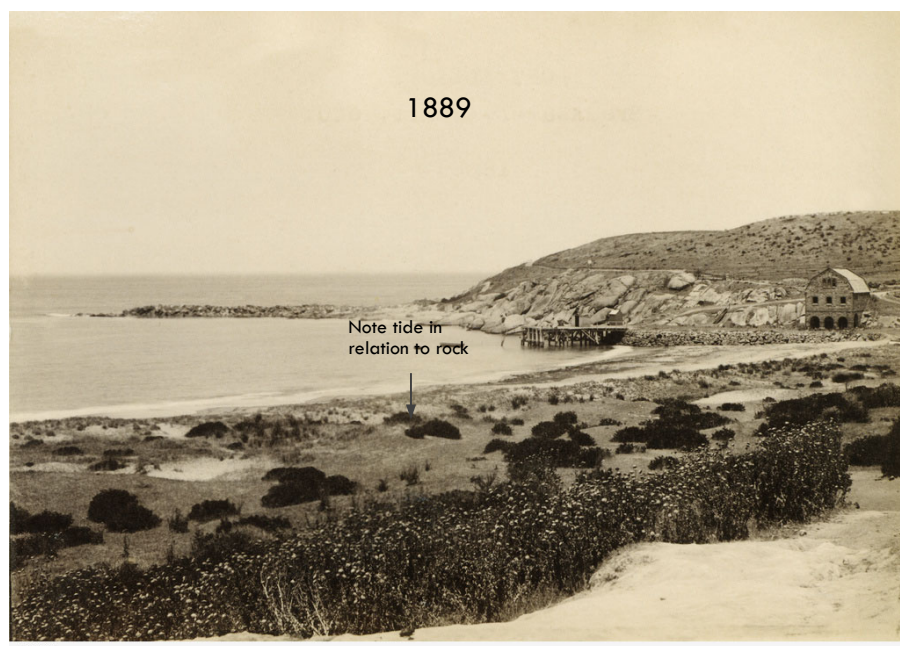
Figure 15: **First intervention** was installation of breakwater, jetty, and stone walling. The breakwater changed the way in which wave action interacted with the bay. Photograph taken in 1889 from what is now the Blue Dolphin Holiday Apartments.

Figure 16: **Second intervention** was installation of western bowling green. Note the original frontal dune line and the slope of the backshore in 1889

Figure 17: To counteract the natural slope of the backshore, the site was benched, using existing soil on site, and imported fill (later). Photograph of bowling green and esplanade walk from southern side.

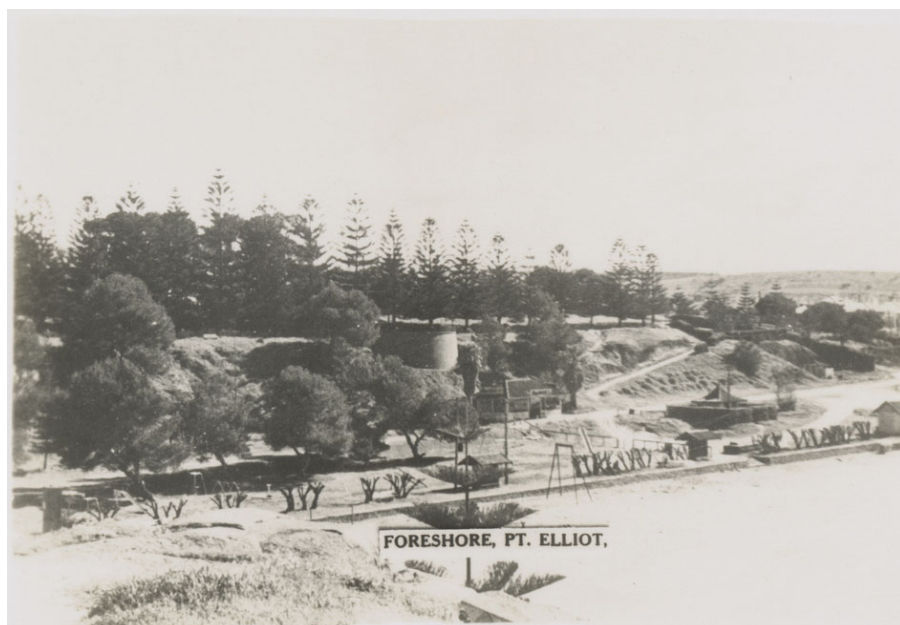
C.1930

Figure 18: The next major intervention was the construction of a **sea wall** from the western end of the bay to the bowling club. The probable purpose was to provide separation of the reserve and the beach, and not to provide protection from actions of the sea. Source: State Library of SA.

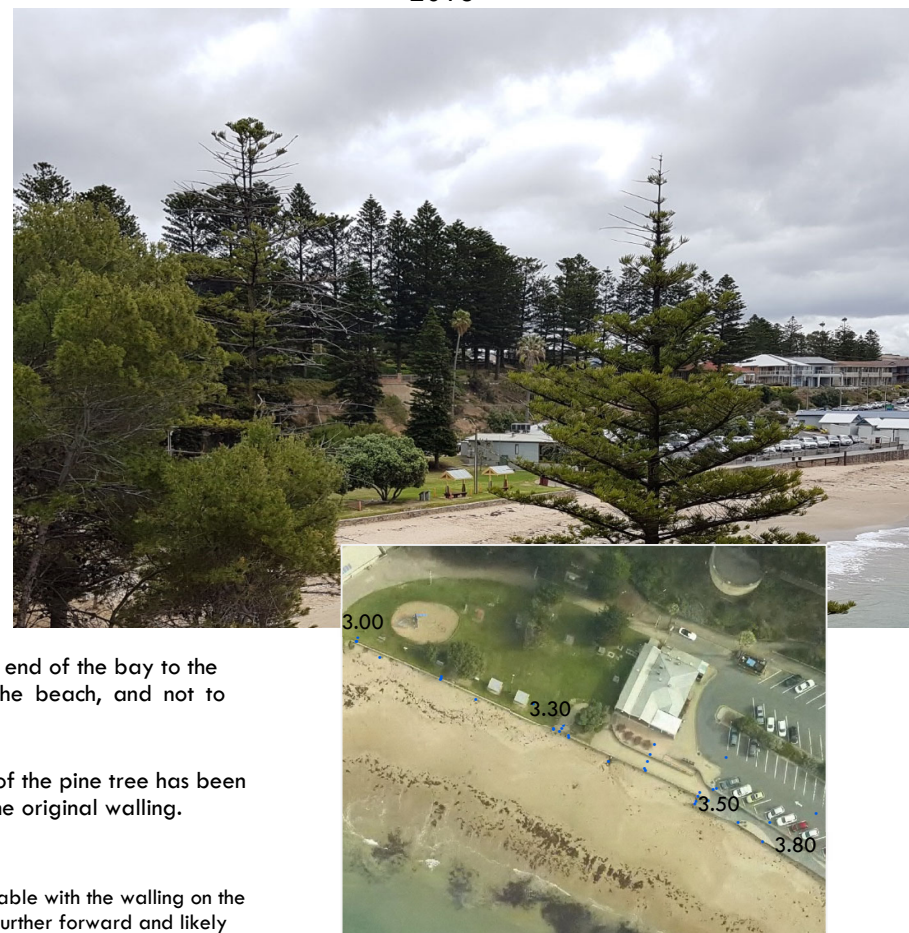
2018

Figure 19: The western end of the wall is the original construction. The section to the right of the pine tree has been replaced, and beach access point modified. It is also likely that this section is higher than the original walling.

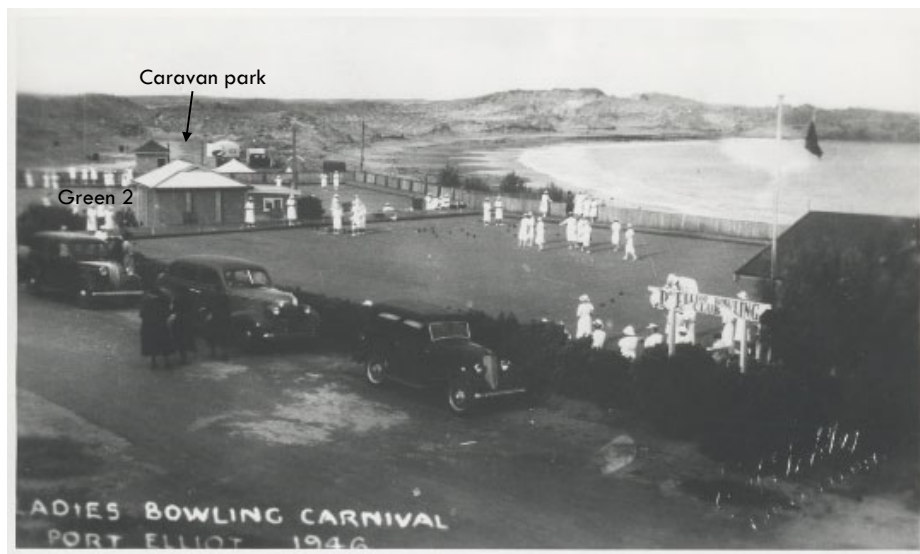
C.1946

Figure 20: By 1946, the bowling greens had been constructed in their current locations. The caravan park began in this era also on the eastern side of the bowling green. (State Library of SA)

Note the size of the dunes between the pictured caravan and the beach, as well as the substantial dunes at the eastern end of the 1946 caravan park. Over a time period of 40 years the caravan park slowly encroached into the foredunes, and along the shore to the east.

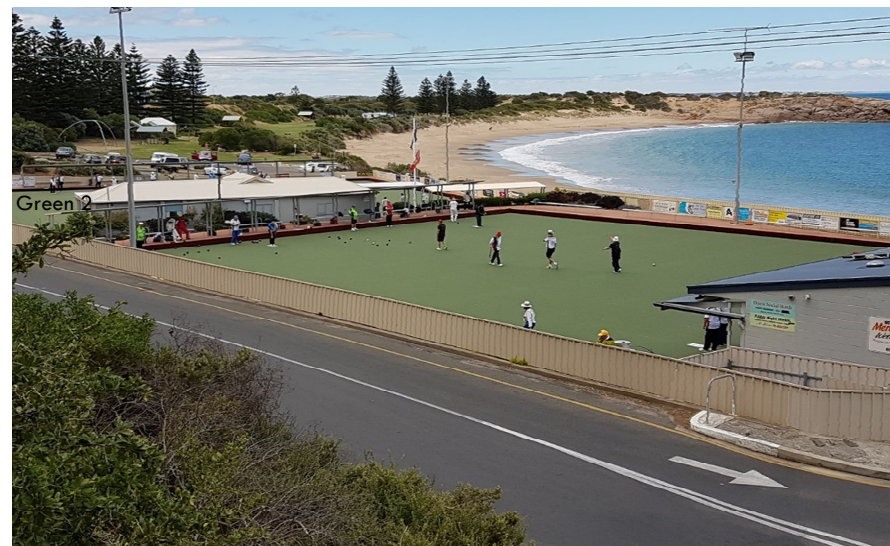
2018

Figure 21: The caravan park slowly expanded eastwards until the late 1980s when it was relocated into the dune section on the eastern end of the bay.

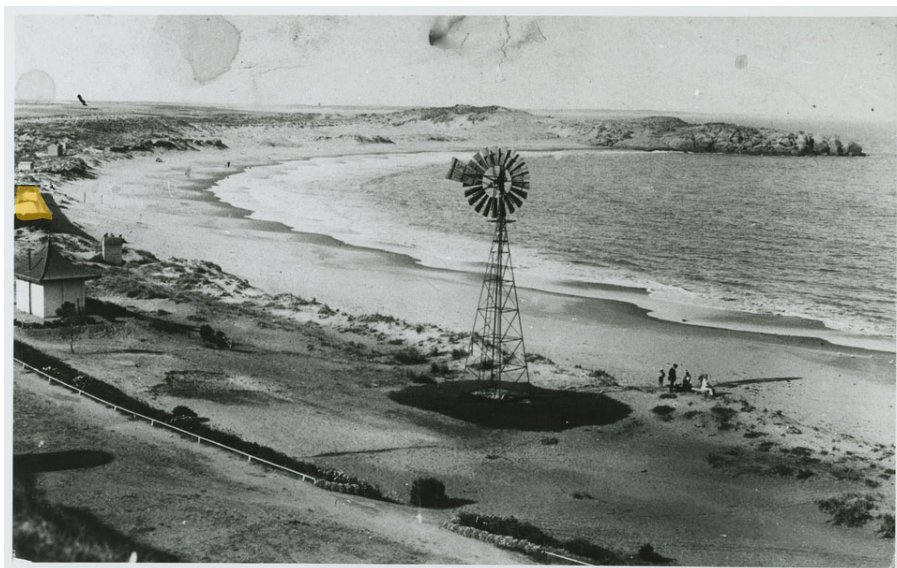
C.1910 (1913?)

Figure 22: The **final major intervention** in the bay was the relocation of the caravan park from the mid-section of the bay into the dune field at the eastern end. The State Library states that this photograph was taken C1910. However, it appears as if the **bowling green fence is in view**, and thus this may be 2013 or later. Source: State Library of SA.

Note the tidal swales in 1910. These appear about 20m away from the base of the dunes. Currently tidal swales reach the base of the current embankment. (Caution: direct comparison may not be valid, depending on the tidal regime at which the 1910 photograph was taken).

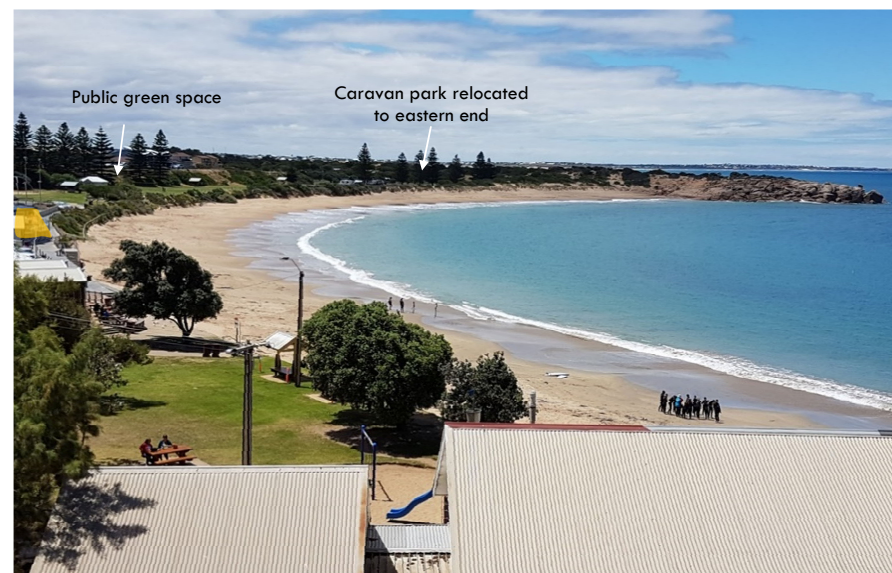
2018

Figure 23: Photograph taken from behind the SLSC. (Source M. Western, 2018)

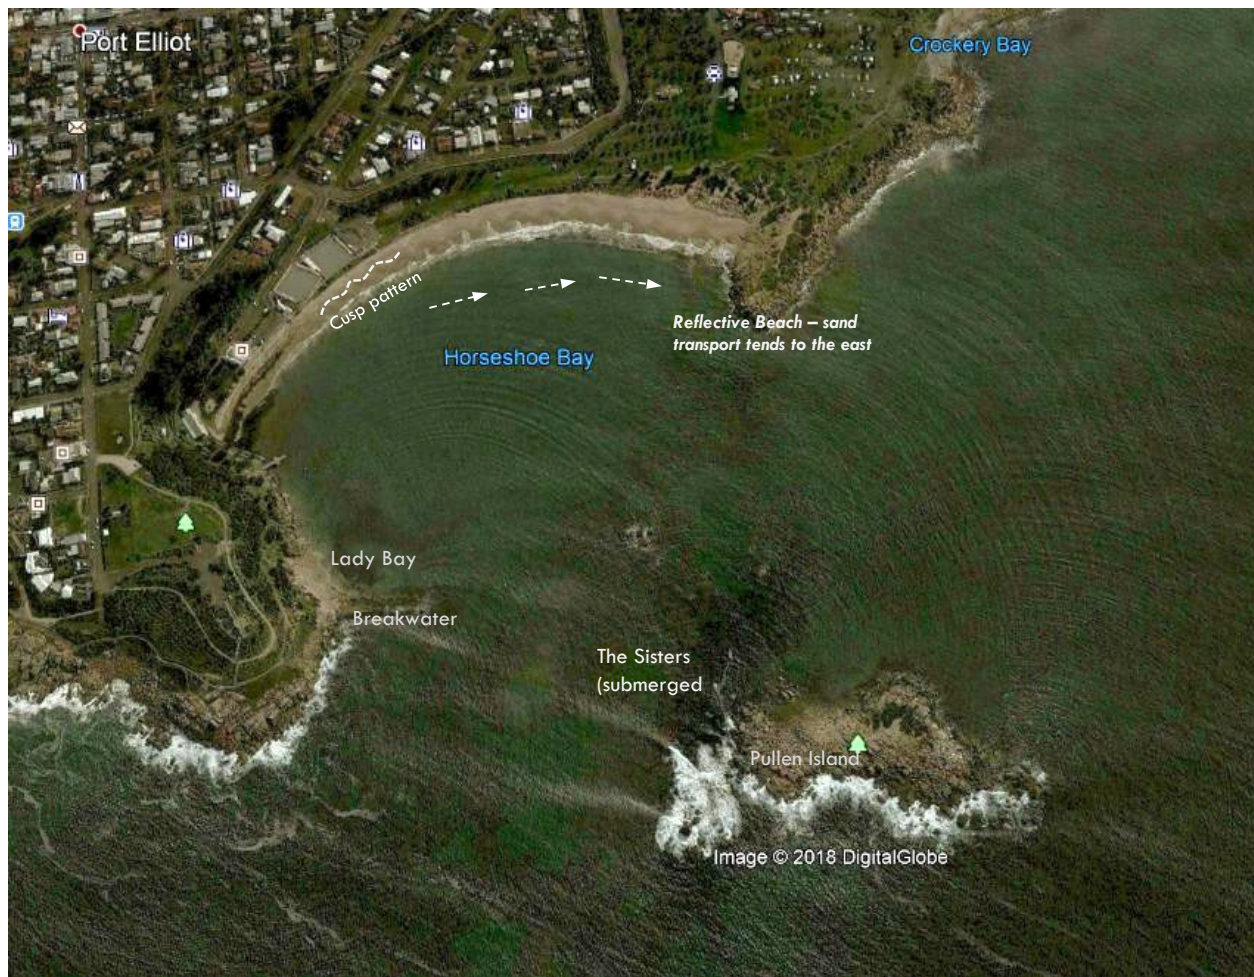
Figure 25: Wave and sand patterns in Horseshoe Bay

These headlands enclose a semi-circular bay 500m across at its widest. Waves approaching the bay are refracted (bent) and diffracted (spreading out after passing through openings) by the islands, headlands, rocky reefs and remnants of an artificial breakwater on the western side of the bay (Figure 25).

Horseshoe Bay has been formed by the various wave patterns that have interacted with softer sediments between the headlands. The overall slope of the beach is steep, and waves tend to run a long way up the shore.

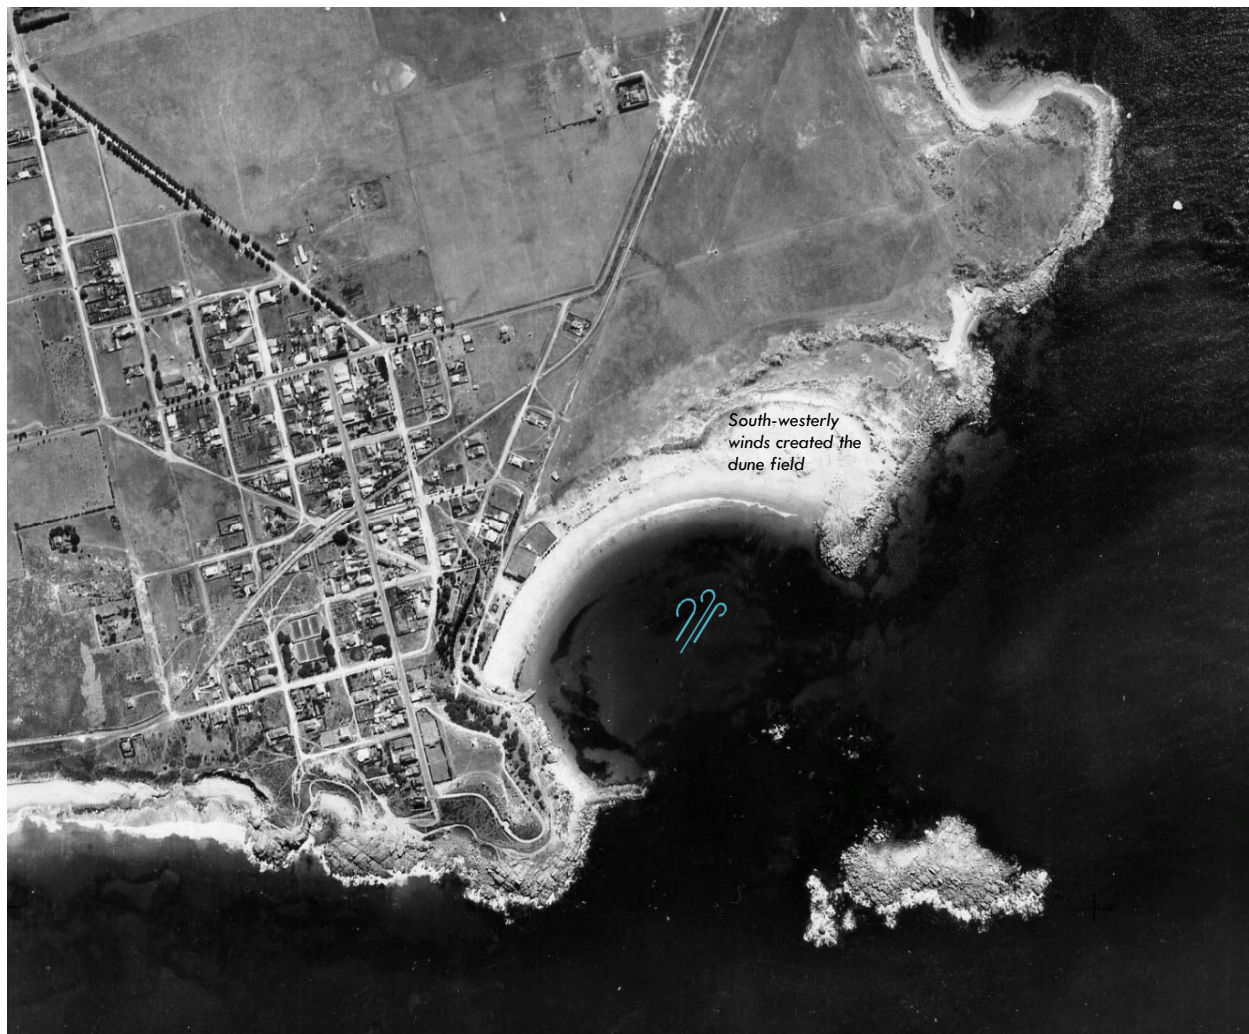
Figure 26: 1949 aerial photograph showing the bays, headlands and islands of the Port Elliot coast from Boomer to Fisherman Bay (R. Bourman)

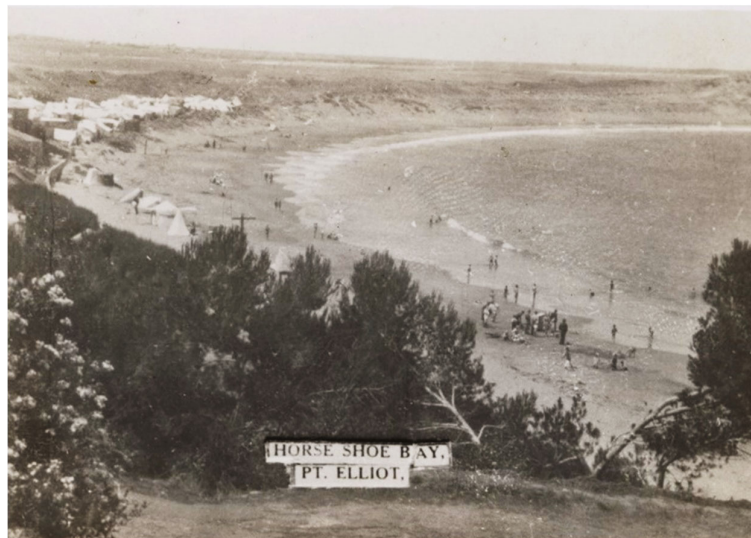
Figure 27: Photograph taken in 1944 (three years prior to the aerial photograph on previous page). Source: State Library of SA.

- The dune system is far higher in 1944, elevated above the former caravan park area (see Fig. 27)
- The volume of sand at the back of the beach is far greater in 1944 (and therefore the overall slope is greater)
- Tidal cusps appear much closer to the back of the beach in 2018.

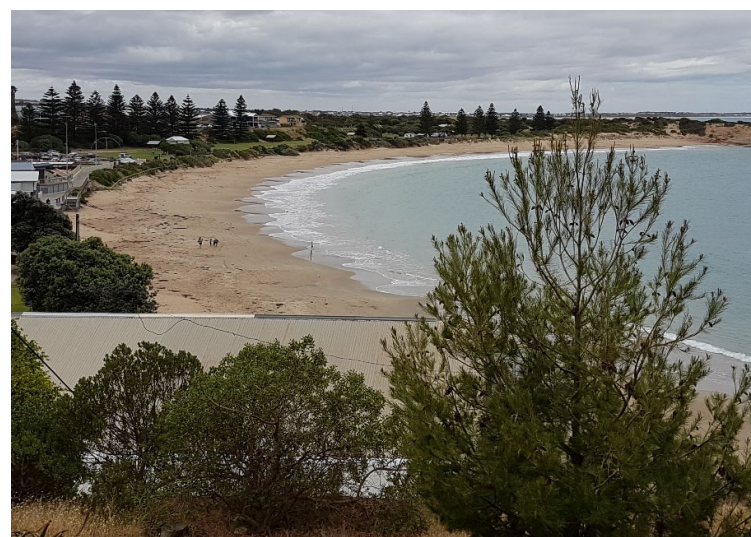
Figure 28: Photographs taken on 14 November 2018 (M. Western)

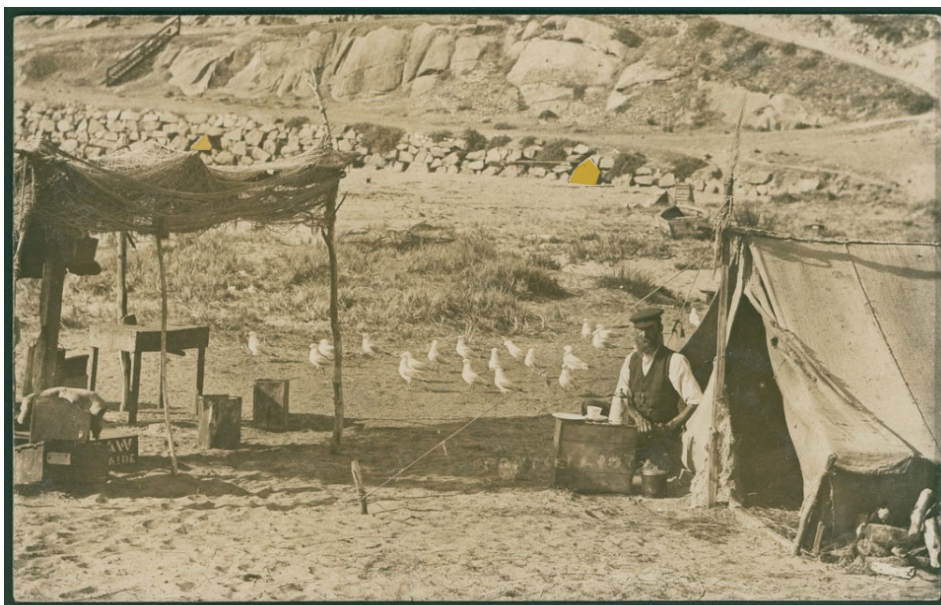
C.1908

Figure 29: Fisherman Camp, circa 1908 (State Library of SA).

- Note the presence of vegetation and a small dune which would have been out of tidal range in 1908.
- Note the line of seaweed in 2018 from a previous event (unknown). We know that tides do get to the wall (almost).
- Note the position of the yellow line. A comparison between the two sets of rocks reveals that this line replicates exactly the curve of the beach in 1908.
- Sand levels are not excessively low in 2018 picture. Sand is currently covering the base of the ramp, whereas in winter it can be 200mm lower. The point in the context of this study is that the sand is not excessively low in November 2018.

- The profile of the beach appears to have receded ~12m.
- The low dune and vegetation observed in 1908 demonstrates that the tide was not encroaching into this region at the time (Figure 29).
- High tide now appears ~20m closer to the wall. Higher tide events reach the wall.
- Sand levels immediately adjacent the wall appear at similar height to 1930s.

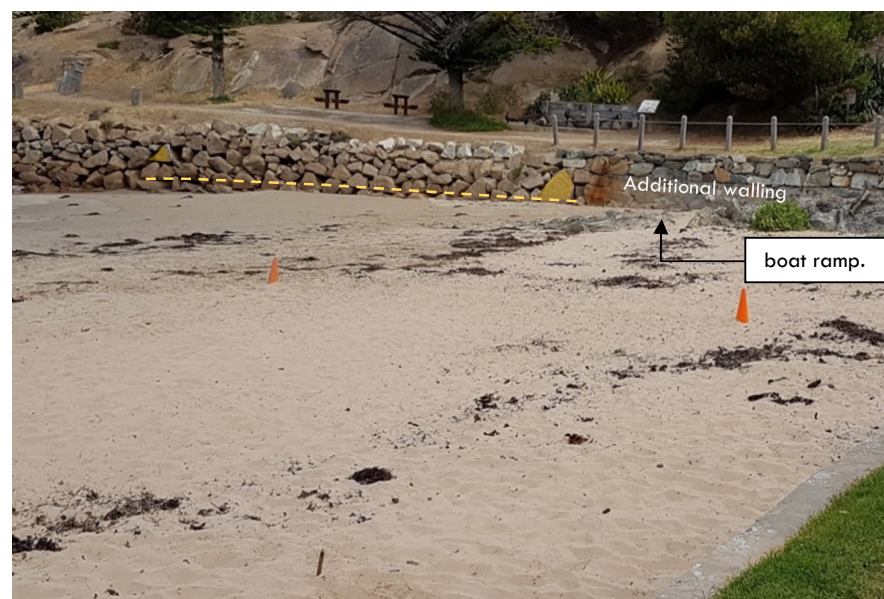
Figure 30: Horseshoe Bay, M. Western, 14 November 2018 (taken from similar location as the seated fisherman)

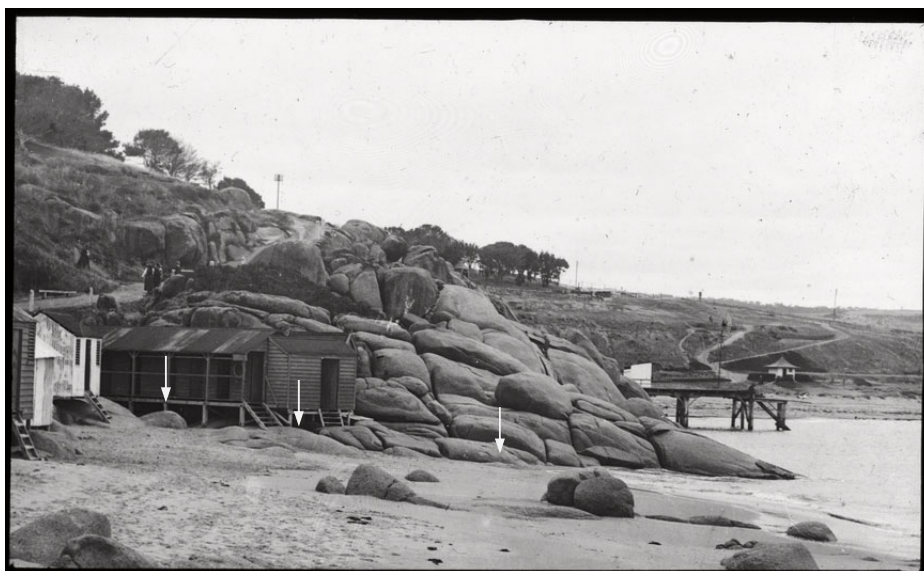
Figure 31: Photograph by Tenterfield in 1915 (State Library).

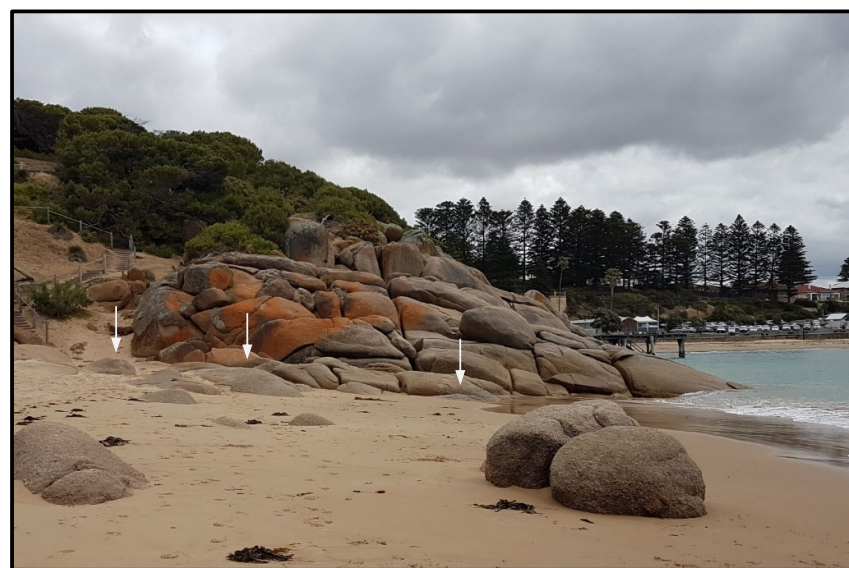
2018

Figure 32: Lady Bay (M.Western, 2018)

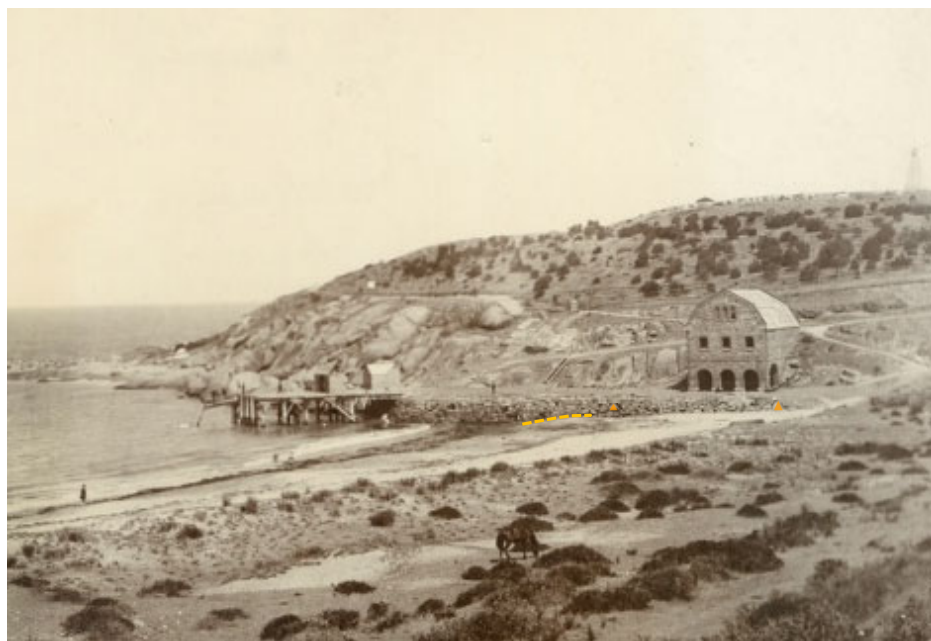
C.1890

Figure 33: Photograph of Port Elliott foreshore, 1890, (State Library).

This study compares the height of all the tides by analysing seaweed lines and high tide marks in the context of one (or two) rocks that remain in same position as 1860. Click on link below to access the full comparison.

Comparisons between photographs over time show seaweed strands at approximately 20m from the sea wall. In current photographs seaweed strands (and tidal marks) are found very near the sea wall.

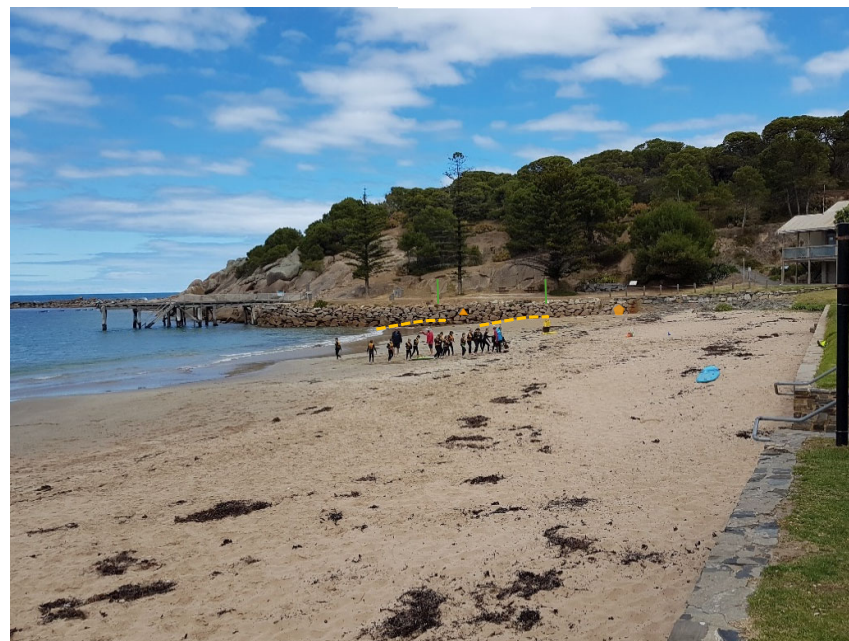
2018

Figure 34: Photograph by M. Western (2018).

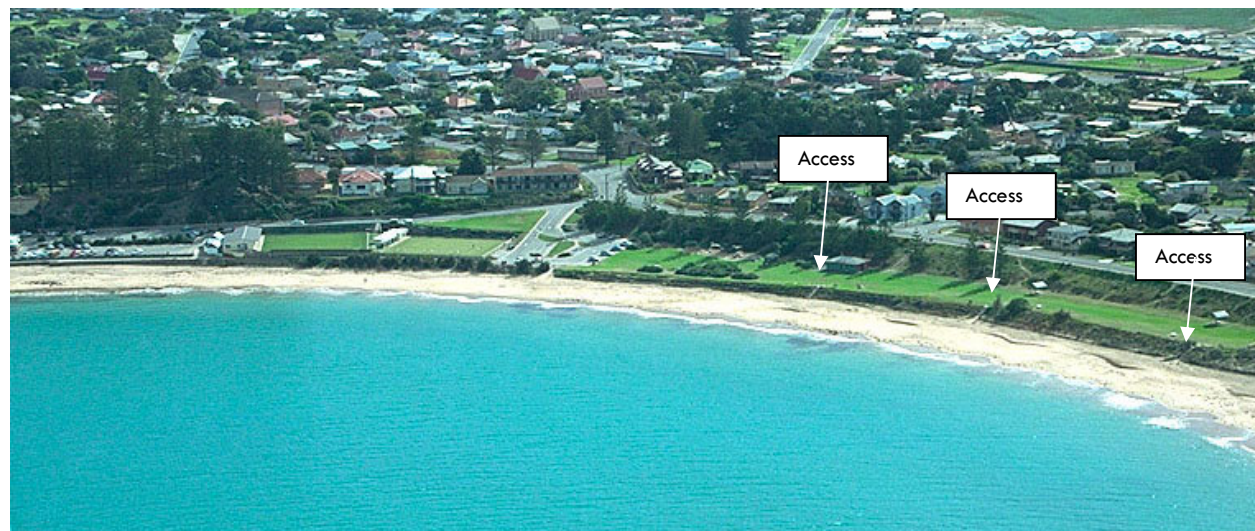
Figure 38 and 39: Aerial photographs taken by Coastal Management Branch (DEW, 2003)

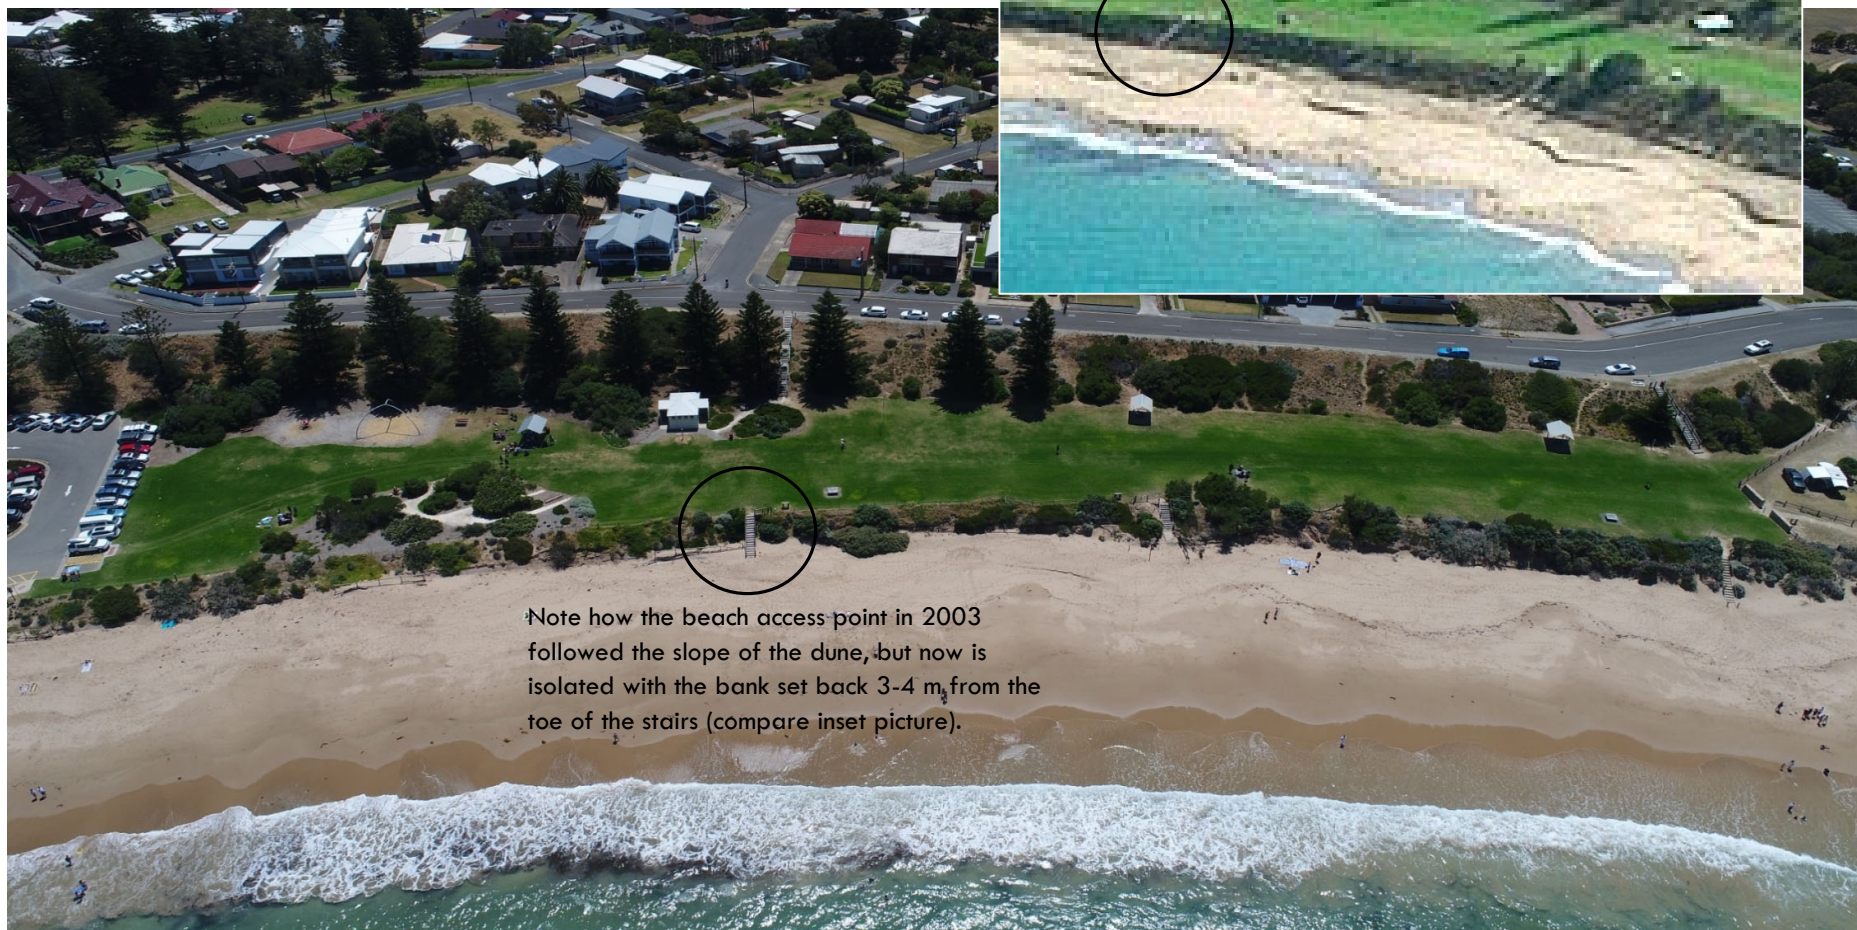
Changes 2003-2018

Figure 41 and 42: Comparison between backshore profiles of 2003 and 2018, DEW, 2003.

Since 2003, parts of the frontal dune have been eroded back by ~4m and the dune escarpment has become increasingly vertical (see inset diagram).

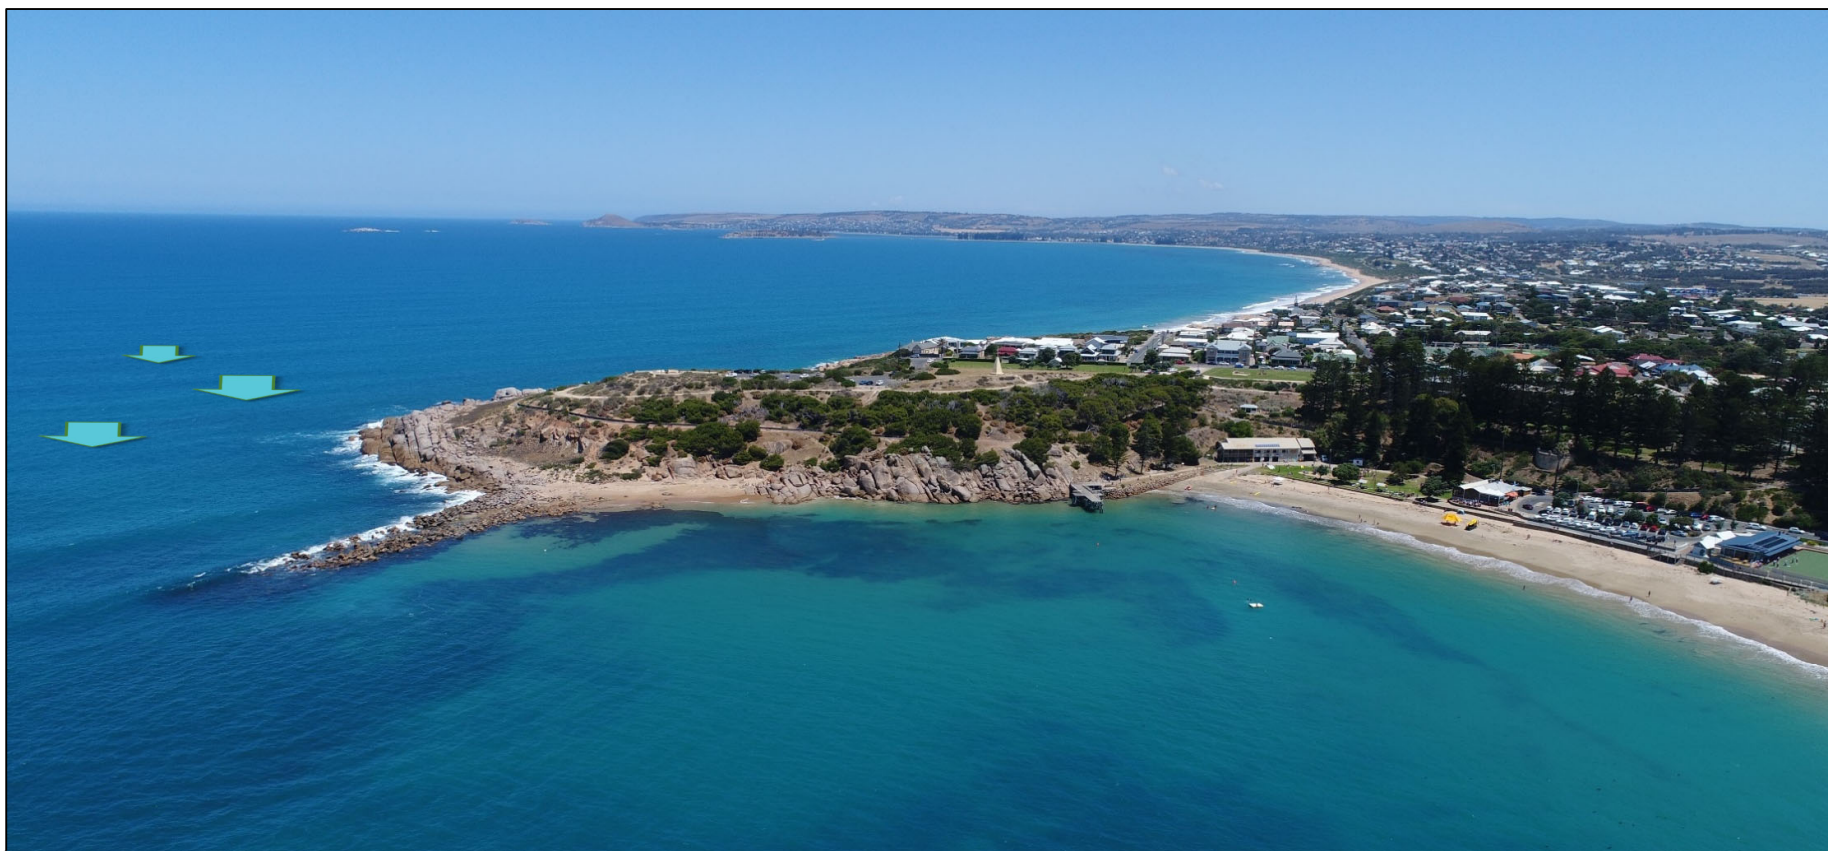
THE BREAK-WATER

Breakwater installed in 1854 to protect the bay from south-westerly swells. The breakwater has also protected the western end of the bay from swells that would normally 'wrap around' Freemans Nob.

The breakwater has broken down from impact of seas. The first breakdown occurred shortly after construction. In the 1980s Council observed that it had 'deteriorated rapidly'. See photographic comparison next page.

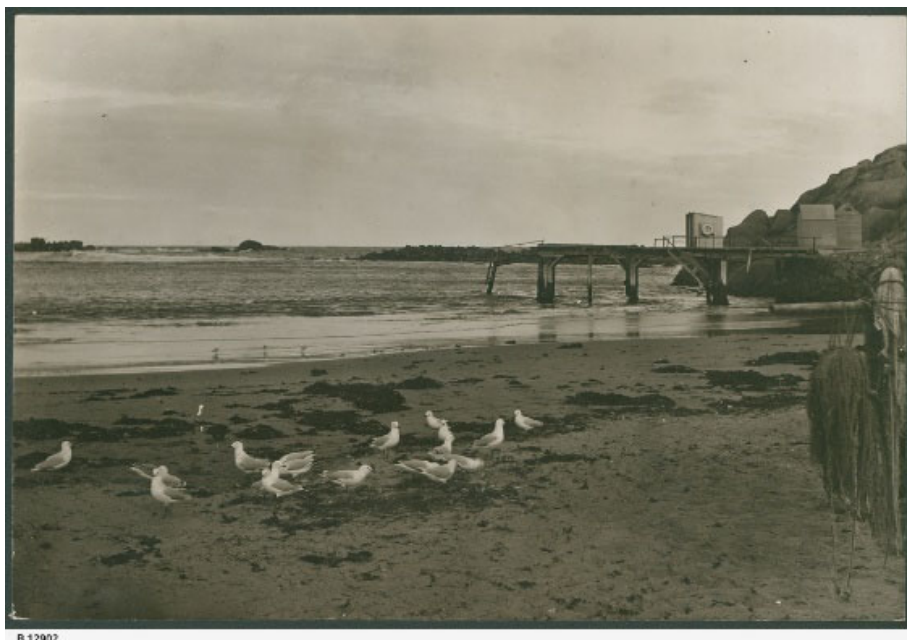
C.1942

Figure 43. The point of this comparison is to quantify changes to the breakwater. Note the lower section at the end of the breakwater. The archives say that blocks were dislodged in the first storms, and perhaps this was the location. Note that the breakwater in 1942 is almost 'level top' aligned with the former jetty. Source: State Library, permissions pending.

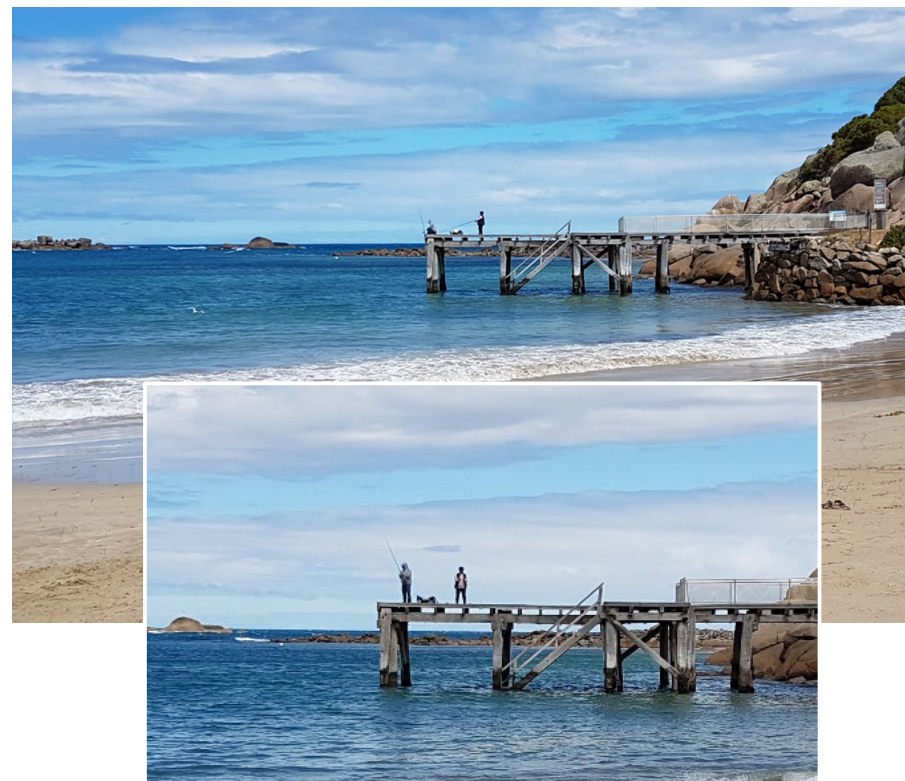
2018

Figure 44: In the first photograph on the right, an attempt was made to align the top of the jetty in a similar way. However, the second photograph makes it very plain how much height the breakwater has lost since 1942. The lower section is still seen in current day. The archives above noted that in the 1980s, there was a 'rapid disintegration' of the breakwater. This was also the time of high erosion and storm activity in the bay.

Research questions: What does a lower top to the breakwater mean in the context of sea level rise? Could the lower top, and a higher sea actually increase the height of the waves into the bay?
