Coastal Adaptation Study for Alexandrina Council

PORT ELLIOT

Report to be cited as: Western, M, Bourman, R., Hesp, P (2019) Coastal Adaptation Study for Alexandrina Council (Cell SF8 Horseshoe Bay) prepared by Integrated Coasts, South Australia.

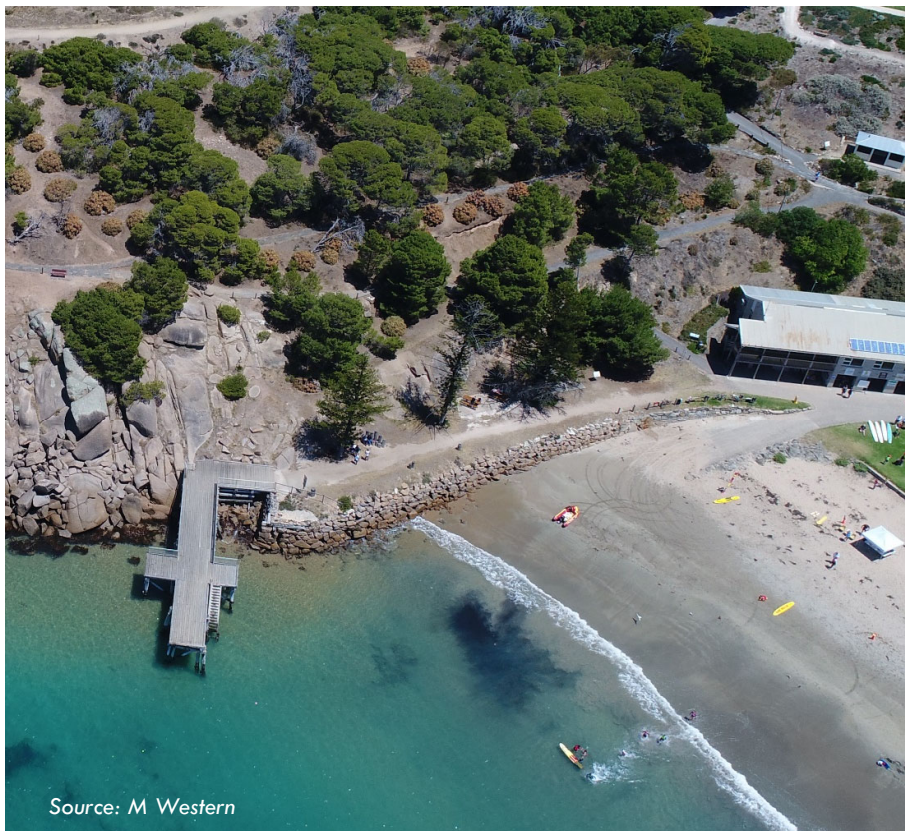
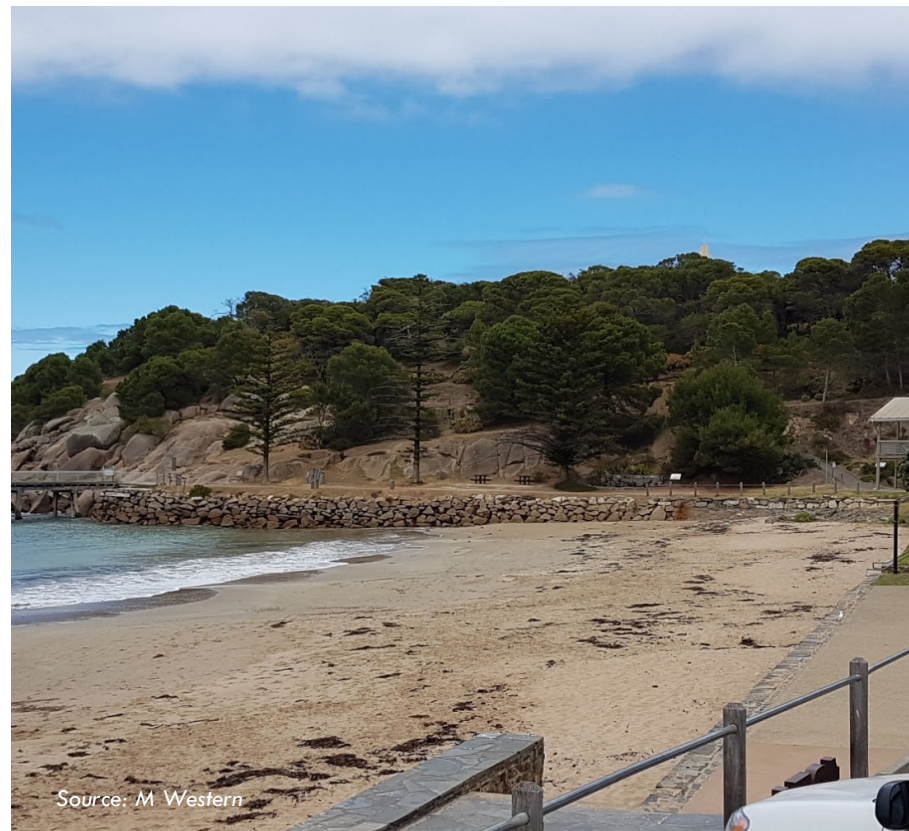
JETTY RETAINING WALL

Although most of the wall was constructed in 1850s, the wall appears to remain in appropriate condition to serve the purpose of retaining the accessway to the jetty.

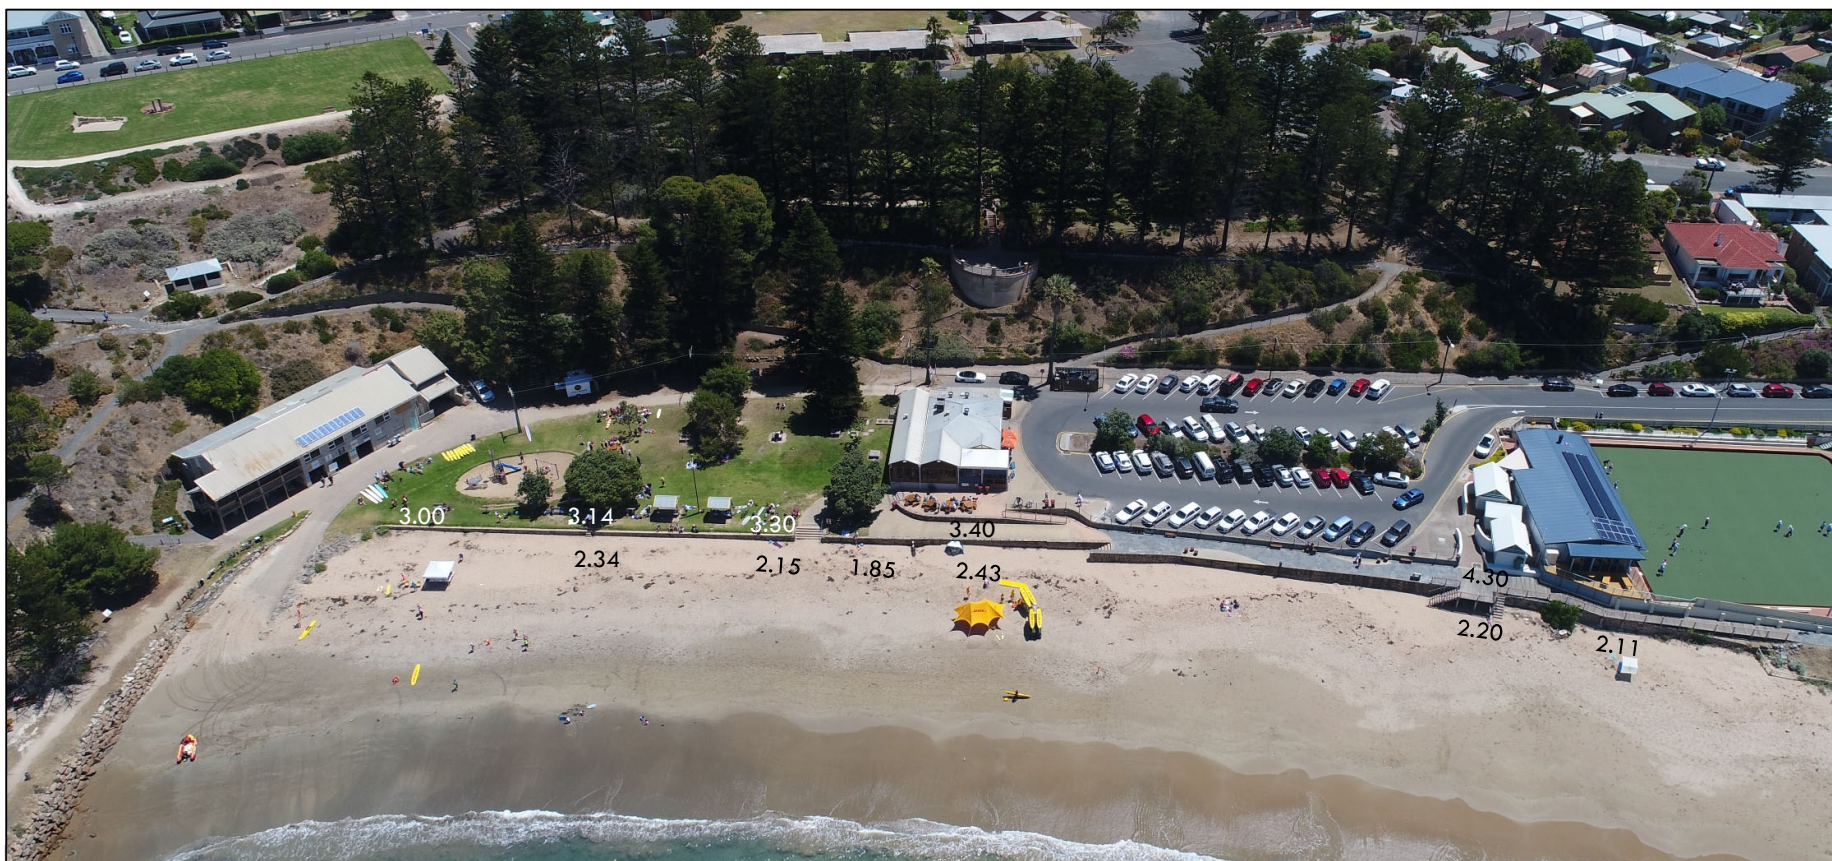
STONE WALL SECTION

Strategy
 Low stone wall installed circa 1930 to separate the reserve from the beach and to provide elevation to the carpark, and not primarily to protect from actions of the sea. See earlier tidal analysis that shows that it is unlikely that seawater encroached to the wall very frequently.

Performance
 Damage reports in the 1980s stated that the wall was built without foundation. Walling in front of the carpark failed in two places and was reconstructed. The wall was constructed forward of the old line, and new entrance provided. A section of wall requires repairs (see next page).

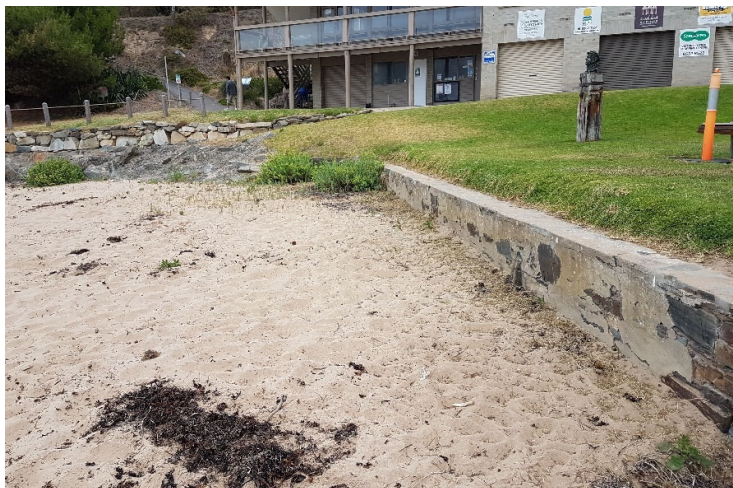
Stone wall on eastern end appears straight and sound. Mortar appears to be wearing away. The wall does not suffer routine impact from the sea. Routine impact is likely to cause the wall to deteriorate (Fig 45).

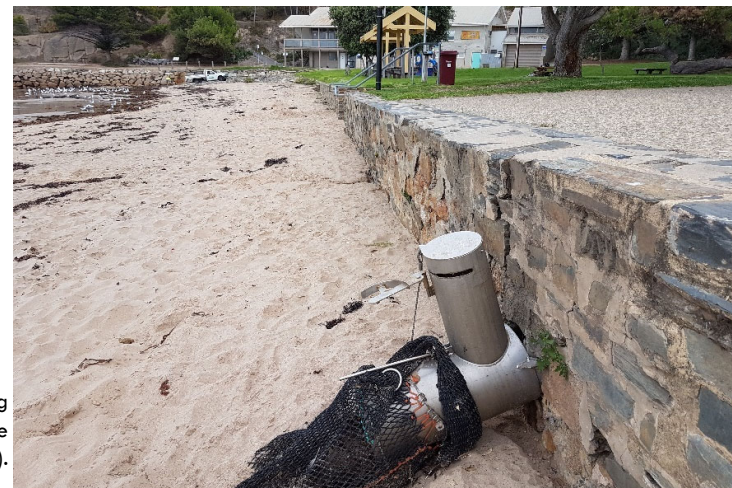
Stone wall in front of café is cracking and moving forward. Repairs are likely required (Fig 46).

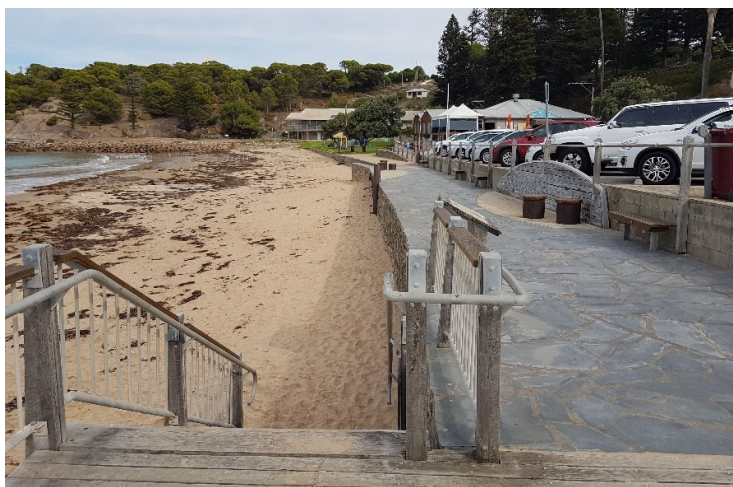
Walling in front of the carpark was replaced in the 1980s and is in sound condition (Fig 47).

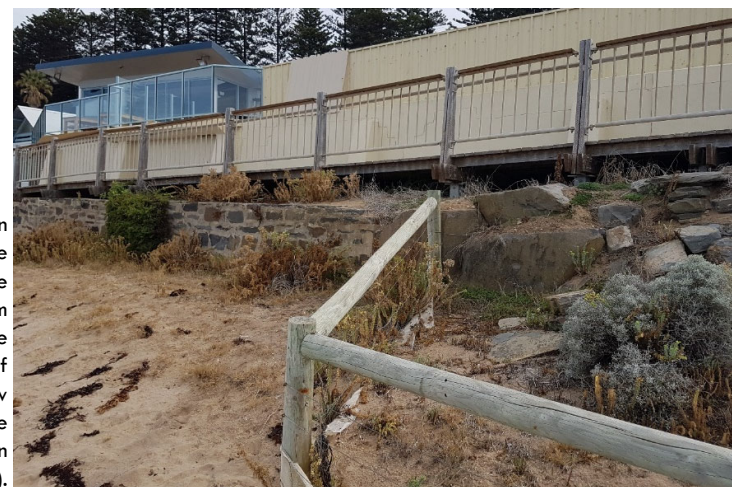
A board walk has been constructed over the top of the western end of the wall. While this tends to hide the wall from view, the wall still must be capable of protecting the base of the bank. Seaweed strands show location of a recent high tide. The wall appears to be less stable in this location (Fig 48).

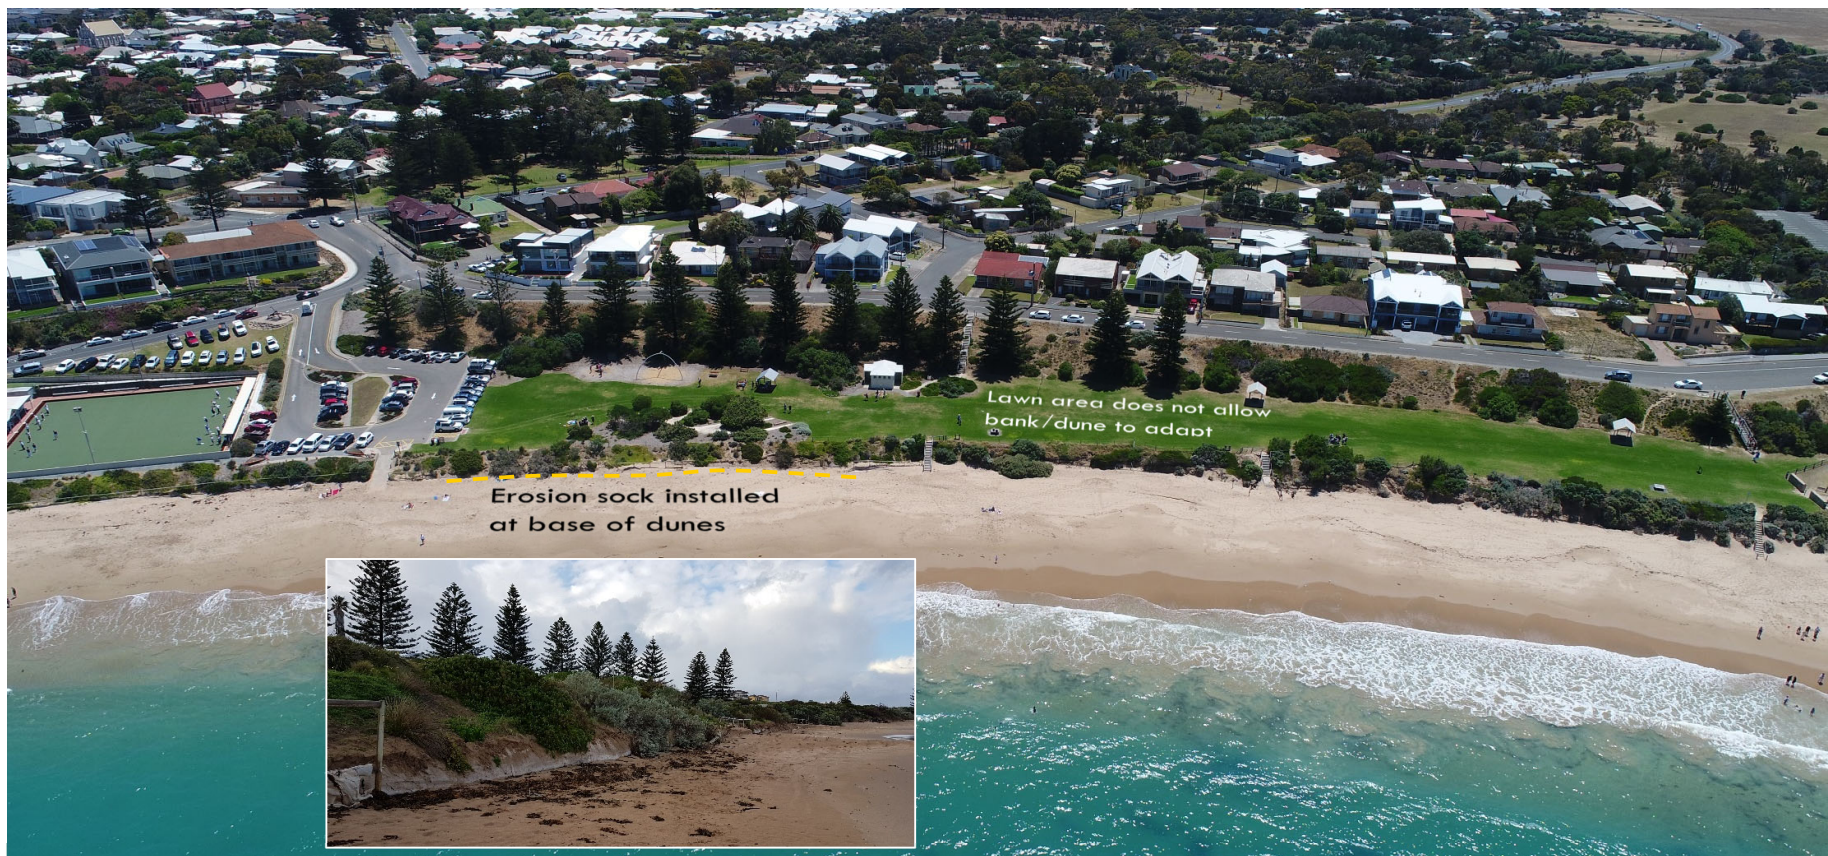
EMBANKMENT SECTION

Strategy
 Erosion in the 1980s necessitated action to slow erosion. Pedestrian access ways were limited, dunes fenced, and dunes/embankment vegetated. This strategy appeared effective until circa 2008 (P.37).

Performance
 Over the last ten years, erosion has increased. It is likely that sand level in the centre of the bay have dropped, combined with increases of sea level, has seen increasing recession of the dunes, and the escarpment of the bank becoming vertical. An erosion sock was installed in 2013 to a section of the bay.

The geomorphic analysis (p.37-39) showed that erosion was first noted in the 1980s (and an erosion reduction strategy employed). But the embankment has receded since 2003 and some remedial action is required.

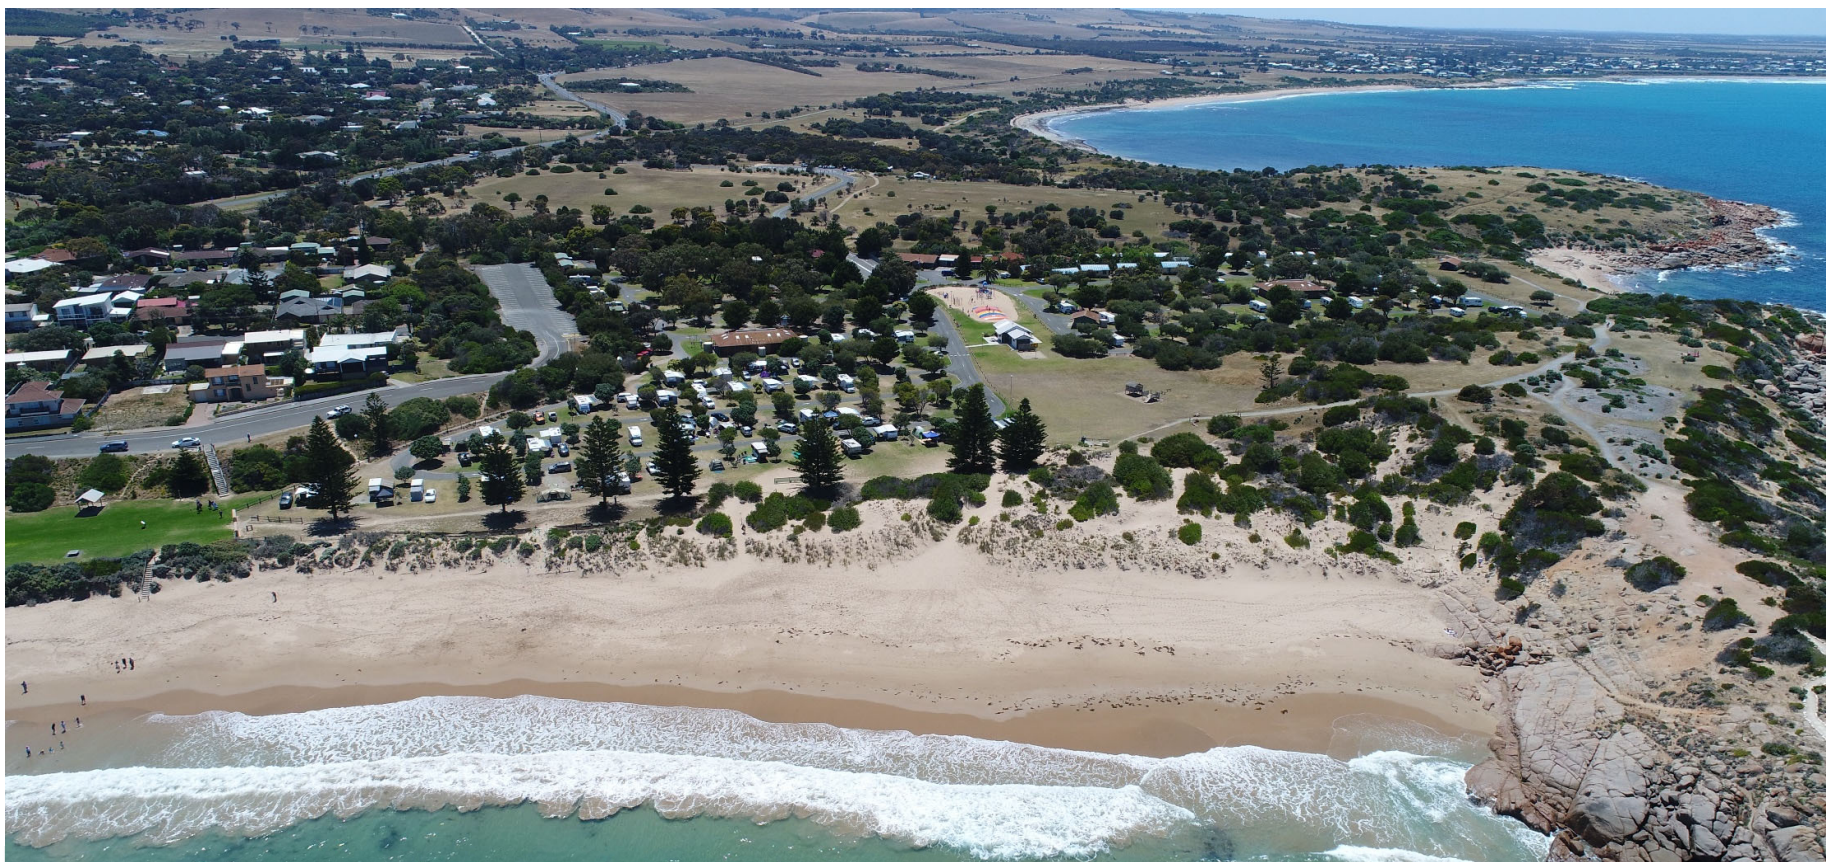
NATURAL DUNE SECTION

Strategy
 Erosion in the 1980s necessitated action to slow erosion. Pedestrian access ways were limited, dunes fenced, and dunes/embankment vegetated. This strategy appeared effective until circa 2008 (P.37).

Performance
 The reflective nature of the bay tends to move sand to the east and this nourishes the dunes. Excess sand accumulates behind the dunes in the caravan park and is removed periodically.

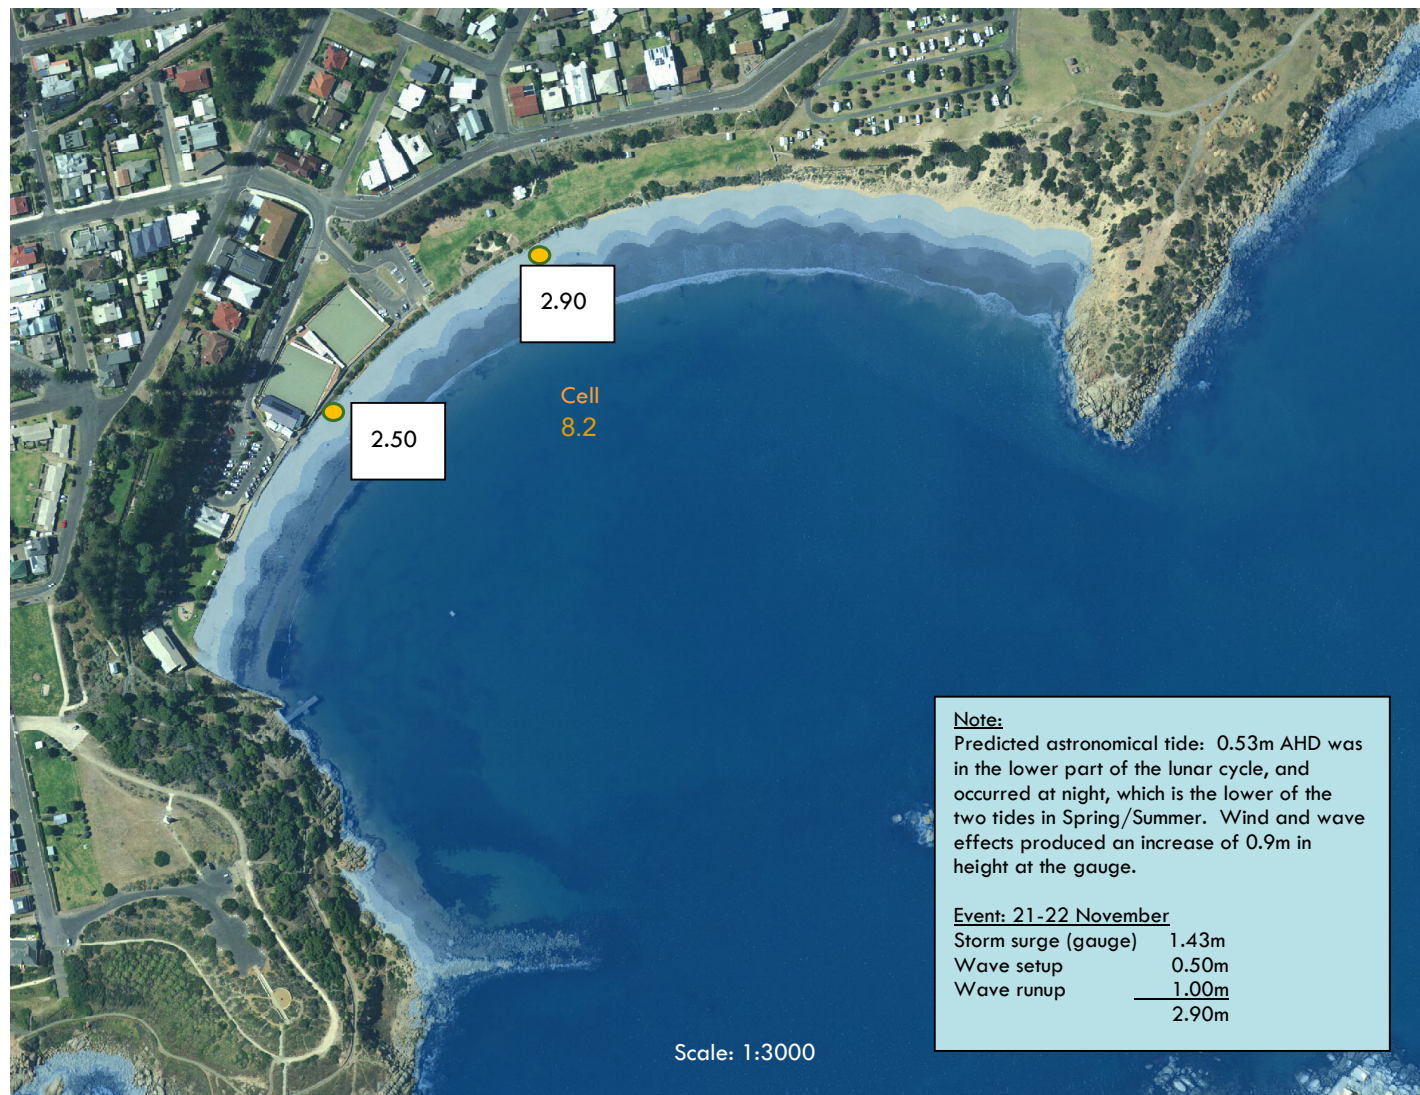
Predicted astronomical tide: 0.53m AHD was in the lower part of the lunar cycle, and occurred at night, which is the lower of the two tides in Spring/Summer. Wind and wave effects produced an increase of 0.9m in height at the gauge.

If this event did occur, then it is very likely that substantial damage would occur to the embankments in at the bowling club and green space (middle of bay). Older walls may also be impacted.

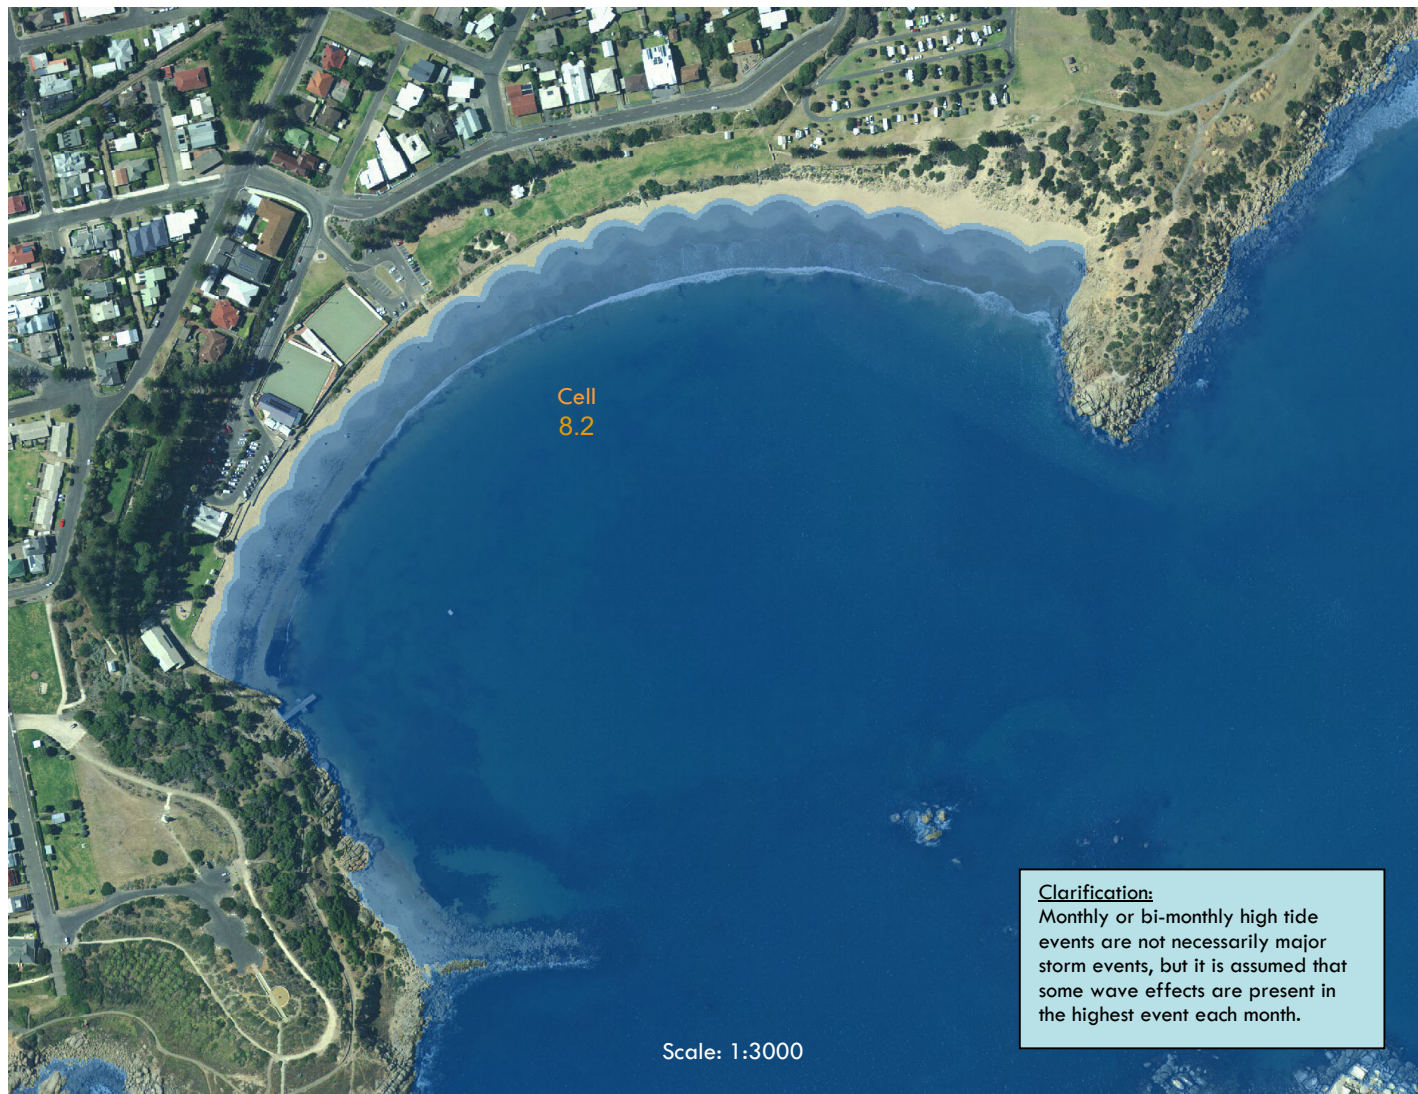
Monthly or bi-monthly high tide events are not necessarily major storm events, but it is assumed that some wave effects are present in the highest event each month.

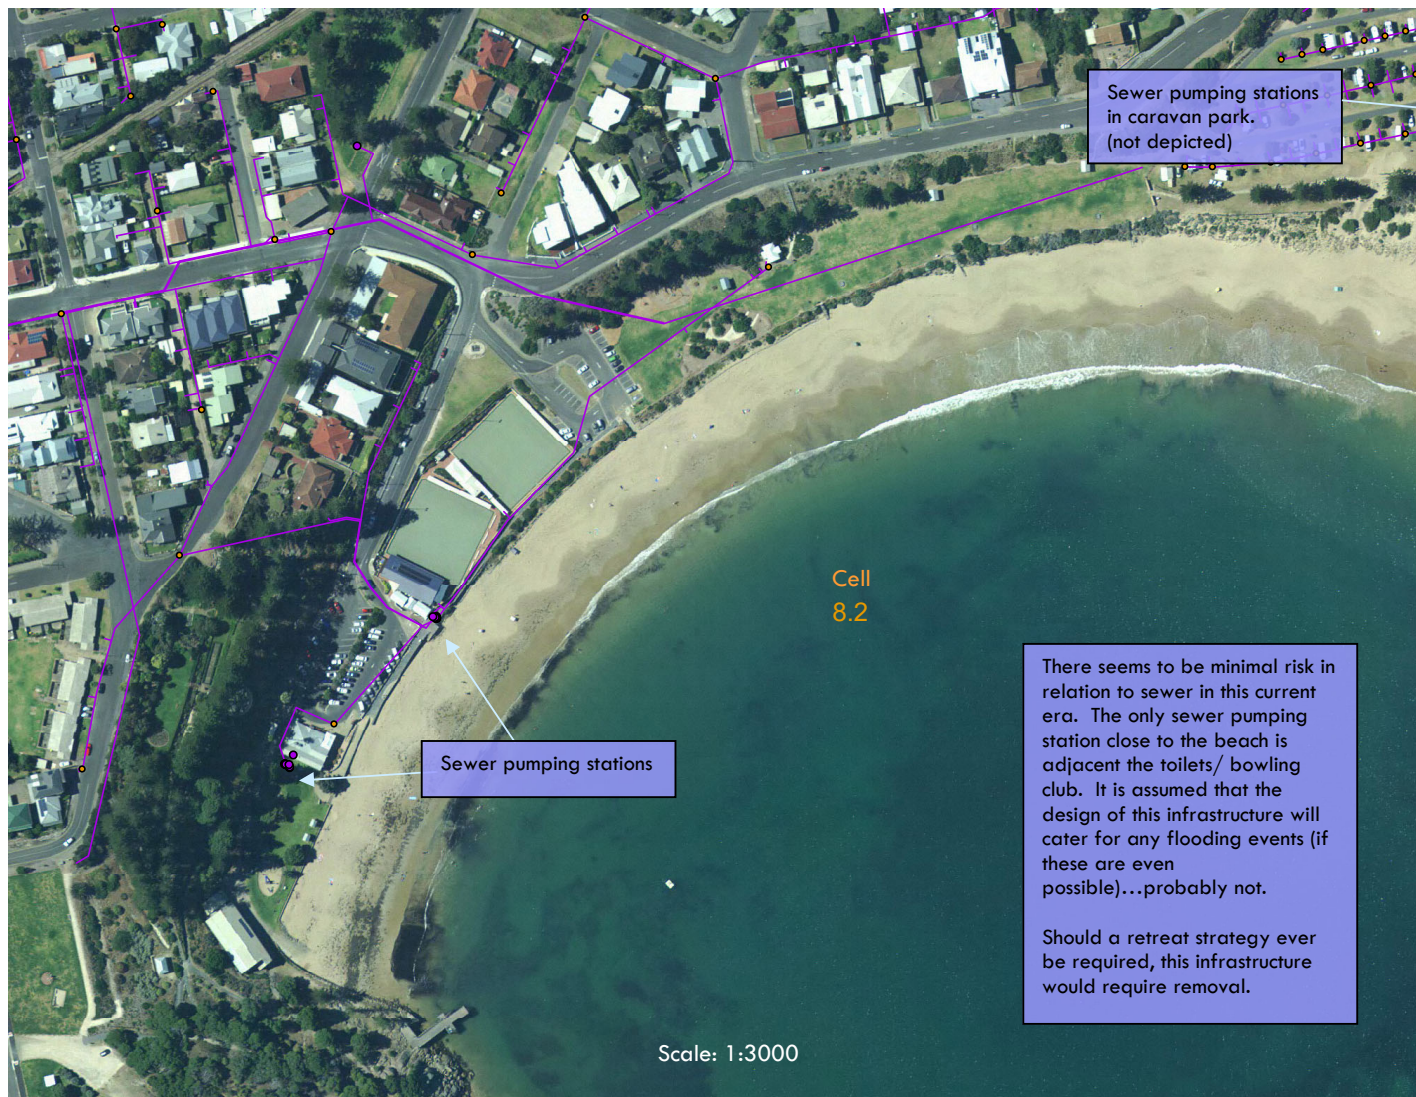
There seems to be minimal risk in relation to sewer in this current era. The only sewer pumping station close to the beach is adjacent the toilets/ bowling club. It is assumed that the design of this infrastructure will cater for any flooding events (if these are even possible)...probably not.

Should a retreat strategy ever be required, this infrastructure would require removal.

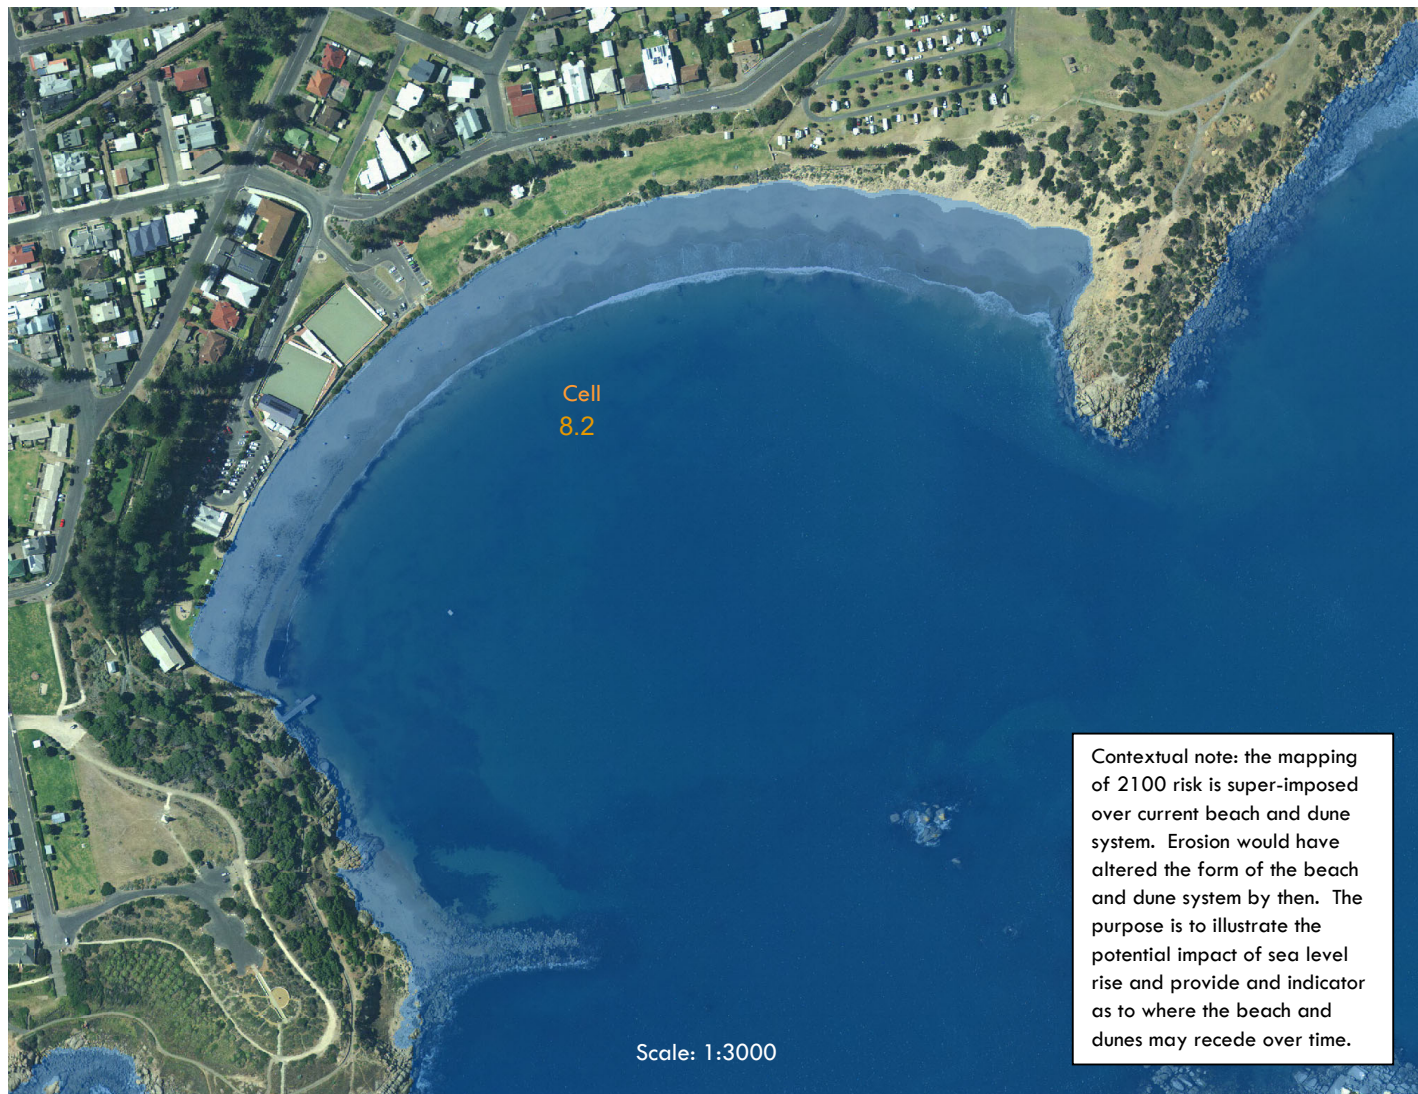
Contextual note: the mapping of 2100 risk is super-imposed over current beach and dune system. Erosion would have altered the form of the beach and dune system by then. The purpose is to illustrate the potential impact of sea level rise and provide an indicator as to where the beach and dunes may recede over time.

Scale: 1:3000

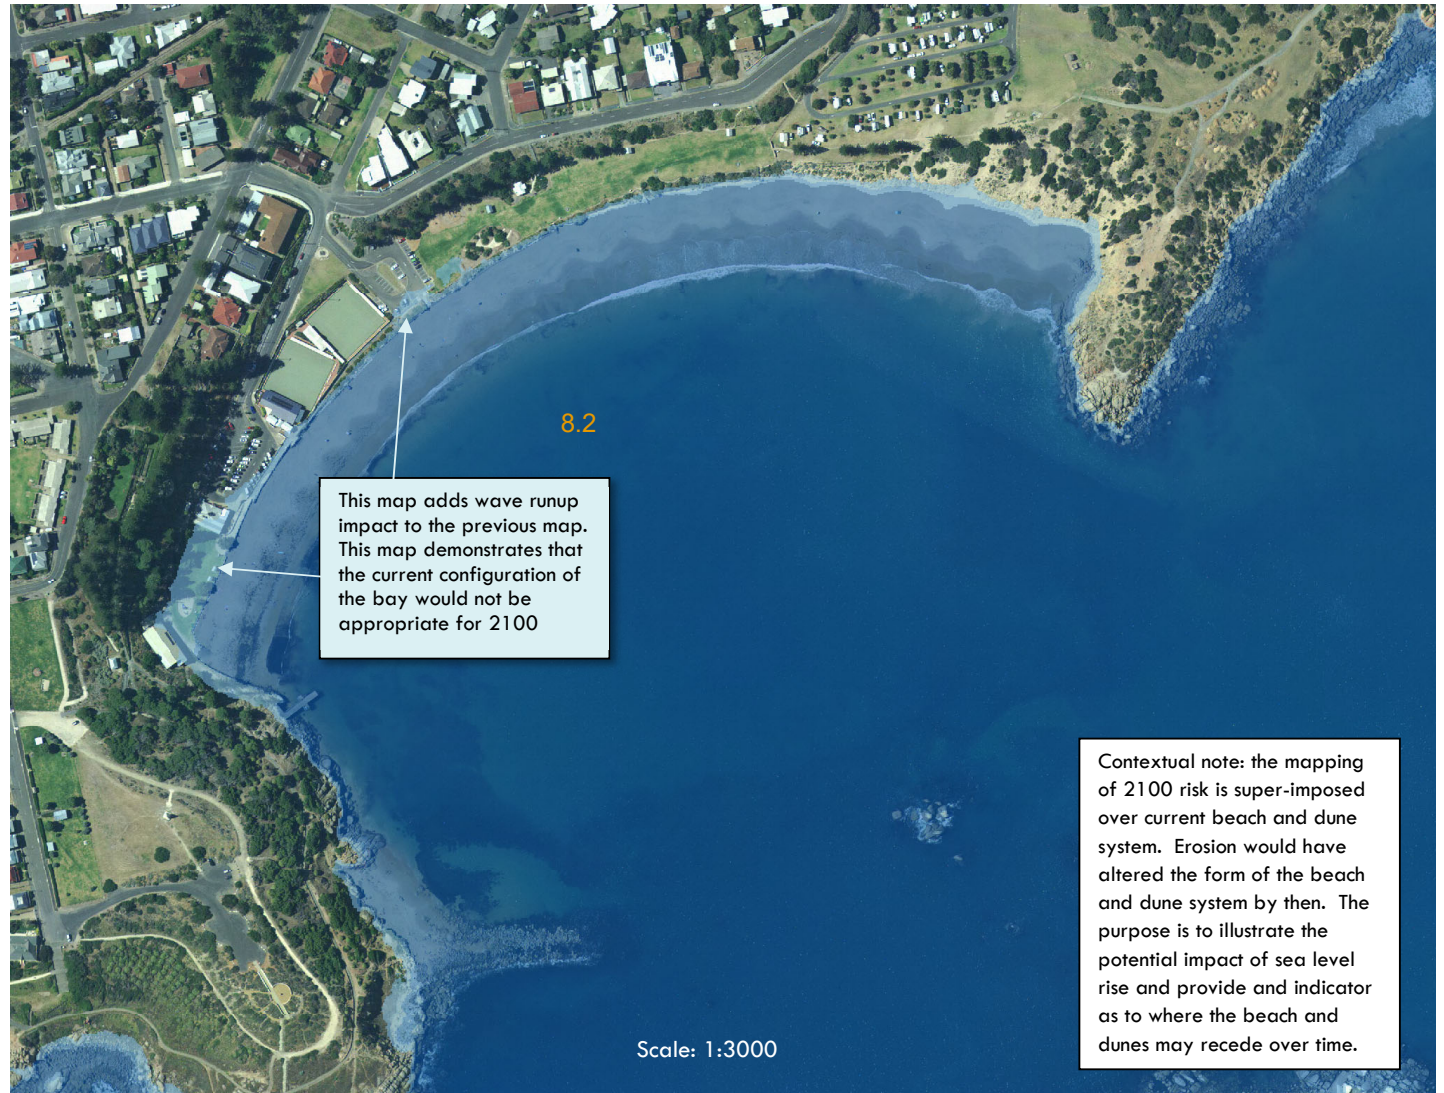
Contextual note: the mapping of 2100 risk is super-imposed over current beach and dune system. Erosion would have altered the form of the beach and dune system by then. The purpose is to illustrate the potential impact of sea level rise and provide an indicator as to where the beach and dunes may recede over time.

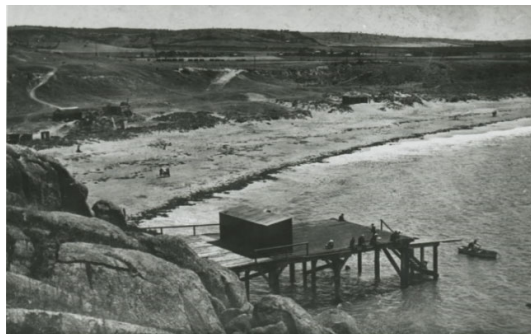
Figure 52: Geological layout of Horseshoe Bay 1900

One question to ask is – in the context of sea level rise, what does the bay want to do? To answer that question, it is helpful to review the form of the bay in 1900. The bay was formed by a receding sea level which left a gentle slope of softer sediments. As the seas rise, the bay will want to respond in reverse. The shoreline would recede.

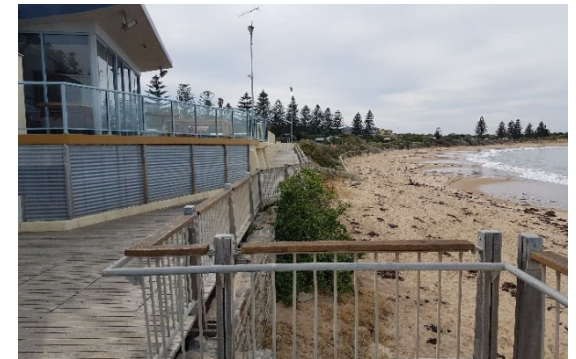
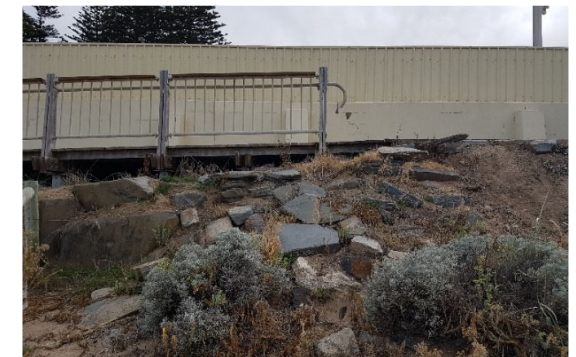
Figure 53: Bowling club has created an elevated front edge (M. Western 2018)

However, human intervention has placed a rigidity in the bay with hard structures. But more than that, to create spaces that are flat enough for bowling greens and carparks, the front edge has been raised above the natural form of the bay.

As noted on p.54, human intervention has imposed a rigidity into Horseshoe Bay. It is recommended that the fundamental adaptation principle to be adopted for Horseshoe Bay is to replace this rigidity with **increasing flexibility** from the western portion of the bay to the eastern part of the bay. The reason for adopting this approach is that western end is the most sheltered and will be the area most able to accommodate the impacts of sea level rise. As we move around the bay to the east, the impacts from wave effects, which will be exacerbated by sea level rise over the course of the century, will need to be absorbed in some way by the back shore.

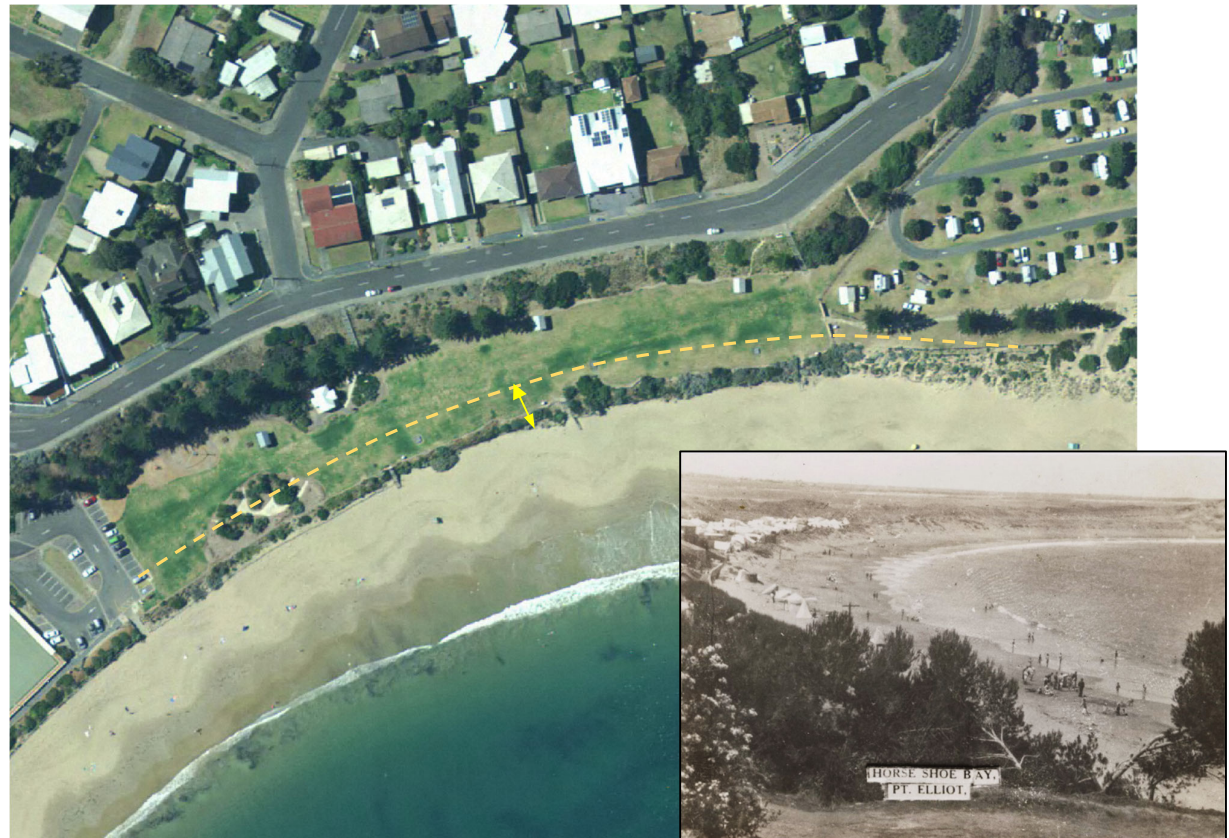
Figure 56: Horseshoe Bay circa 1900 (SA State Library)

A reminder of the profile of the beach in 1900 is provided below. The proposed sand dunes would be less in size, but the principle is the same.
