Coastal Adaptation Study  
for Alexandrina Council  
**MIDDLETON CREEK**

Cell SF6

By Integrated Coasts: Western, Hesp, and Bourman (2019)

Report to be cited as: Western, M, Bourman, R., Hesp, P (2019) Coastal Adaptation Study for Alexandrina Council (Cell SF6 Middleton Creek) prepared by Integrated Coasts, South Australia.

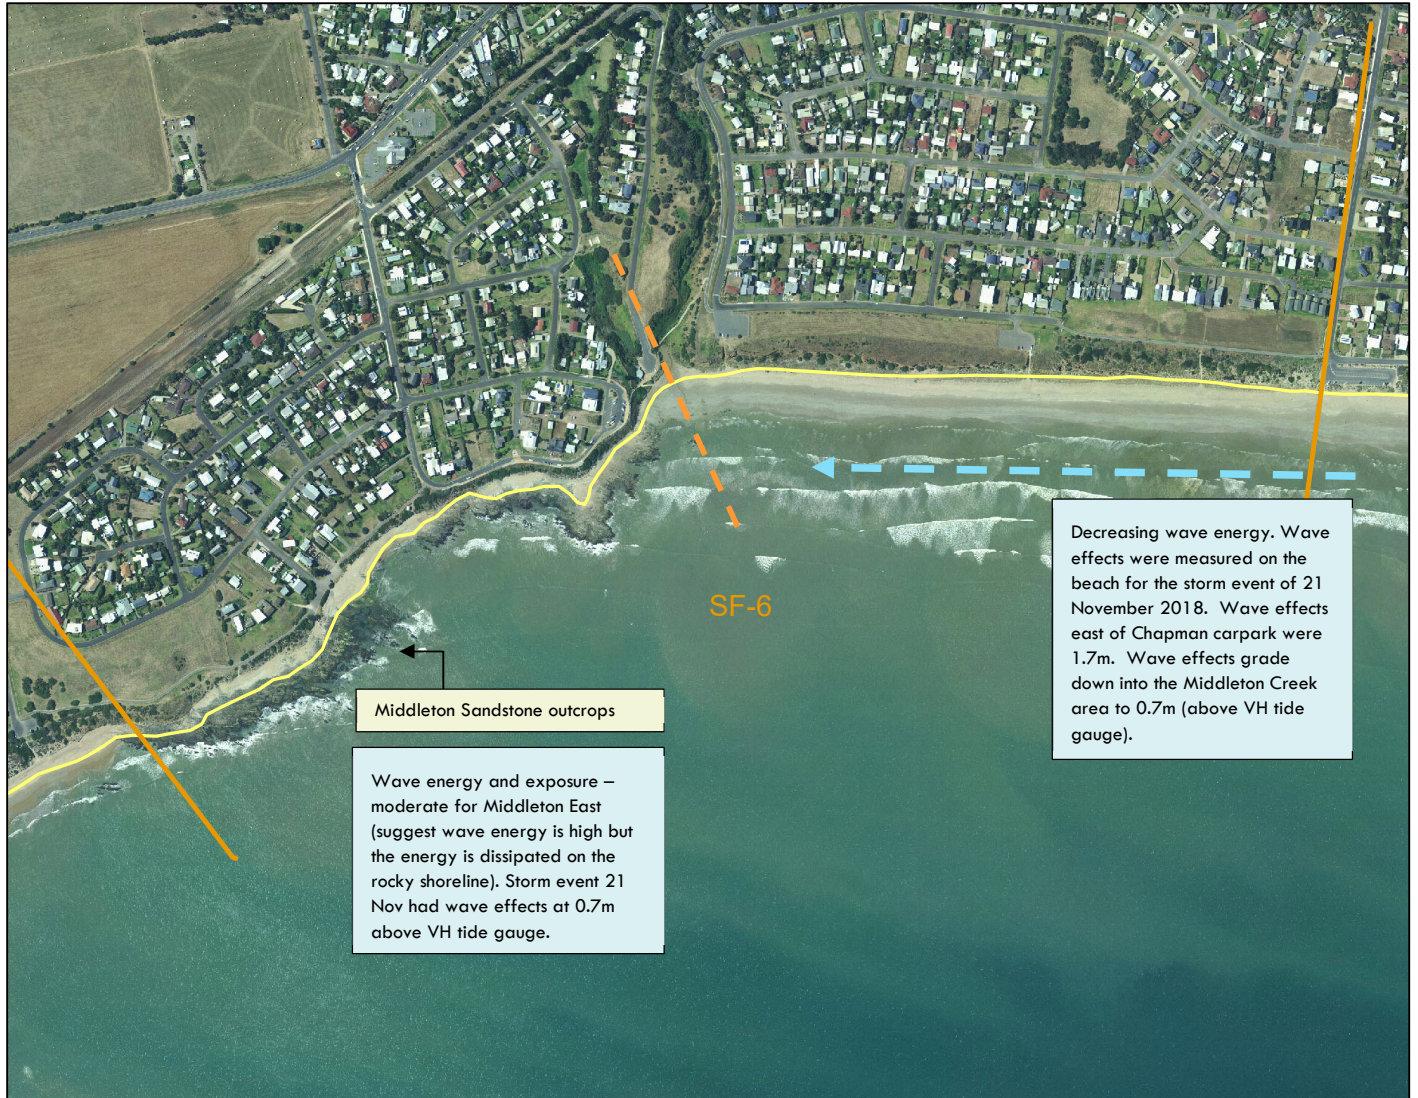
Middleton Sandstone outcrops

Wave energy and exposure – moderate for Middleton East (suggest wave energy is high but the energy is dissipated on the rocky shoreline). Storm event 21 Nov had wave effects at 0.7m above VH tide gauge.

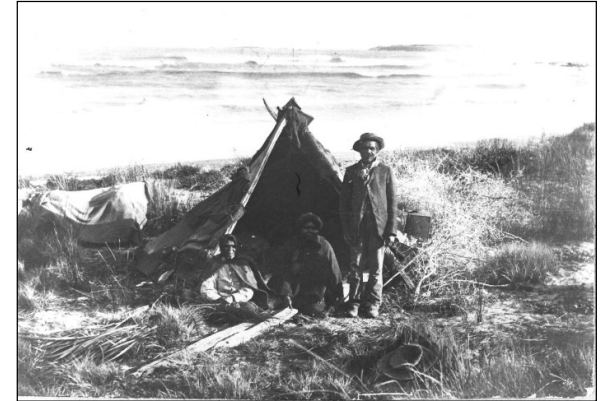
Figure 5: Early photograph of camp on dunes at Middleton Beach (the inference is that these dunes are in front of cliffs?)

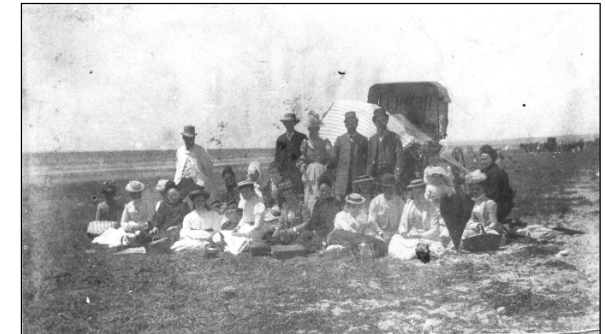
Figure 6: View of Middleton Beach in 1890s showing its broad extent. The people in the photograph are those of the Basham family. Photo kindly provided by Miss P. Basham.

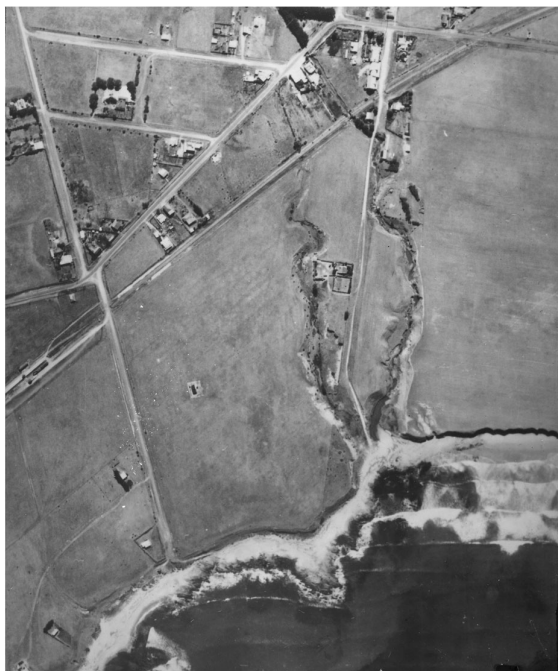
Figure 7: Middleton coast in 1949. Hard rocks of the Middleton Sandstone protect the shoreline to the left of the outlet of Middleton Creek. To the right of the creek mouth the crenulated nature of the cliff top indicates that active erosion is still occurring at this time. The hard rock outcrop bends the waves, focusing erosion on the alluvial cliffs.

Nevertheless, aerial photographs taken in 1949 and 1972 clearly indicate that erosion of terrestrial alluvial deposits has formed a cliff line up to 8 m high and that there was a coastal retreat of many metres in this 23-year period.

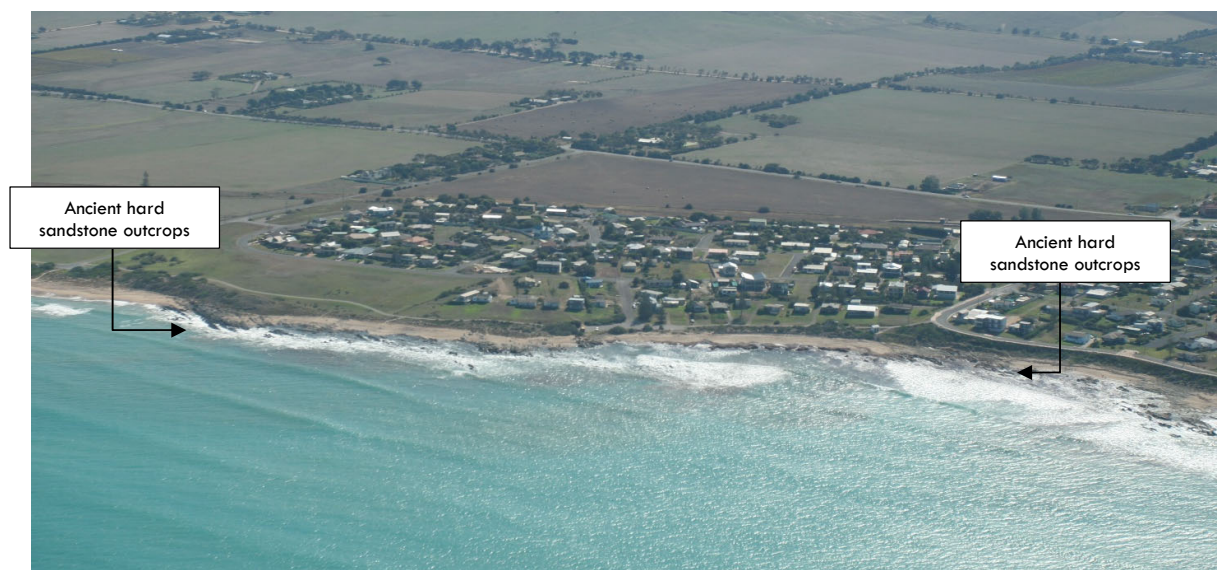
The foreshore area of Middleton Point (west of the creek) is underpinned by hard ancient sandstone outcrops that bring stability to the coast and dissipate the energy of the waves.

Figure 9: Location of ancient sandstone outcrops that dissipate wave energy upon the coast.

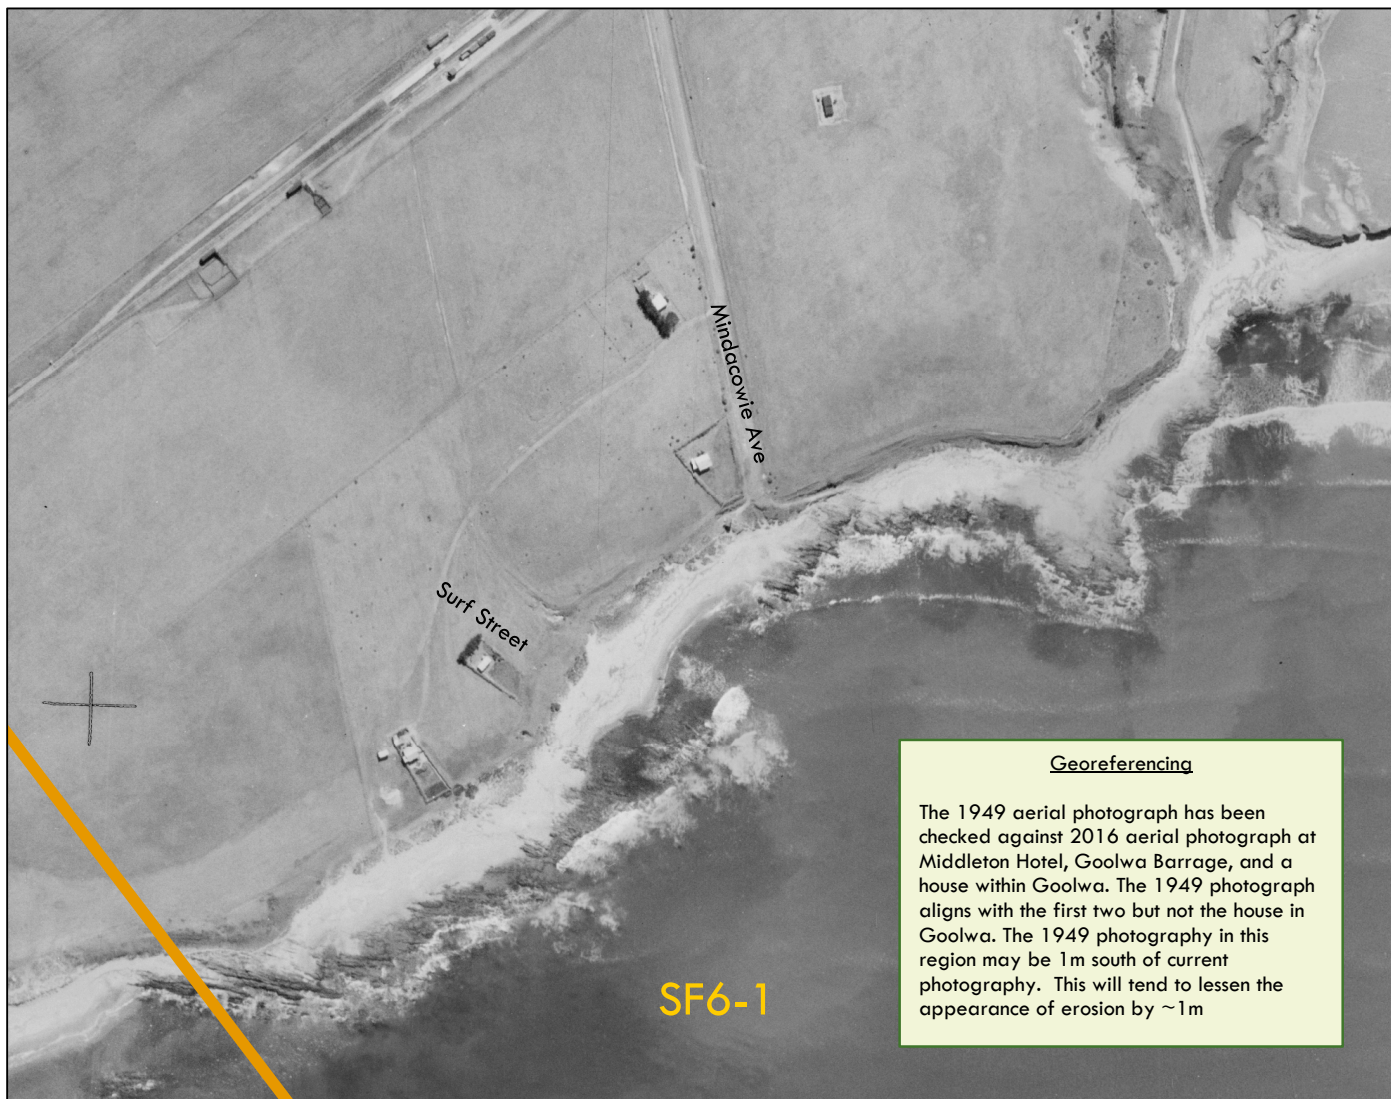
The 1949 aerial photograph has been checked against 2016 aerial photograph at Middleton Hotel, Goolwa Barrage, and a house within Goolwa. The 1949 photograph aligns with the first two but not the house in Goolwa. The 1949 photography in this region may be 1m south of current photography. This will tend to lessen the appearance of erosion by ~1m

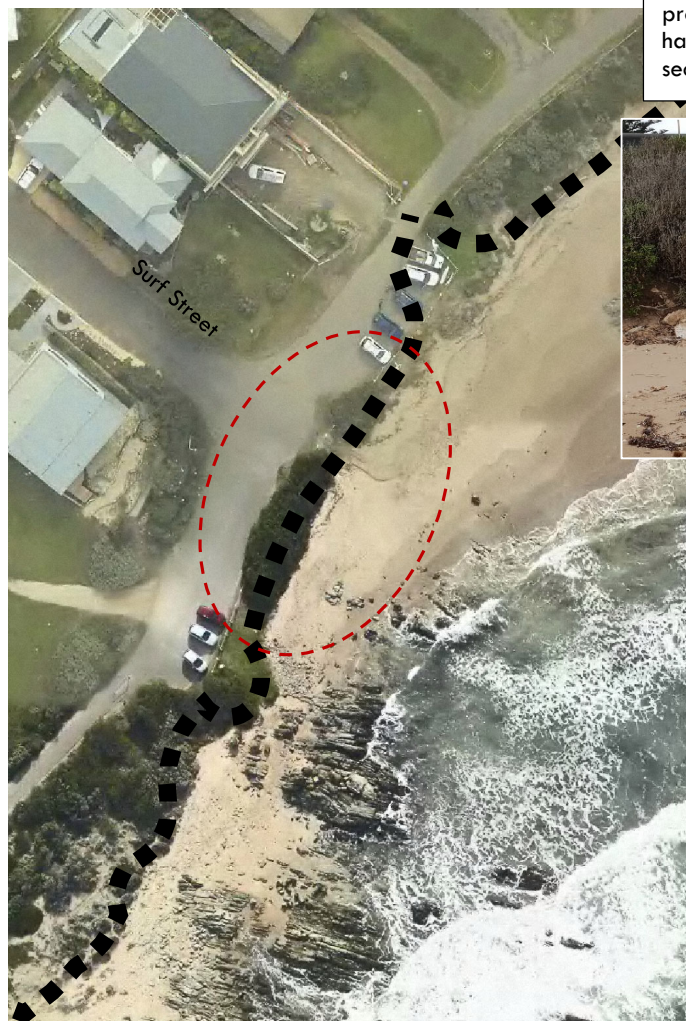
A sea wall and embankment has been constructed to provide for the carpark behind. Storm water piping has also been installed through the wall (see exposure section, storm water)

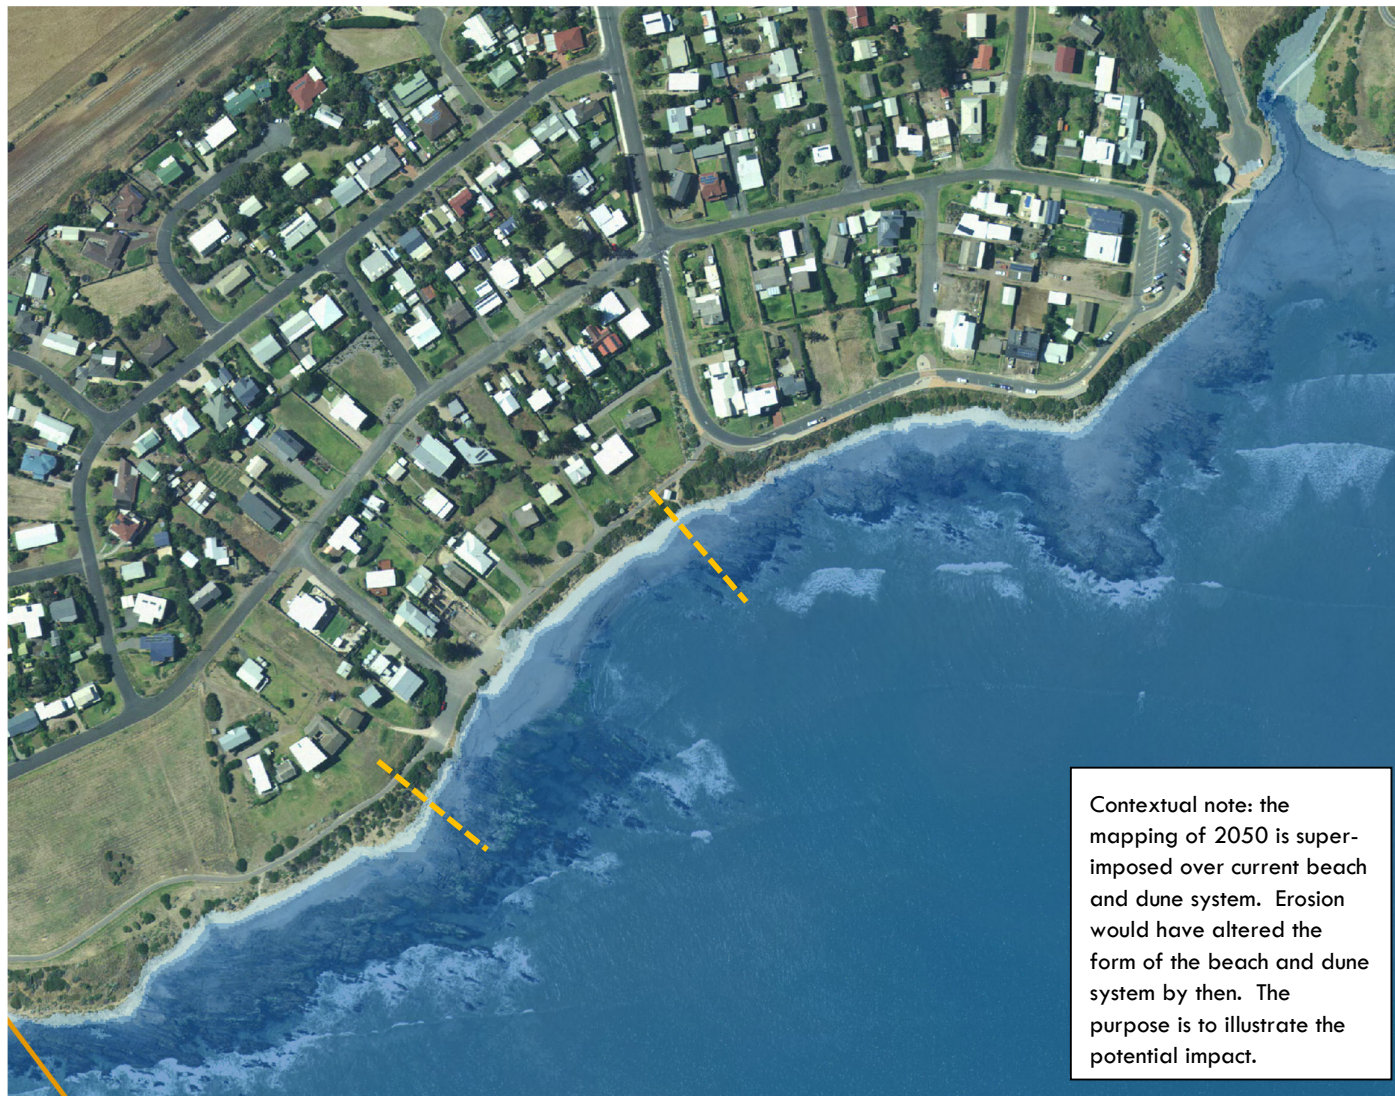
Contextual note: the mapping of 2050 is super-imposed over current beach and dune system. Erosion would have altered the form of the beach and dune system by then. The purpose is to illustrate the potential impact.

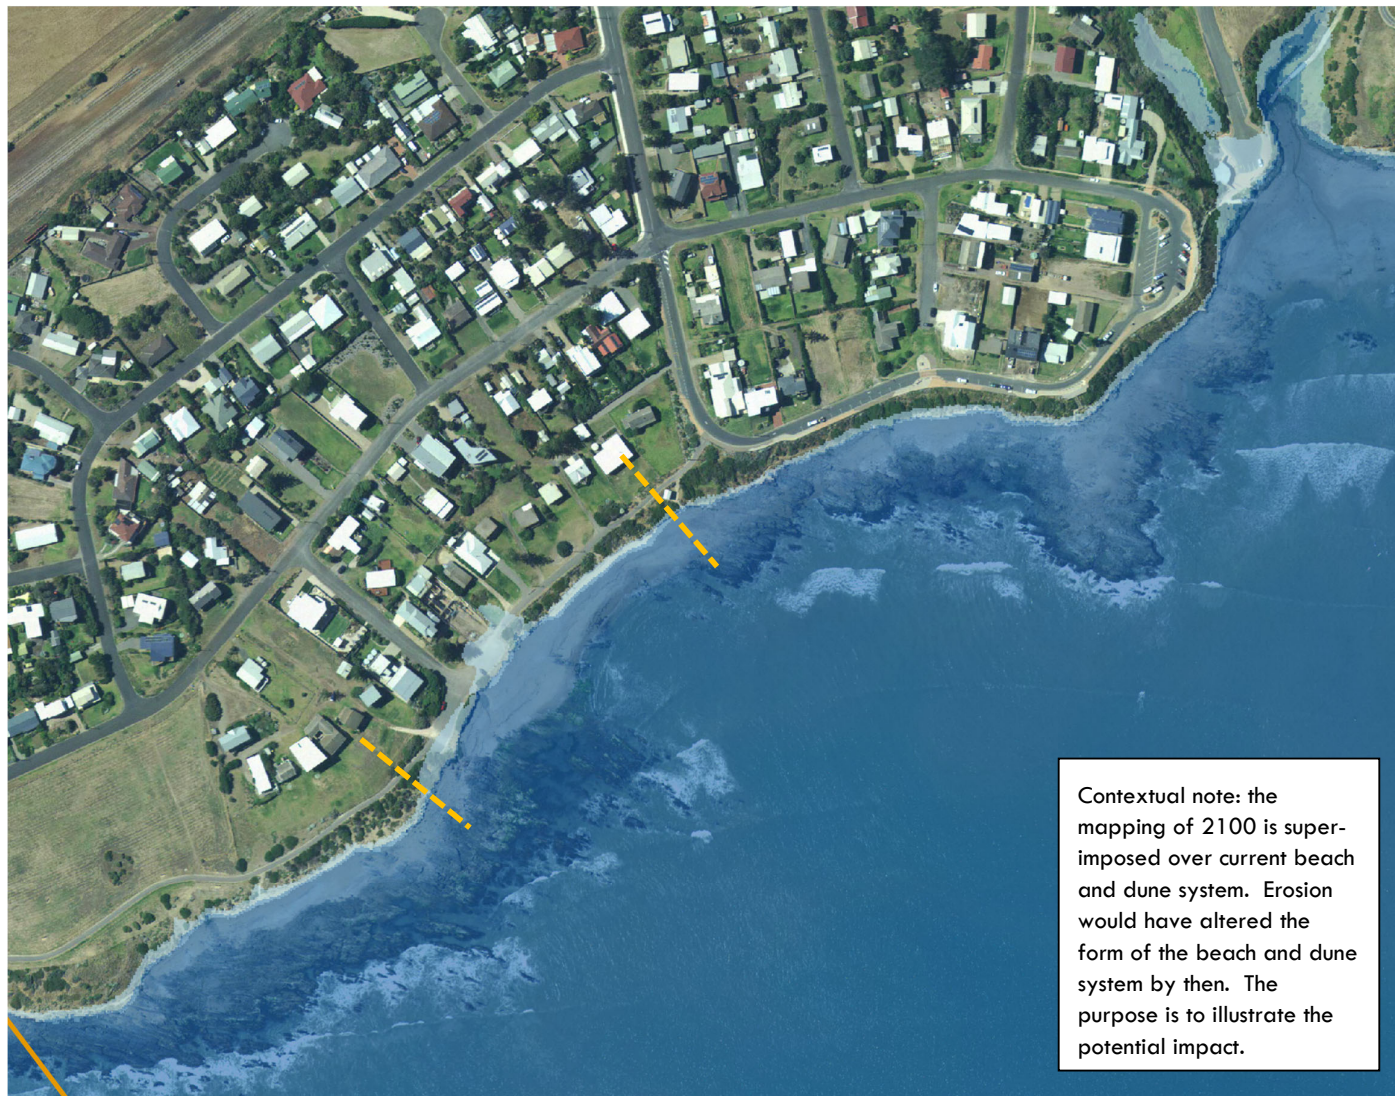
Contextual note: the mapping of 2100 is superimposed over current beach and dune system. Erosion would have altered the form of the beach and dune system by then. The purpose is to illustrate the potential impact.

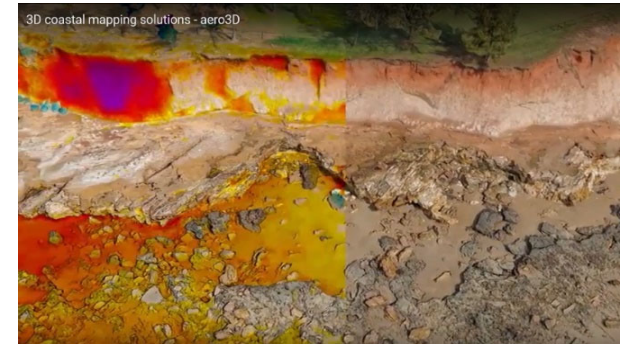
Figure: In a digital environment, software tools can be utilised to compare coastal change (Source: Aerometrex)

We have established a baseline in two ways: First, the capturing of the digital elevation model in 2018 provides a point in time baseline of the current form of the coast. In 5- or 10-years’ time (depending whether the coast is accreting or eroding), another digital elevation model could be captured, and comparisons made between the two digital models (Figure).

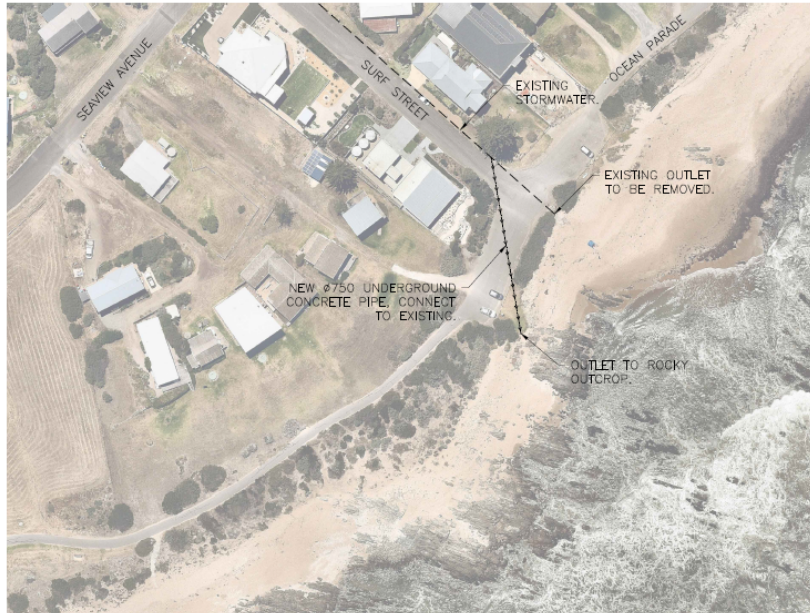
**SURF STREET – MIDDLETON**  
SCALE 1:1000

Storm water diversion away from beach to outlet to rocky outcrop

The long-term strategy for Middleton Creek (west) is to hold the line and protect the backshore (carpark, dune system). This strategy is likely to be effective in the geological setting in which Crockery Bay is located (although dune width is likely to narrow). An incremental approach to adaptation is recommended. Monitoring of beach processes, sand volumes, and impact to backshore will provide the decision-making context for when protection is required. Storm water outflows should be assessed and alternative flow path provided to the sea (see proposed works on following pages).

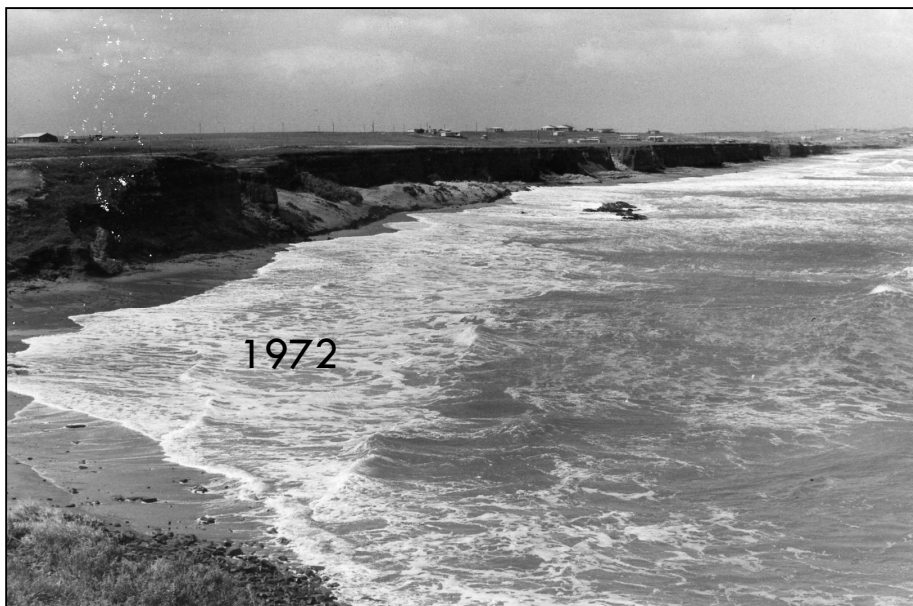
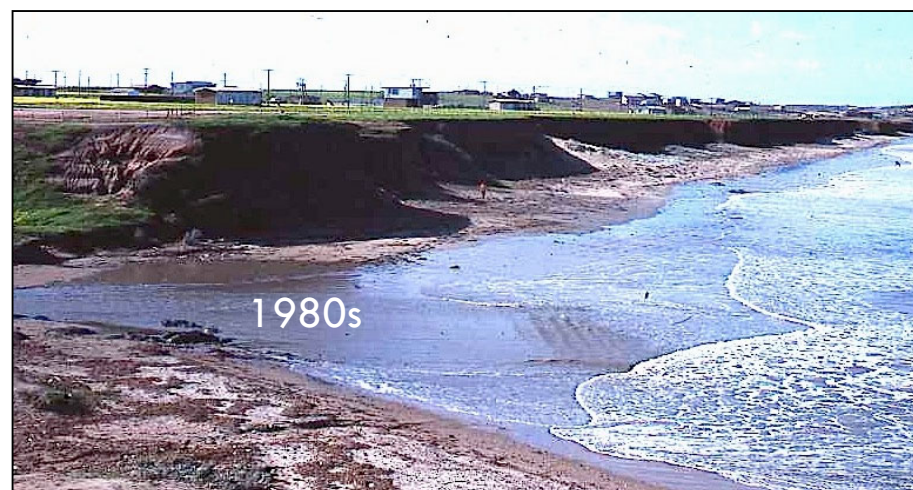
Middleton Beach photographed in 1972. The original sand dunes have now been completely eroded, with the beach now being backed by alluvial cliffs. Note the accumulation of sand at the base of some of the cliff line and the outcrop of hard Middleton Sandstone in the swash zone. Source of photographs, Dr Bob Bourman.

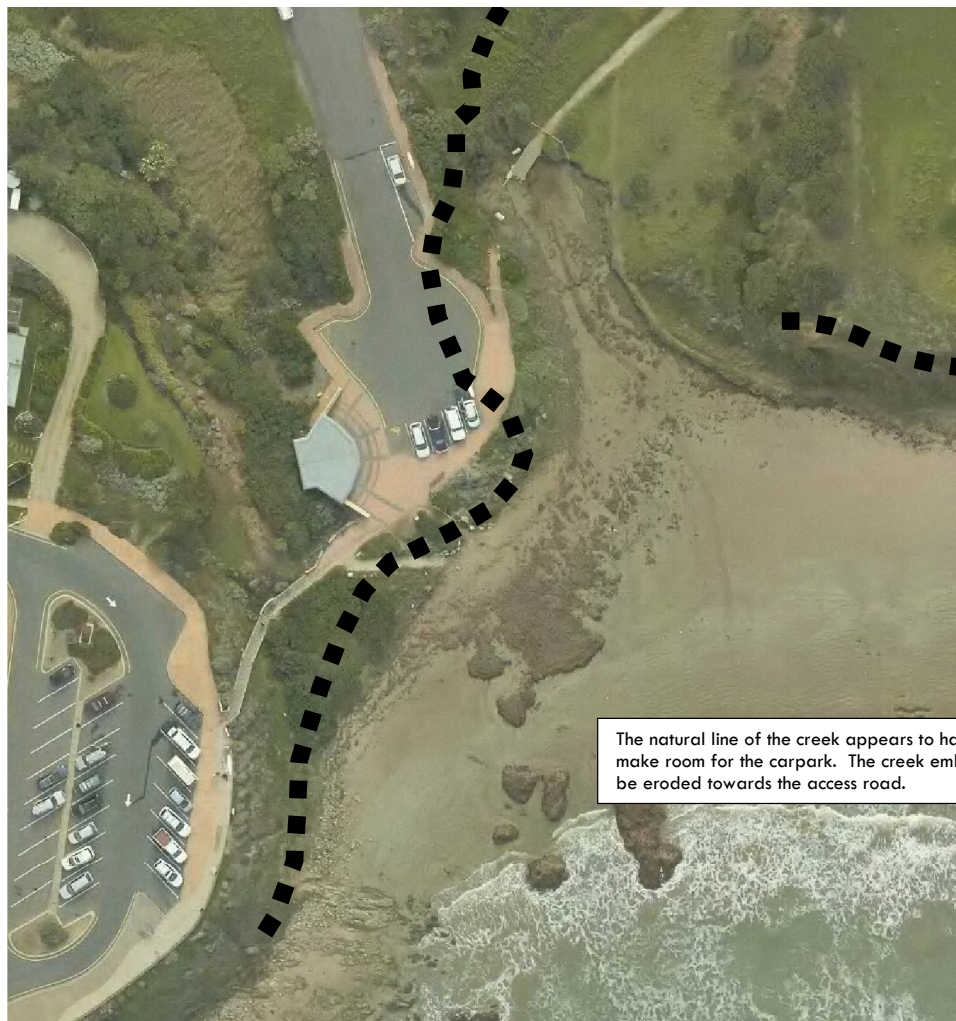
The natural line of the creek appears to have been altered to make room for the carpark. The creek embankment continues to be eroded towards the access road.

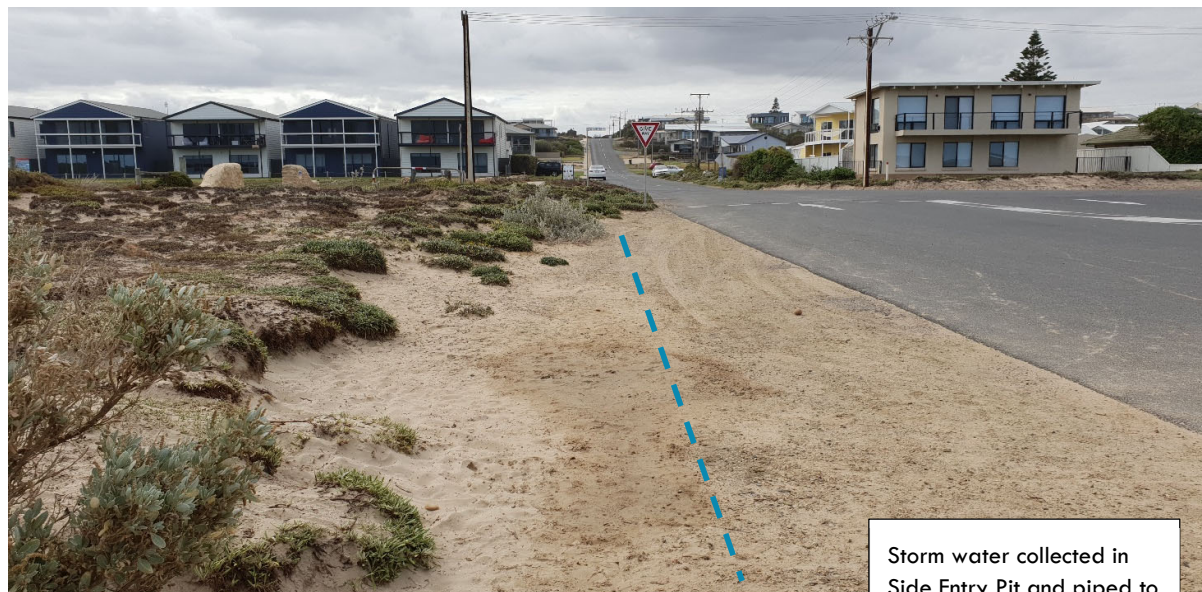
Storm water collected in Side Entry Pit and piped to foreshore (outlet blocked).

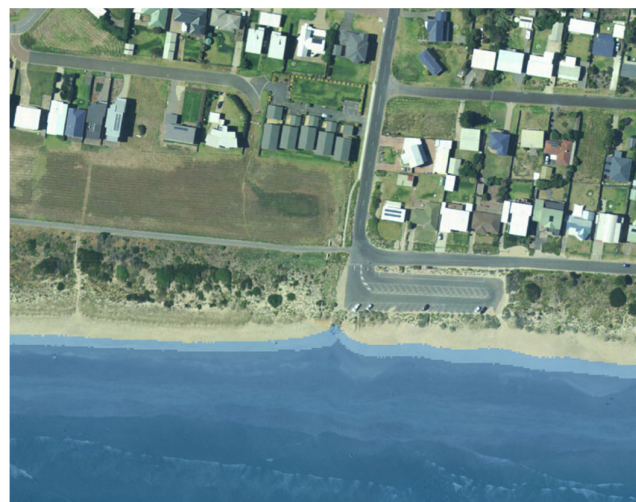
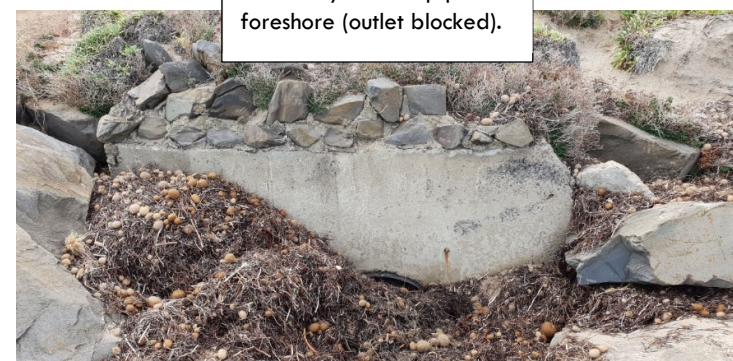
Left: Note the scouring from storm water outflow (DEM 2018). Impacts from storm effects will be greater in locations where the beach has been lowered. Sea level rise will exacerbate the problem.

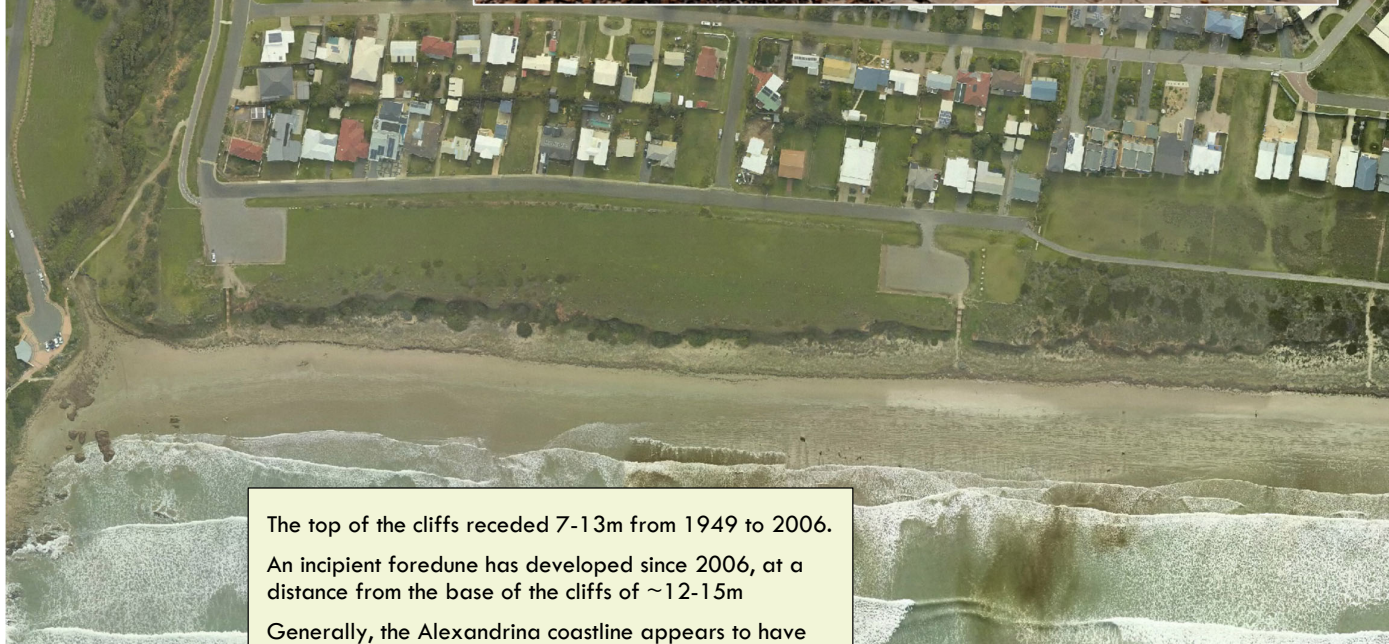
The top of the cliffs receded 7-13m from 1949 to 2006.

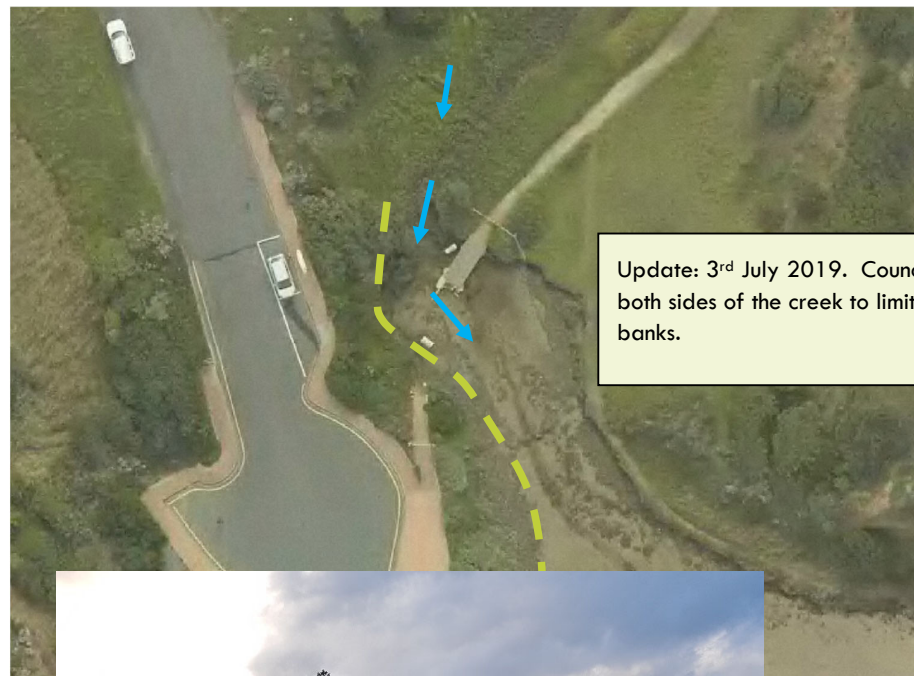
**Above:** Storm water outflows in the creek are eroding the bank back towards the road. A previous event has severed the walking trail/ bridge over the creek.

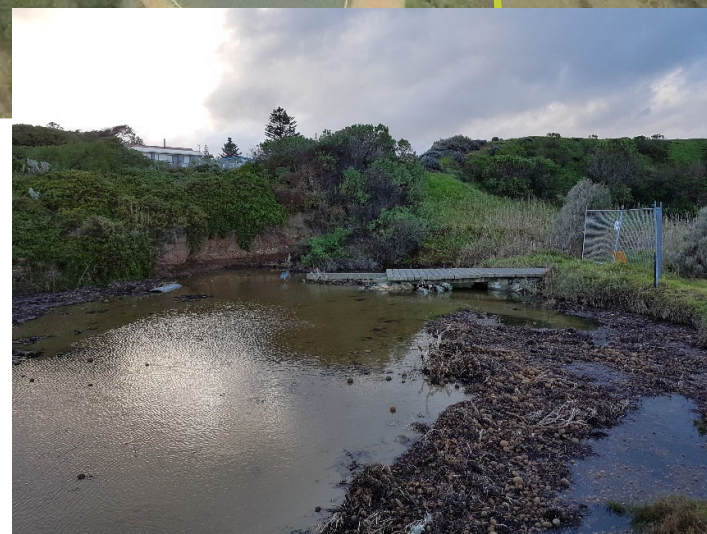
**Left:** The embankment between the creek and the road is being eroded by storm water flows.

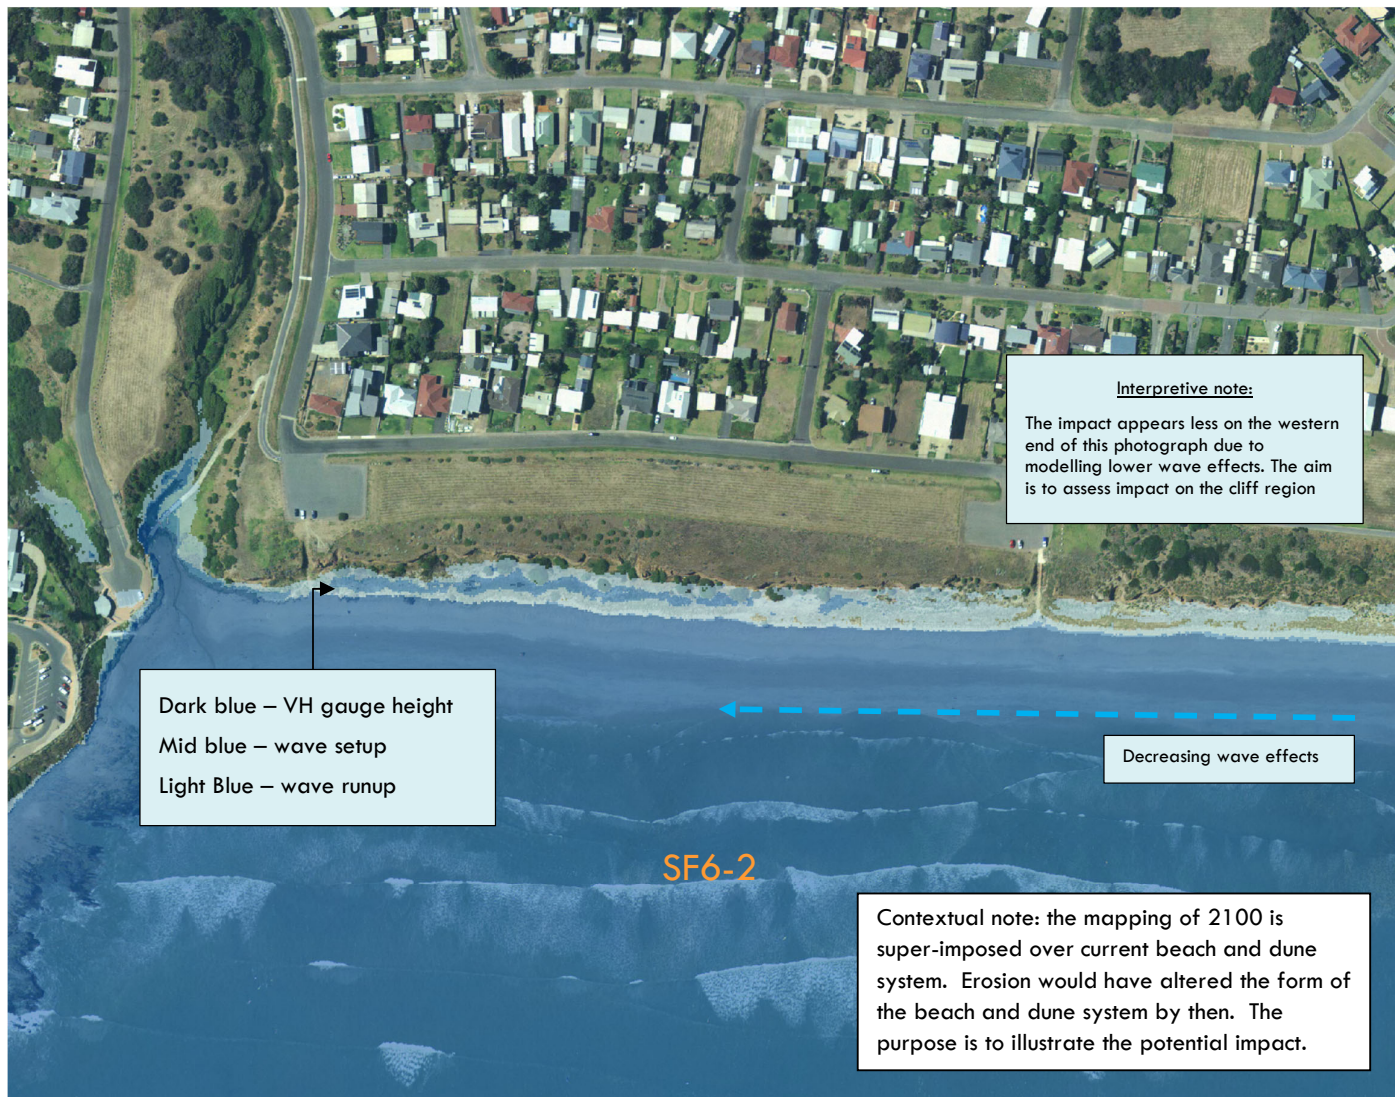
**Interpretive note:**  
 The impact appears less on the western end of this photograph due to modelling lower wave effects. The aim is to assess impact on the cliff region

Dark blue – VH gauge height  
 Mid blue – wave setup  
 Light Blue – wave runup

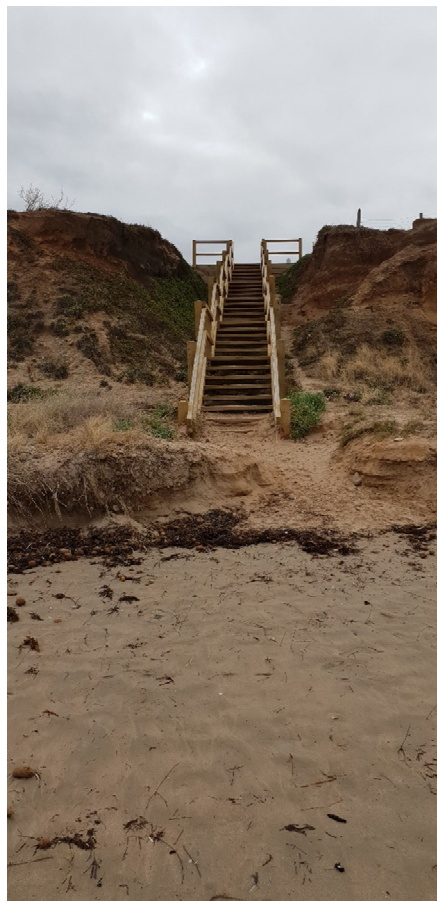
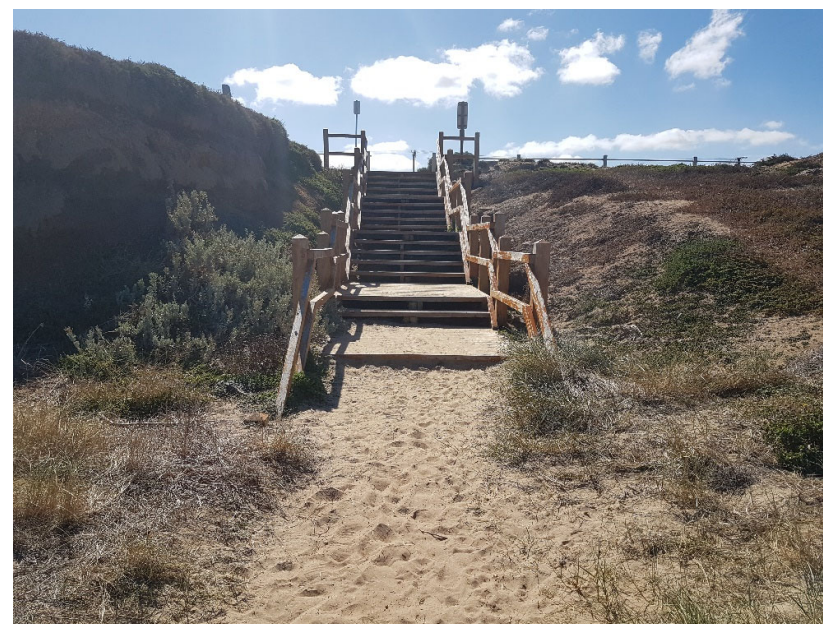
#### Access SF6-2

Access stairs through alluvial cliffs are set behind incipient dune. Sand adjacent final posts at about 700 above base of the post.

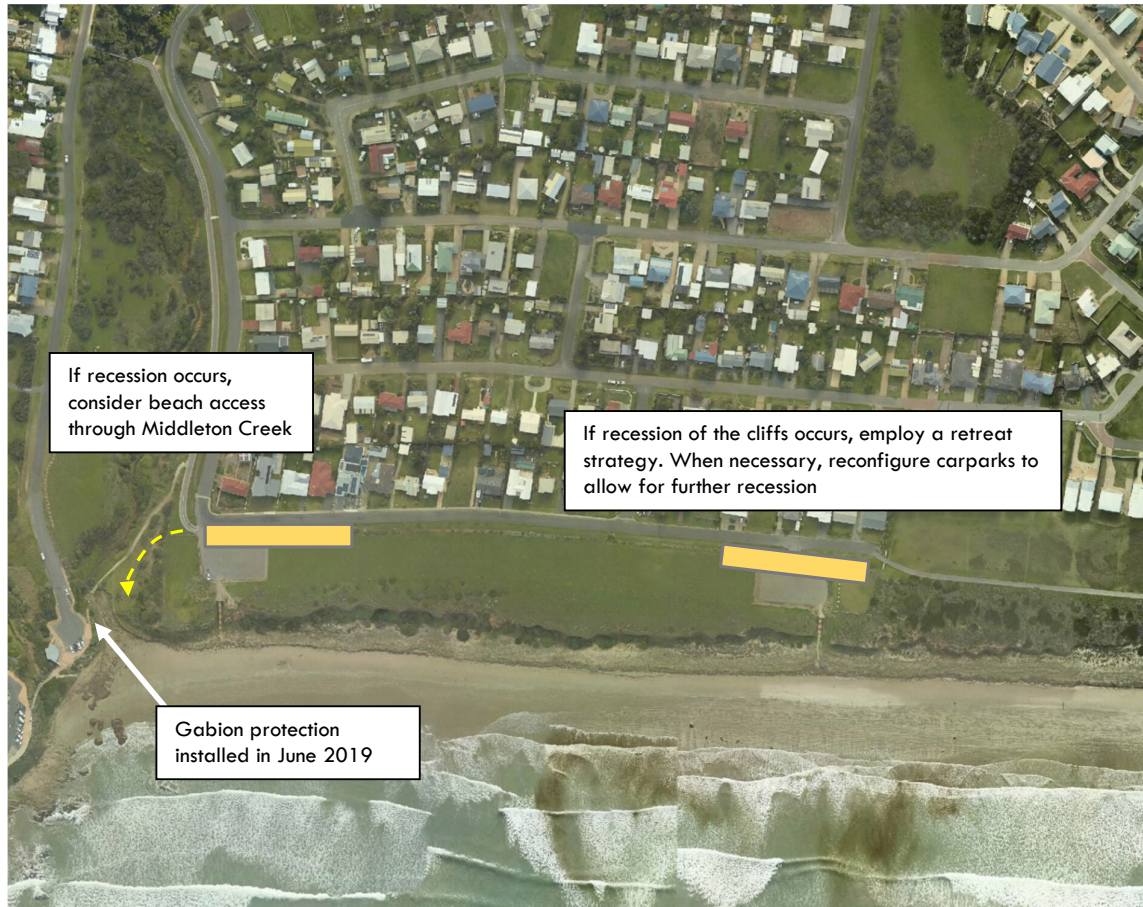
**Respond – retreat**  
 If seas rise as projected and the alluvial cliffs begin to recede, then a **retreat** strategy should be employed. When carparks are due for upgrade, these could be reconfigured and constructed further away from the cliff top.

If cliffs receded, consider closing off the access on eastern side and install access to the beach through Middleton Creek (east side)

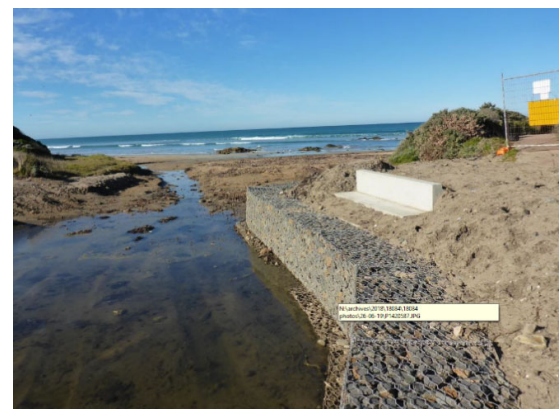
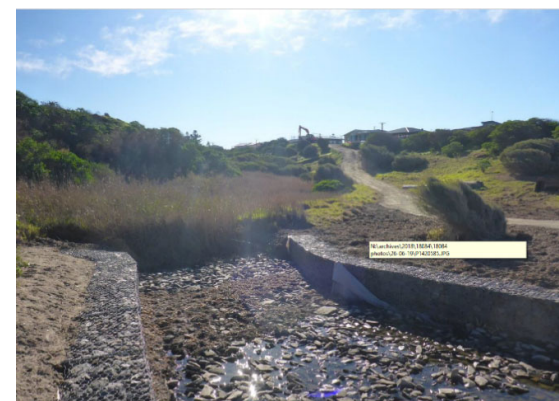
A new pedestrian bridge is under construction, to replace the previous bridge that was destroyed.

A gabion wall has been constructed either side of the creek (with geofabric behind), in an effort to minimise future erosion. The gabions appear to be galvanised mesh baskets, filled with bluestone spalls. The gabion walls may provide some erosion protection; however the steel mesh is not considered suitable for a coastal site. The highly corrosive environment will significantly limit the life of the structure. It is probable the zinc protection will be compromised, and the steel will begin to corrode in several years.

Small rocks have been provided to the base of the creek (presumably for scour protection). These are too small and will likely be washed away under high flow conditions during a storm event.

No scour protection has been provided to the southern half of the creek (with the gabion walls), and erosion has occurred seaward of the creek.

The overall level of the beach south of the creek has dropped as a result of stormwater outflow across the beach.

**Protection option:**  
 Rock protection is likely to be required at the bend in Middleton Creek (in vicinity of former walkway). Update 7<sup>th</sup> July 2019: Gabion baskets have been installed to Middleton Creek (see next page).
