Coastal Adaptation Study
for Alexandrina Council

BOOMER-KNIGHT BEACH

Report to be cited as: Western, M, Bourman, R., Hesp, P (2019) Coastal Adaptation Study for Alexandrina Council (Cell SF9 Boomer-Knight Beach) prepared by Integrated Coasts, South Australia.

This document is a partial output for the Coastal Adaptation Study for Alexandrina Council (Boomer-Knight Beach Cell SF9). This document also represents an output from the coastal adaptation assessment tool designed by Integrated Coast.

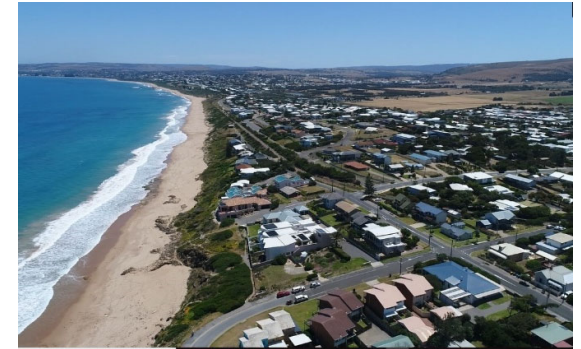
Figure 2: The Goolwa to Victor Harbor railway line dissects the backshore of Boomer Beach

The trainline effectively divides the backshore of Boomer beach into two sections (Figure 2).

The Goolwa to Victor Harbor railway line is owned by the State Government and dissects the backshore of Boomer Beach. As long as the State Government protects the railway line, public and private infrastructure will also be protected behind the line.

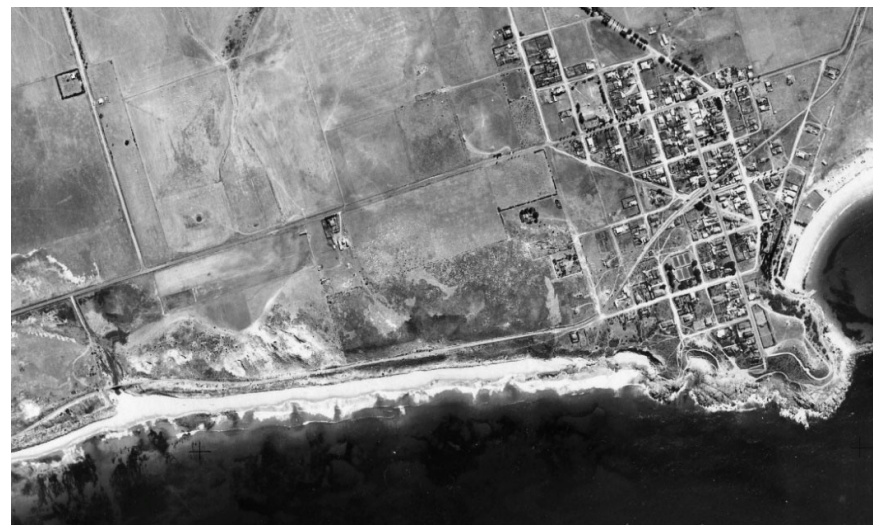
Figure 7: 1949 aerial photograph of the coast between Watson Gap and Port Elliot. This coastal sector is backed by a fossil, consolidated (lithified) sand dune ~250,000 years old with a hard limestone (calcrete)

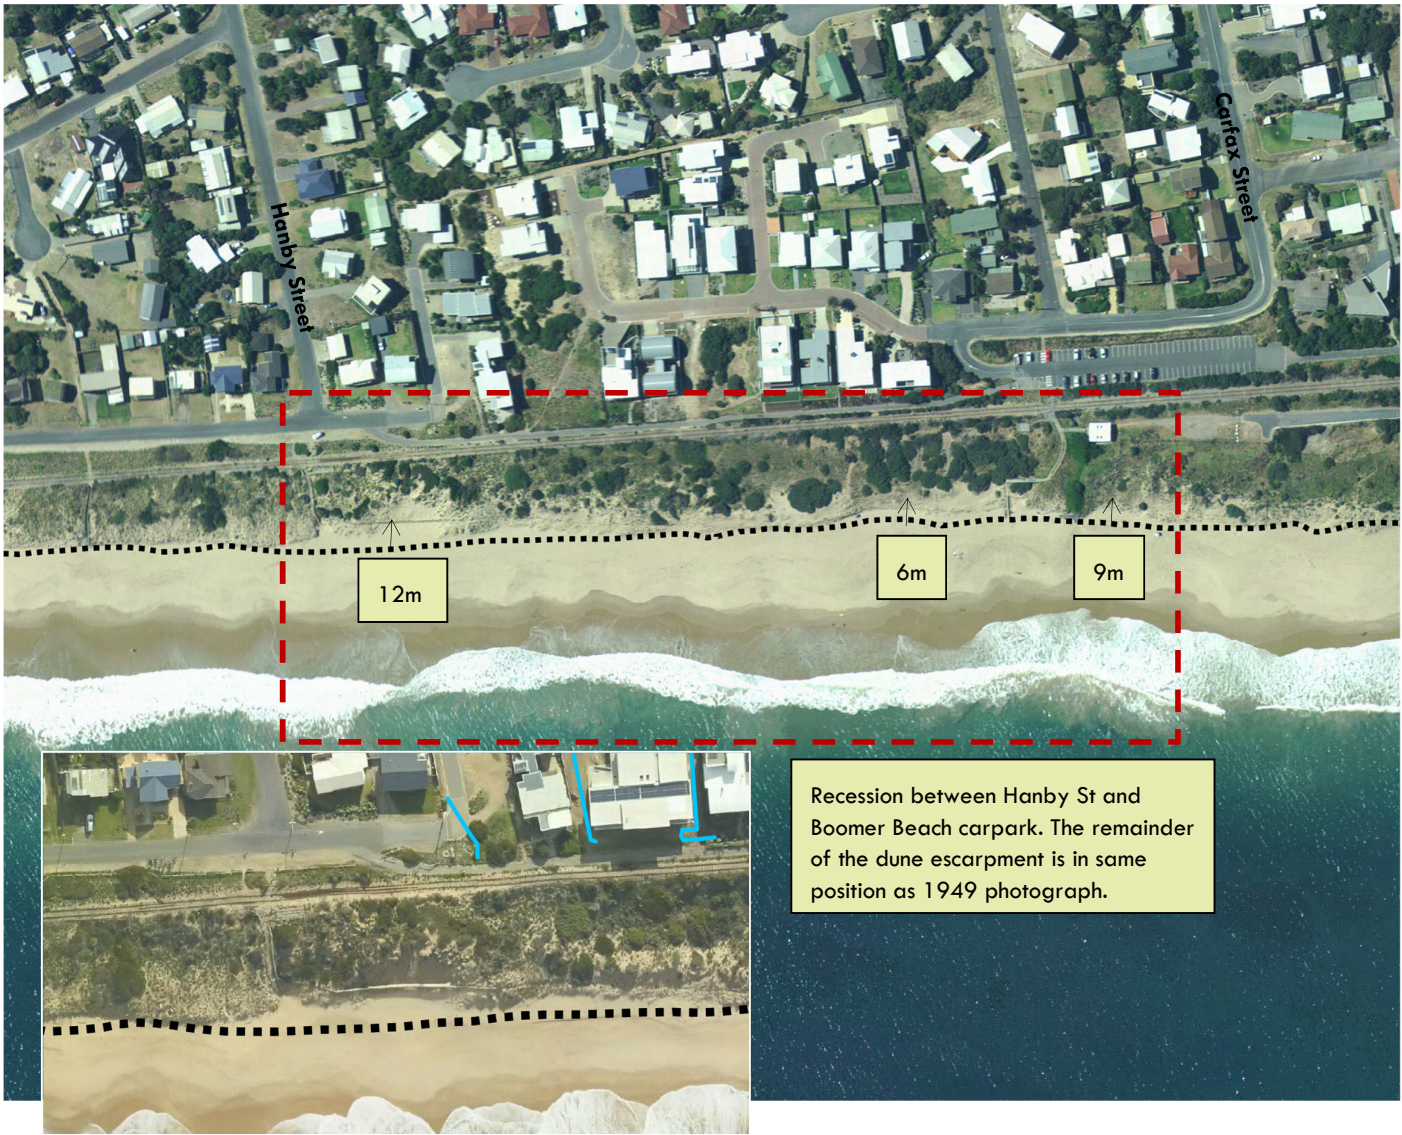
Recession between Hanby St and Boomer Beach carpark. The remainder of the dune escarpment is in same position as 1949 photograph.

Most of these areas appear to be caused by wave-run up. Dune fencing was installed to the major erosion at end of Hanby Street but has been undermined.

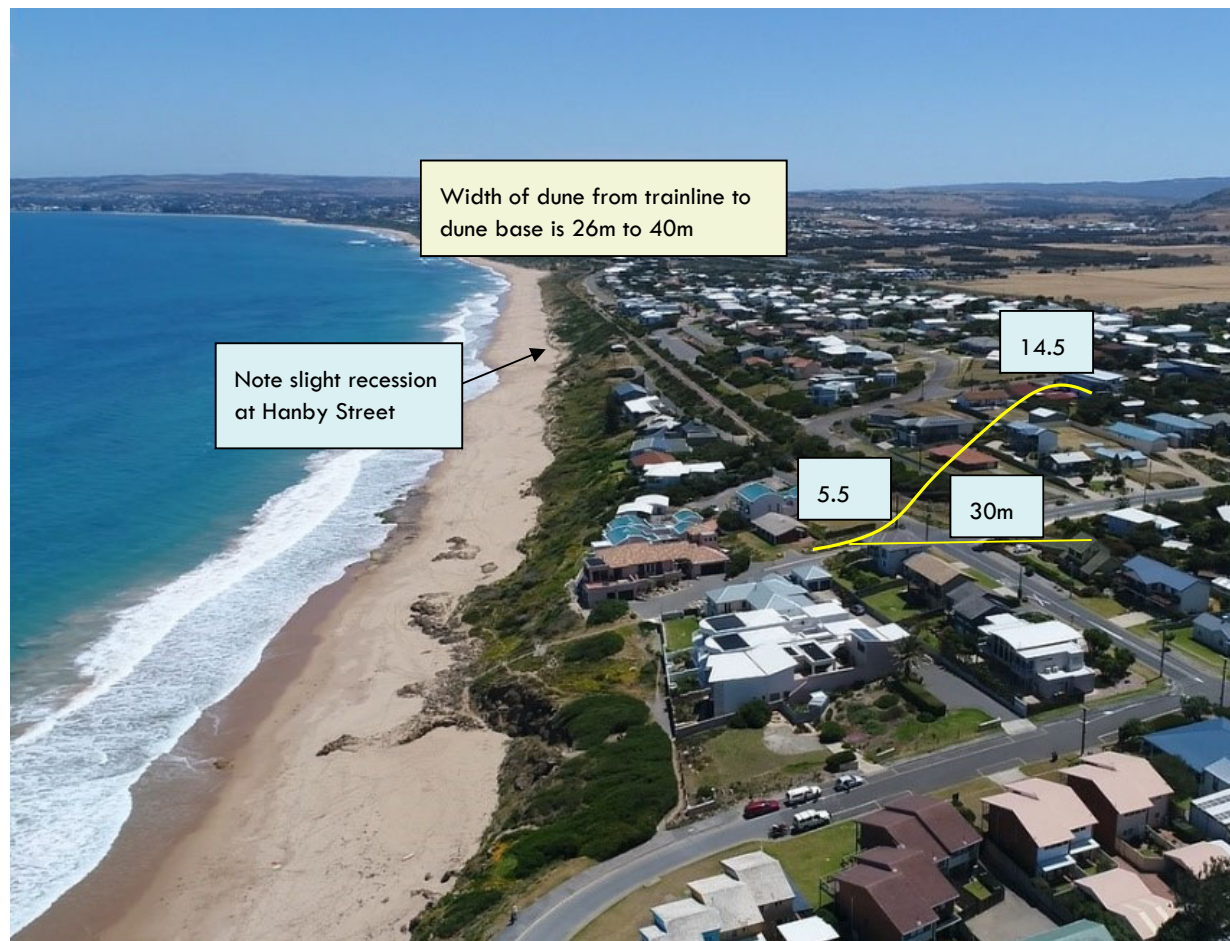
Figure 9: Knight and Boomer Beaches (M. Western, 2018)

The train line sits atop of dune system, dissecting the backshore. This means that the dune system cannot retreat as the trainline acts as a 'hold point'.

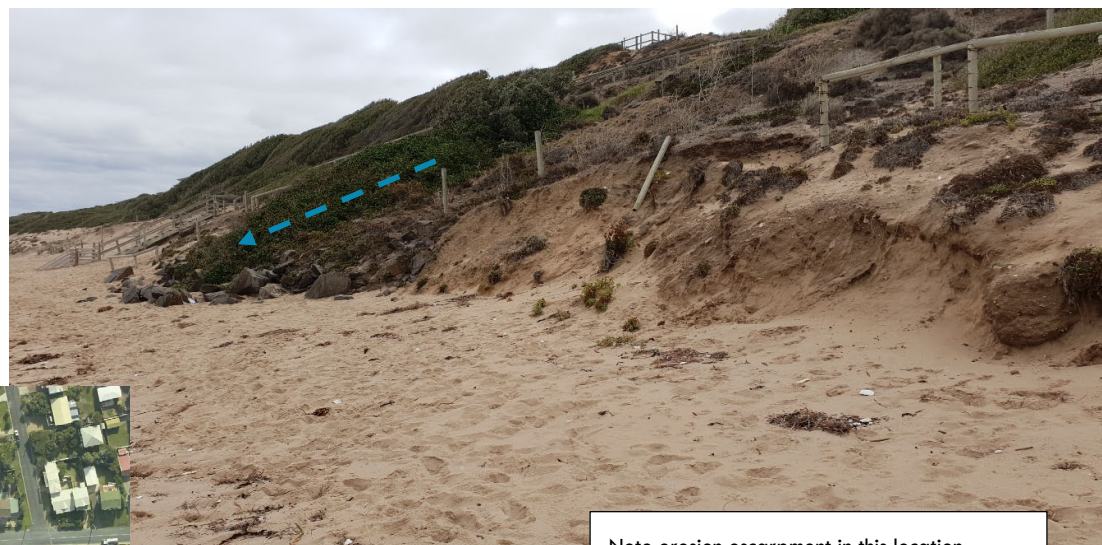
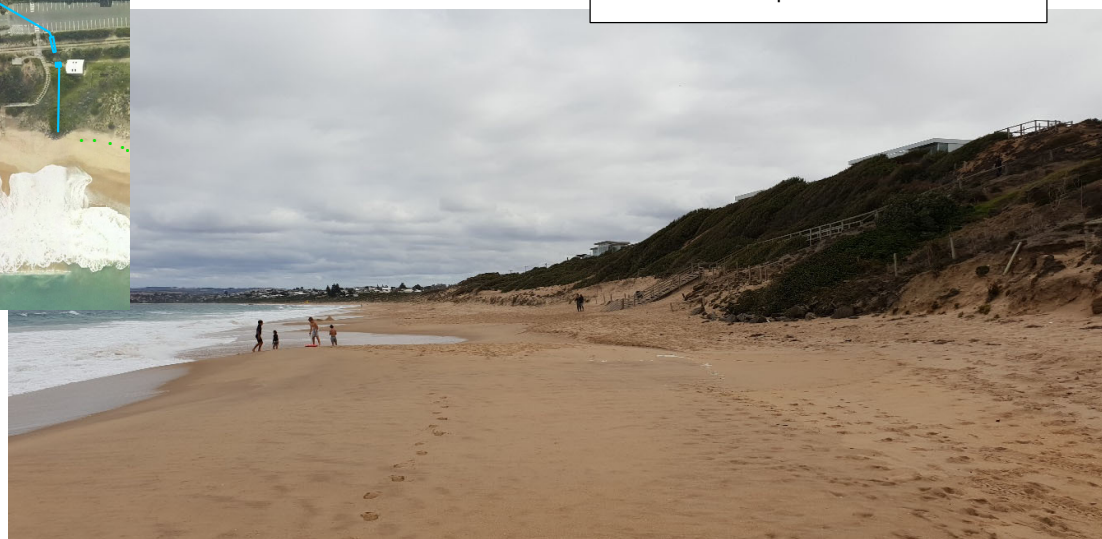
Note erosion escarpment in this location.

Figure 10 and 11:
Boomer Beach (M.
Western, 2018)

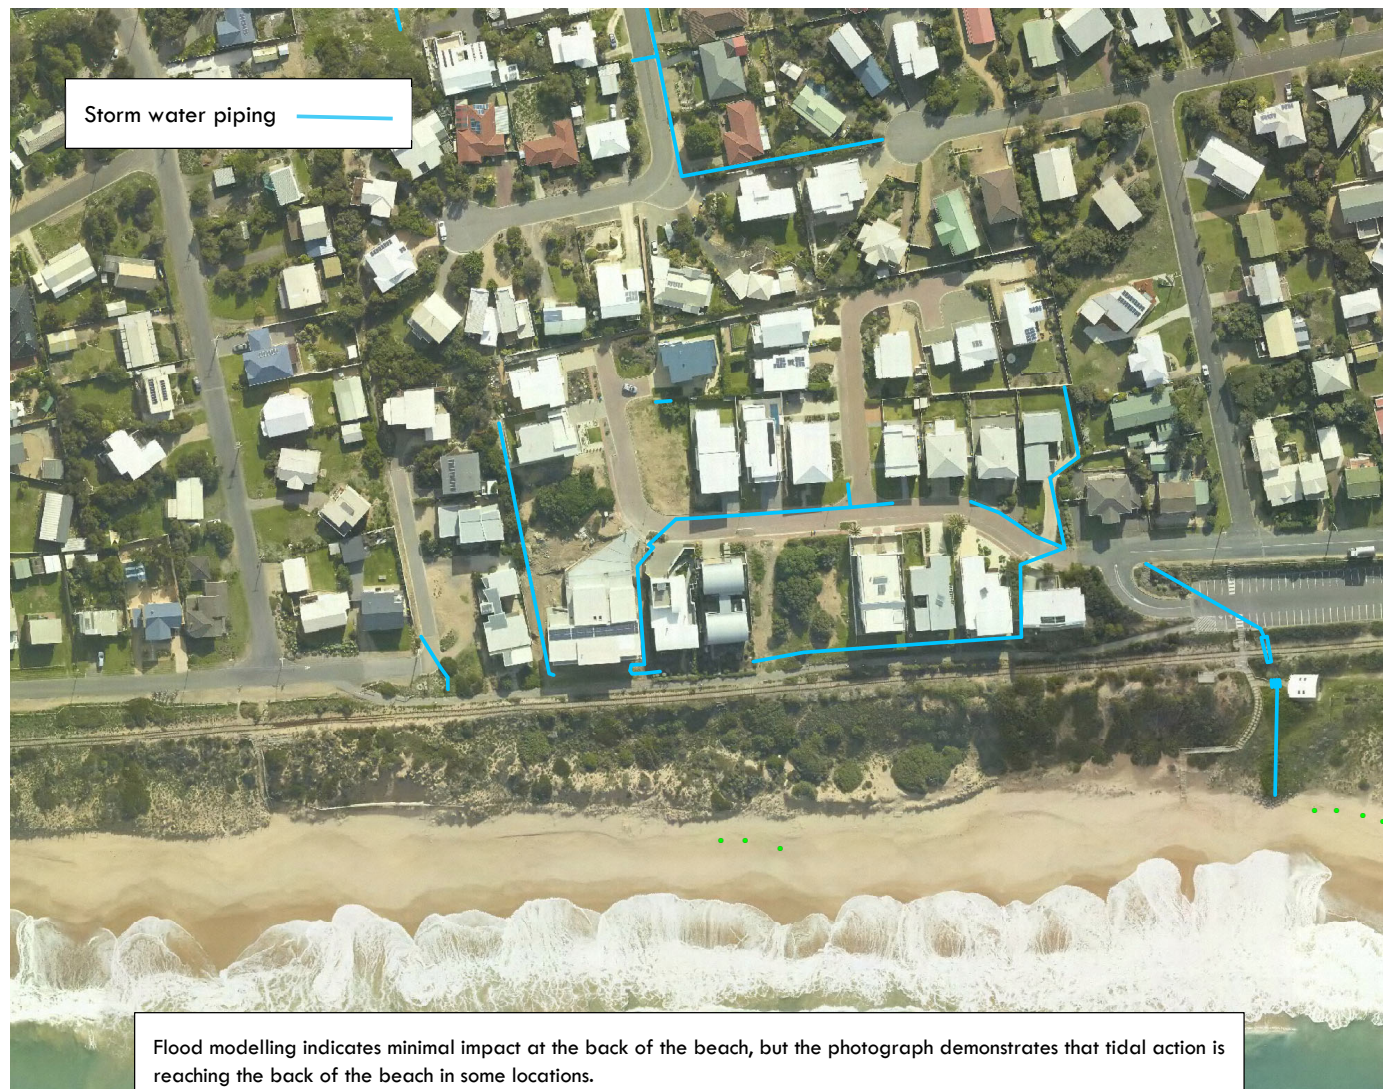
Flood modelling indicates minimal impact at the back of the beach, but the photograph demonstrates that tidal action is reaching the back of the beach in some locations.

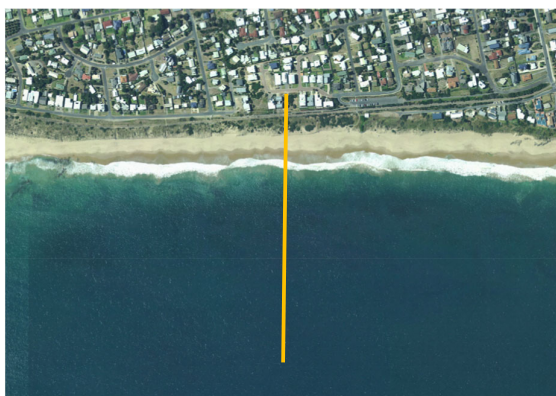
Figure 12. Topographical survey conducted November, 2018 (Inset photograph depicts location of survey).

The distance that the profile is translated horizontally is determined by maintaining the distance between two topographic points (i.e. the slope of the beach-backshore) on the original profile in the projected future translated profile. For example, if the distance between zero m or AHD on the current profile (Figure 12) and the foredune toe is, say, 15m, then that distance between those two points is maintained in the translated 2100 profile.

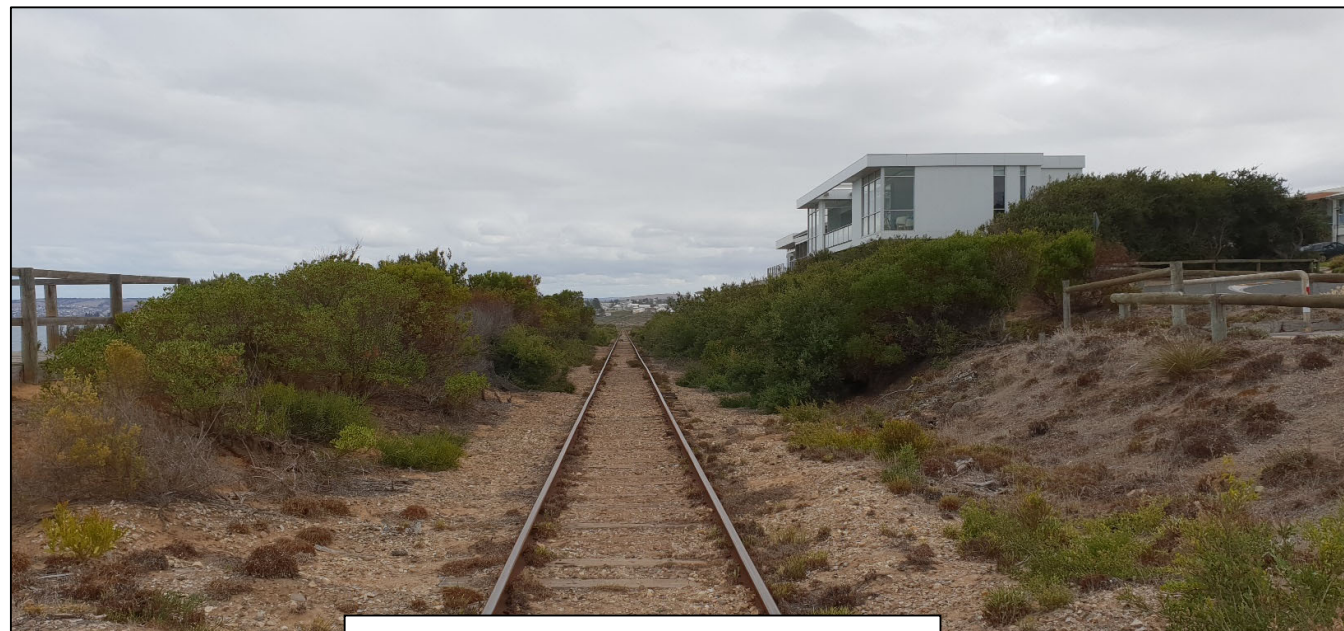
The trainline is a fixed 'hold' line on top of escarpment

The erosion modelling indicates 18m to 23m recession of the shoreline by 2100. The trainline dissects the dune system at the top of the escarpment. As this is a fixed line, it will not be possible for the dune to translate landwards, and therefore the slope of the dune must increase. This slope will become increasingly unstable, and successive collapses will tend to make the escarpment increasingly vertical, and increasingly more unstable.

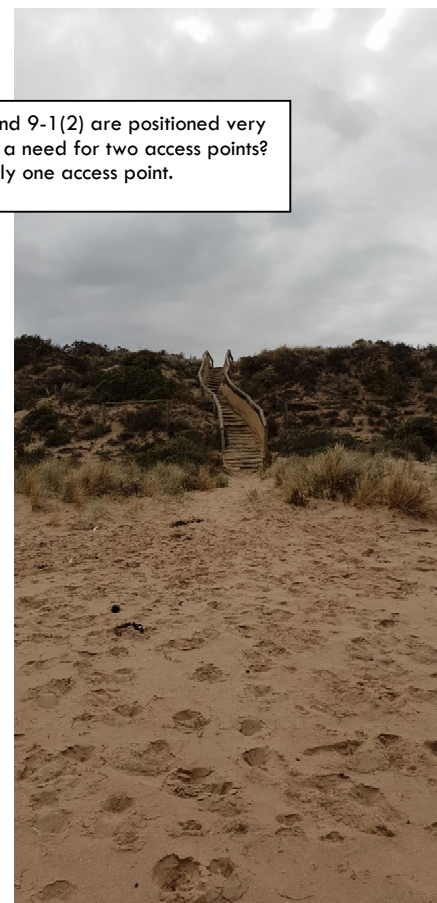
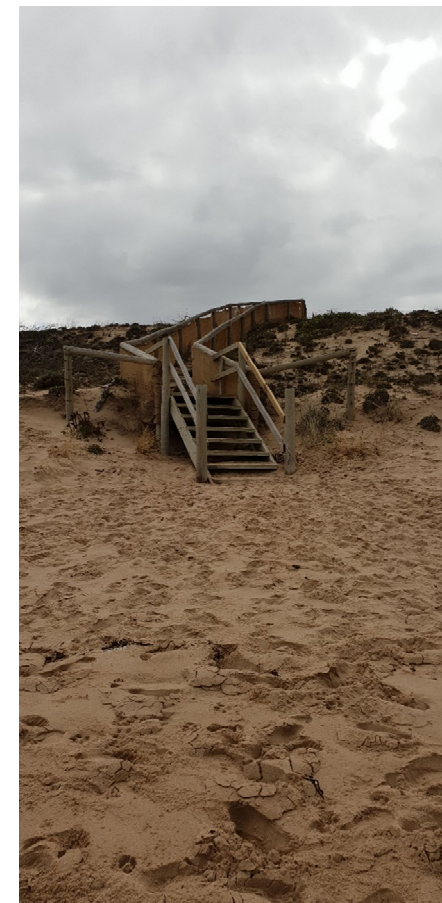
Beach access set well from beach and currently situated behind a small frontal dune. Currently, no risk from impacts of the sea.

General comment: 9-1(1) and 9-1(2) are positioned very close to each other. Is there a need for two access points? On upgrade, recommend only one access point.

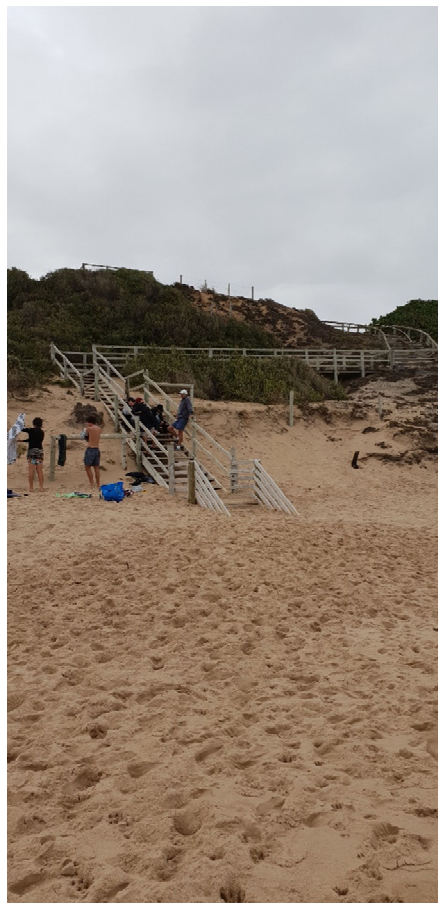
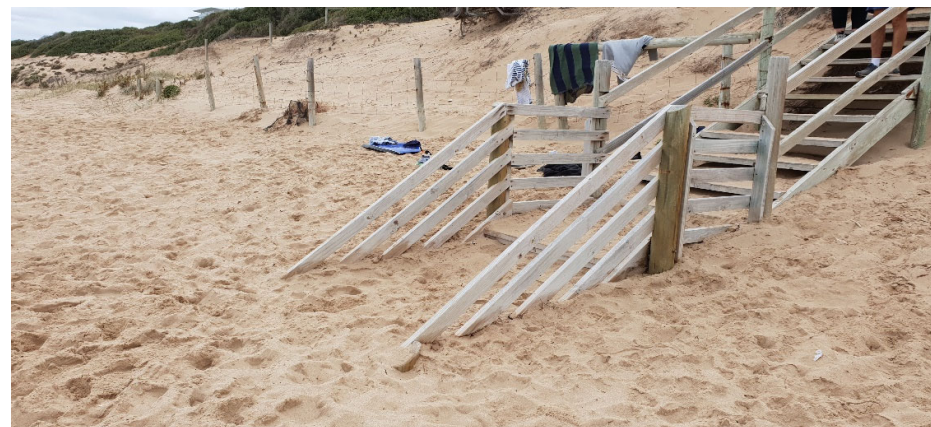
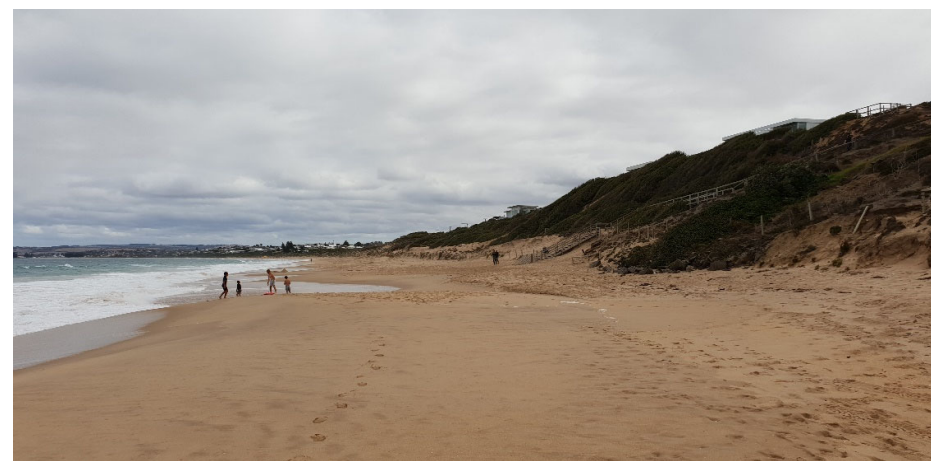
9-1(7)

Significant sand accretion has occurred in this location since installation of stair way.

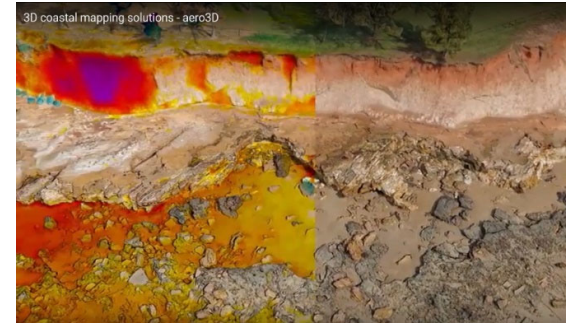
Figure: In a digital environment, software tools can be utilised to compare coastal change (Source: Aerometrex)

We have established a baseline in two ways: First, the capturing of the digital elevation model in 2018 provides a point in time baseline of the current form of the coast. In 5- or 10-years’ time (depending whether the coast is accreting or eroding), another digital elevation model could be captured and comparisons made between the two digital models (Figure).

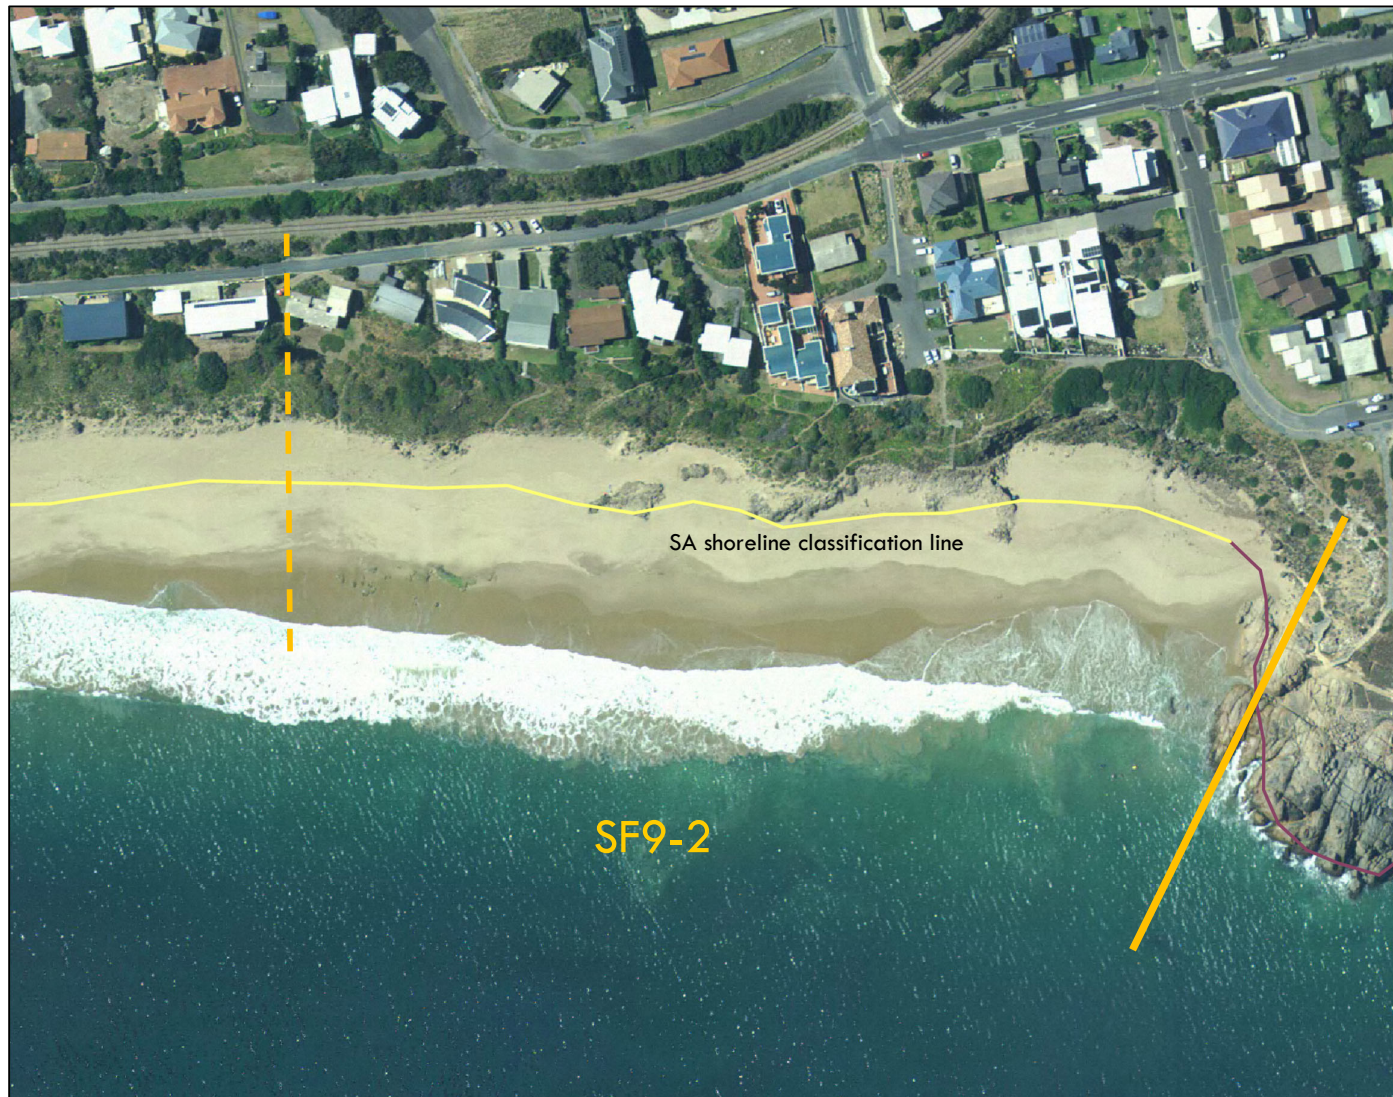
Backshore 1:

Cliff 5m to 20m high

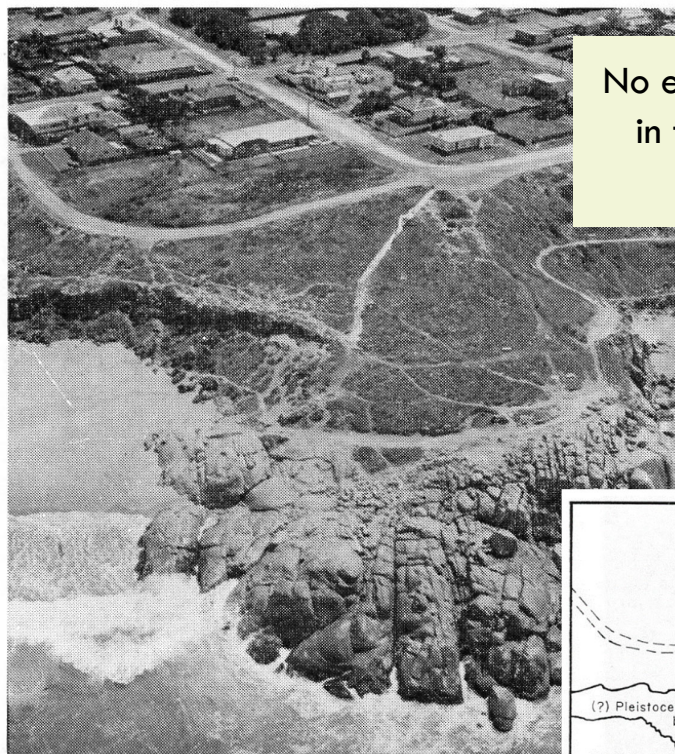
Figure: Oblique aerial view of granite headland with Knight Beach on the left and Green Bay on the right (1947)

No evidence of erosion in the backshore of Knight Beach

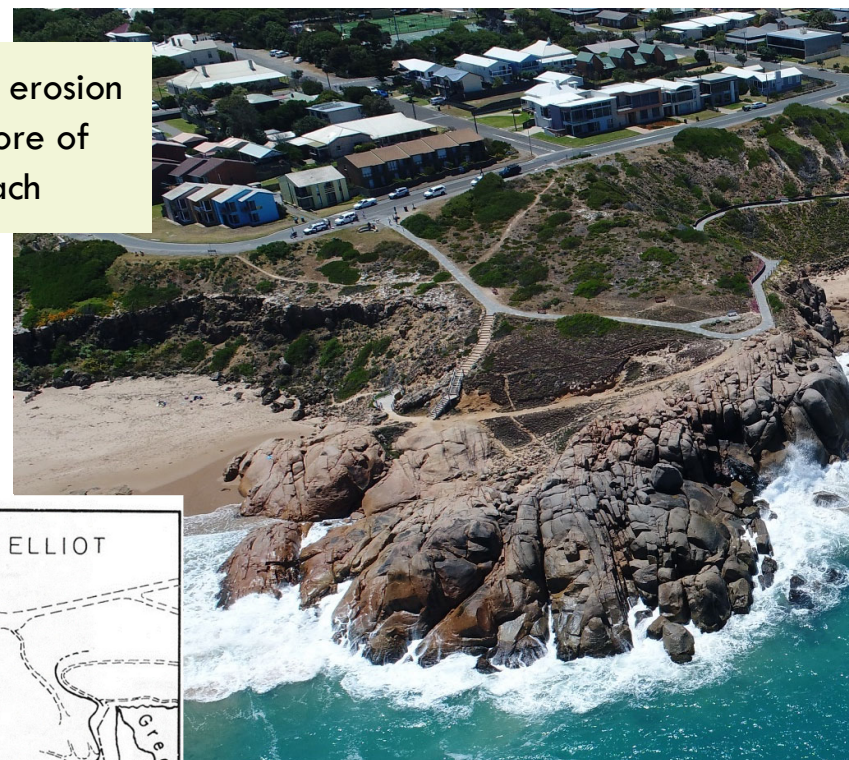
Sketch of previous aerial photographs highlighting the basic geology of the site (R. Bourman, 2016).

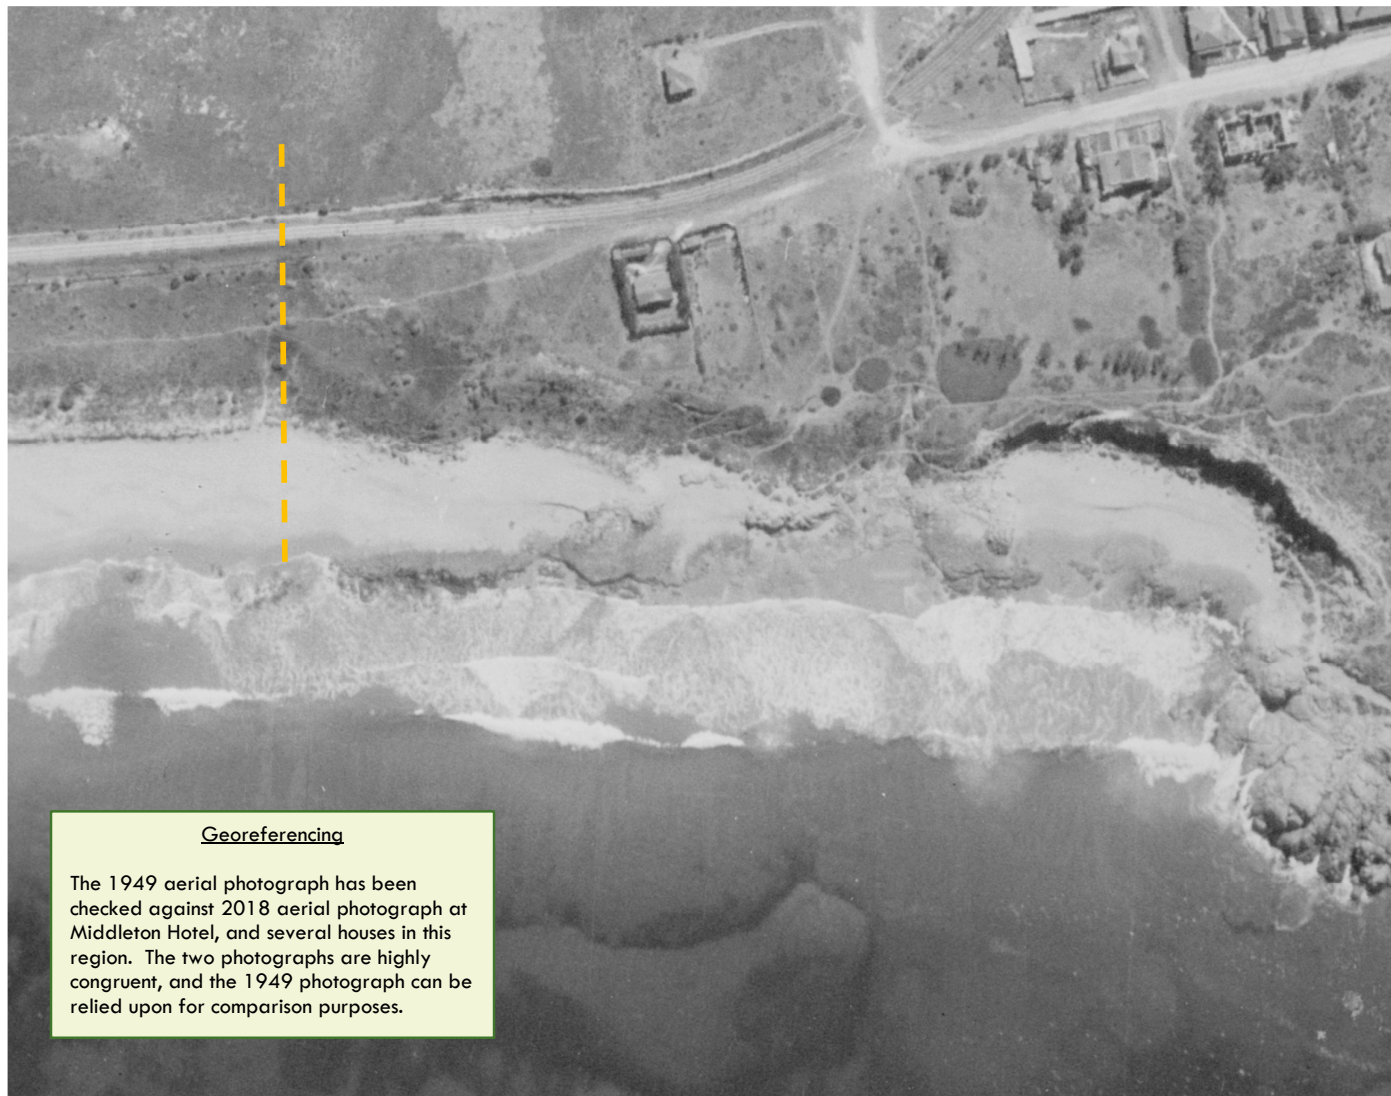
Aerial photograph from 1949.

The 1949 aerial photograph has been checked against 2018 aerial photograph at Middleton Hotel, and several houses in this region. The two photographs are highly congruent, and the 1949 photograph can be relied upon for comparison purposes.

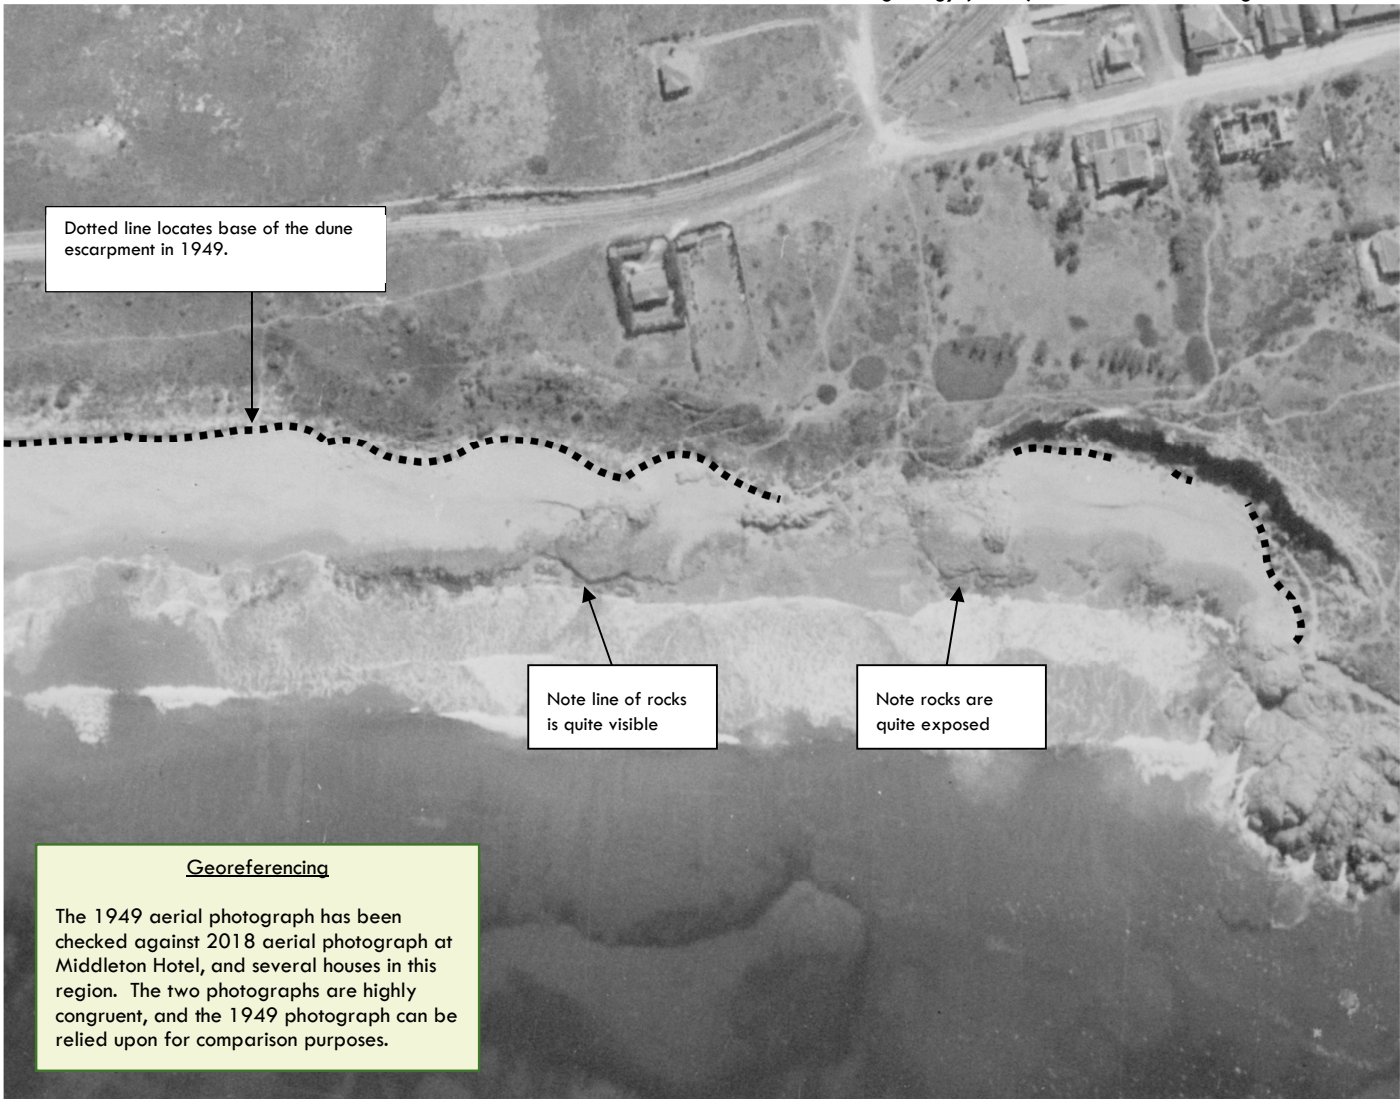
Assessment
Aerial photograph from 2018. The baseline escarpment position is depicted as a dotted line.
Note that the rocks in surf zone are now mostly covered with sand. This suggests accretion/ sand accumulation in this region (as observed in Middleton – Goolwa)
The base of the dune and cliff escarpments are essentially in the same position in 1949.
Direct comparisons were made with the top of the cliff line in Knight Beach and it appears in the same position as 1949.

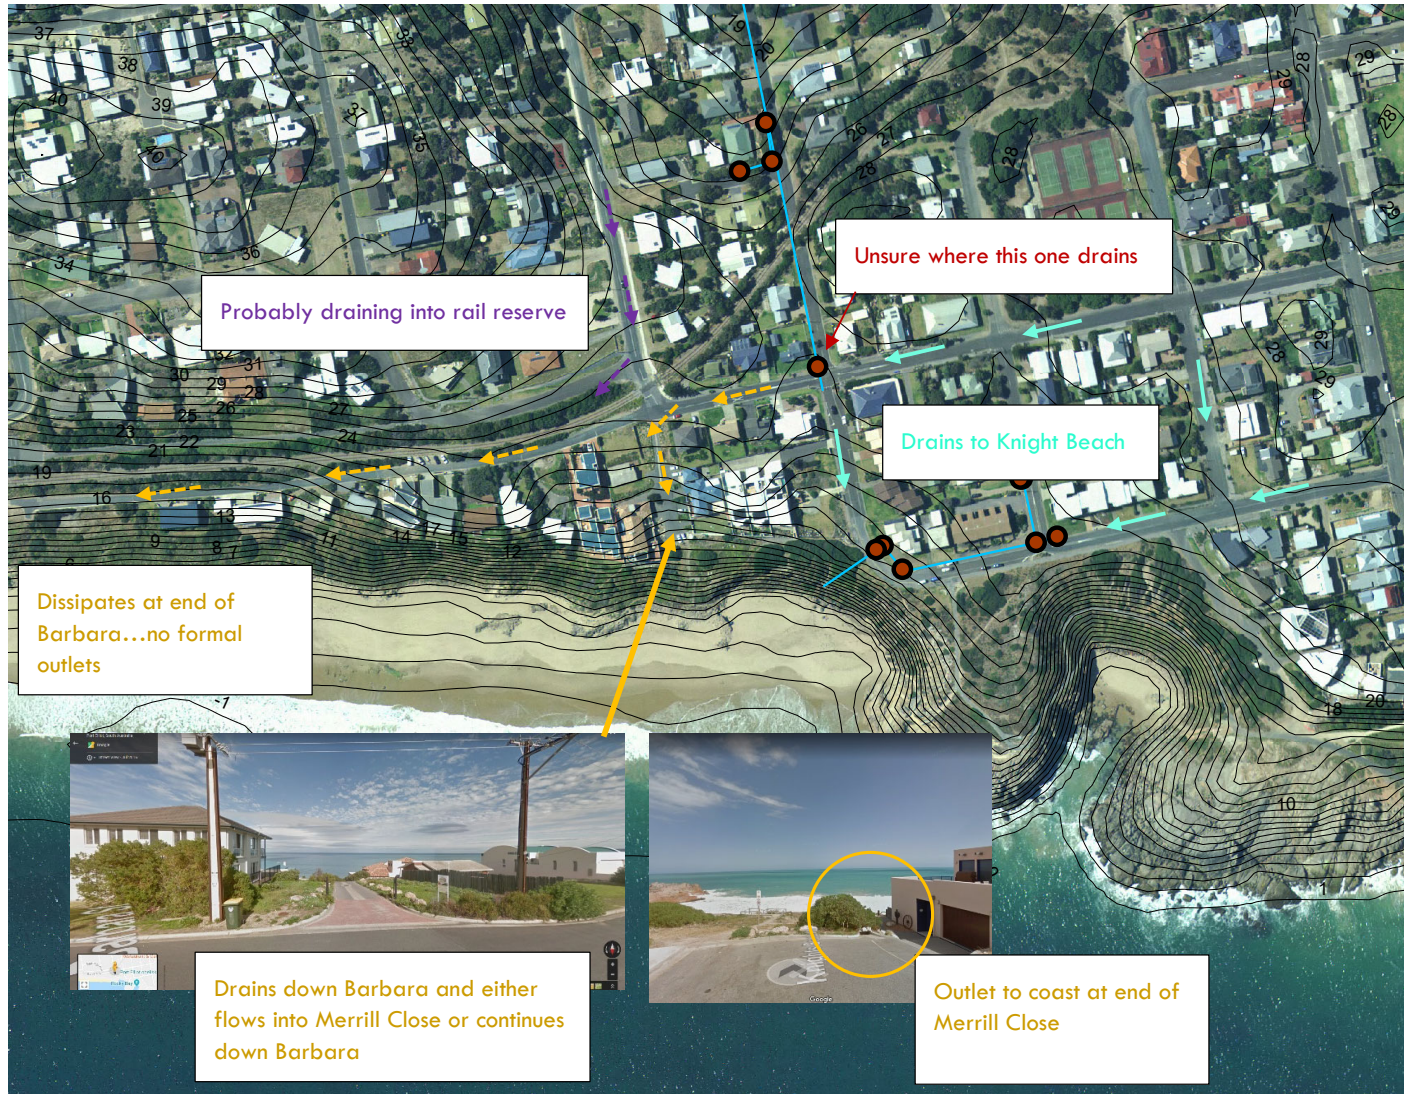
Assessment
 Storm water in SF9-2
 Storm water drains to various locations. The GIS plans are not entirely clear.
 Storm water does flow into Knight Beach from the settlement to the east. The lowering of the beach in the middle can be observed in the photograph to the right.

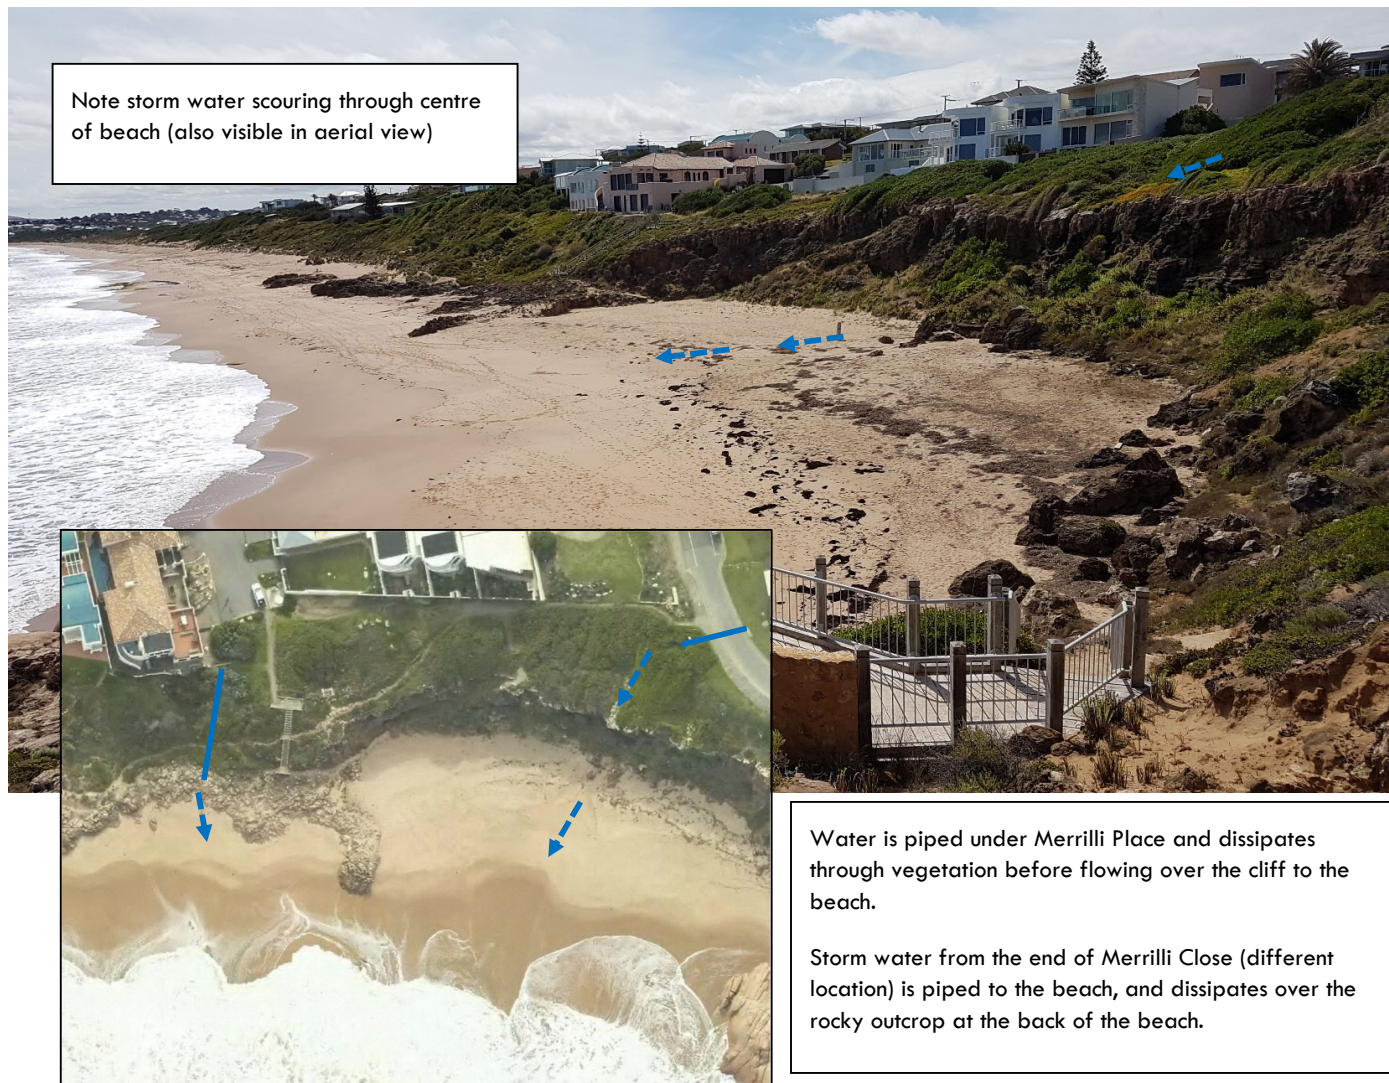
Note storm water scouring through centre of beach (also visible in aerial view)

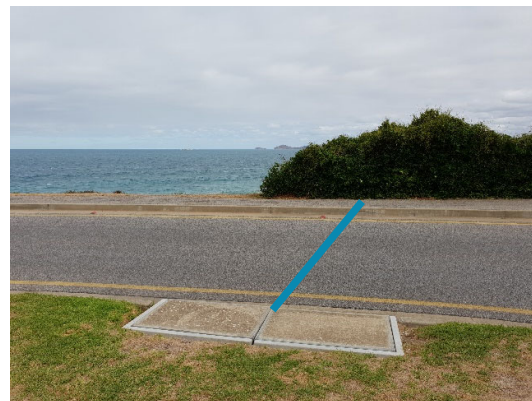
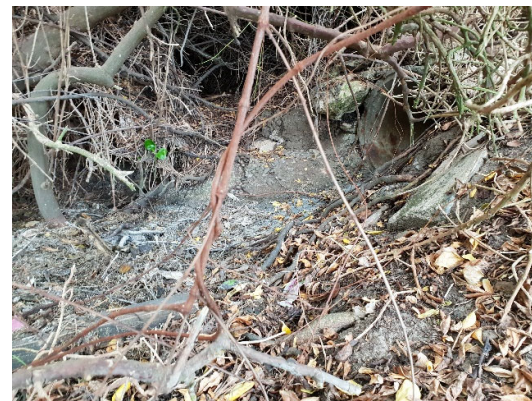
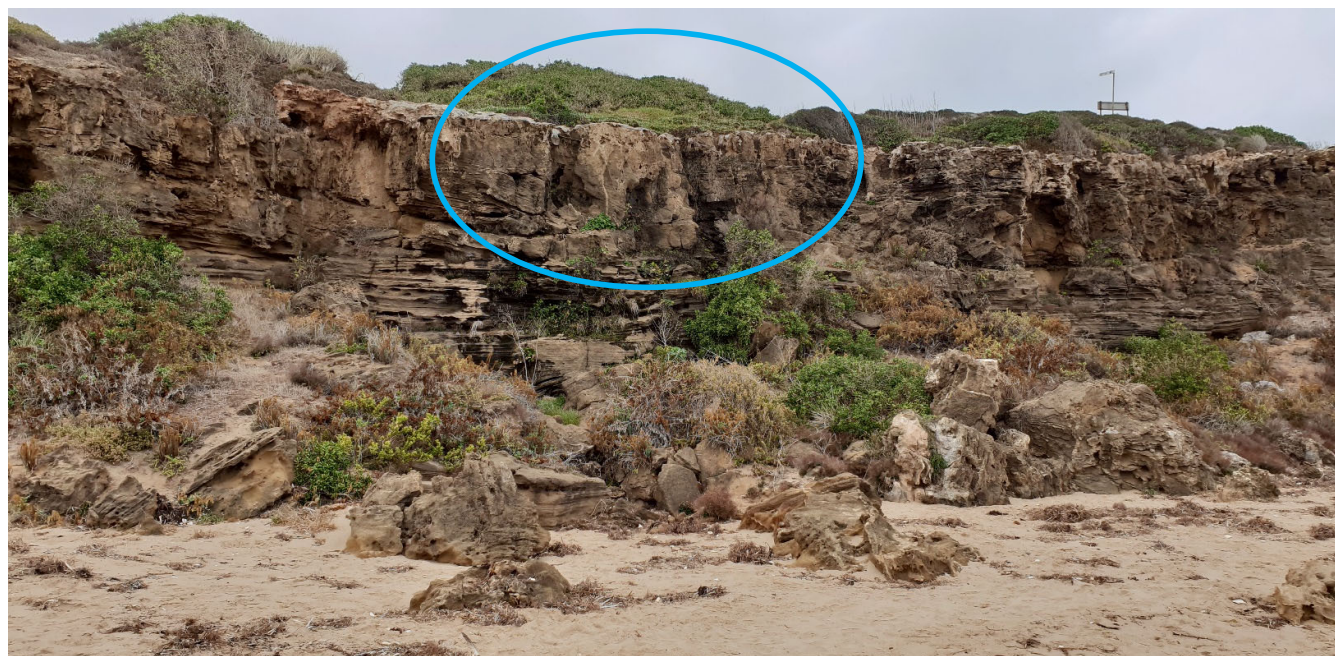
The scouring of the beach was not evident on inspection of 22 April, 2019, but is evident in other photographs.

It appears as if this storm water drainage strategy is appropriate, but further checks should be conducted after rain.

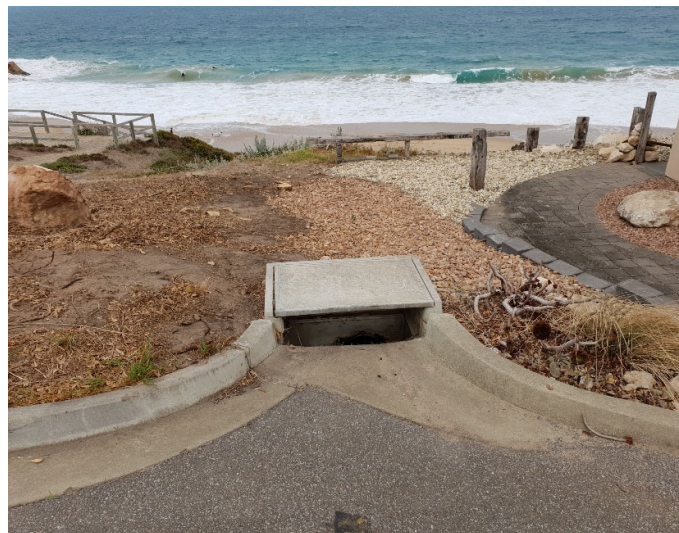
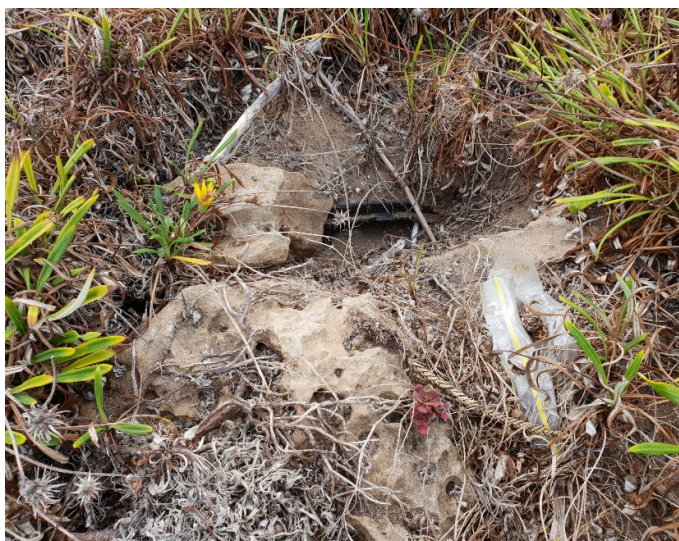
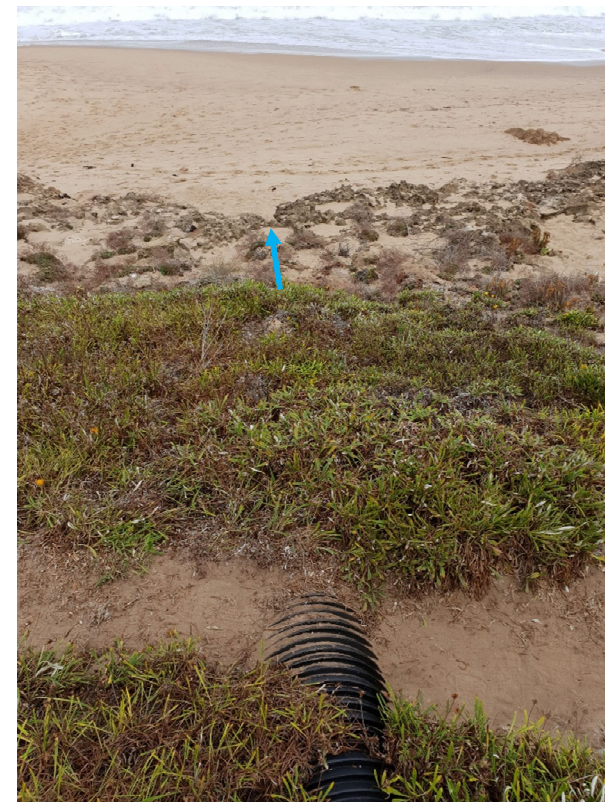
This appears to be a sound strategy.

However, the end of the pipe is currently blocked by sand and requires cleaning.
