Coastal Adaptation Study
for Alexandrina Council

BOOMER-KNIGHT BEACH

Report to be cited as: Western, M, Bourman, R., Hesp, P (2019) Coastal Adaptation Study for Alexandrina Council (Cell SF9 Boomer-Knight Beach) prepared by Integrated Coasts, South Australia.

This document is a partial output for the Coastal Adaptation Study for Alexandrina Council (Boomer-Knight Beach Cell SF9). This document also represents an output from the coastal adaptation assessment tool designed by Integrated Coast.

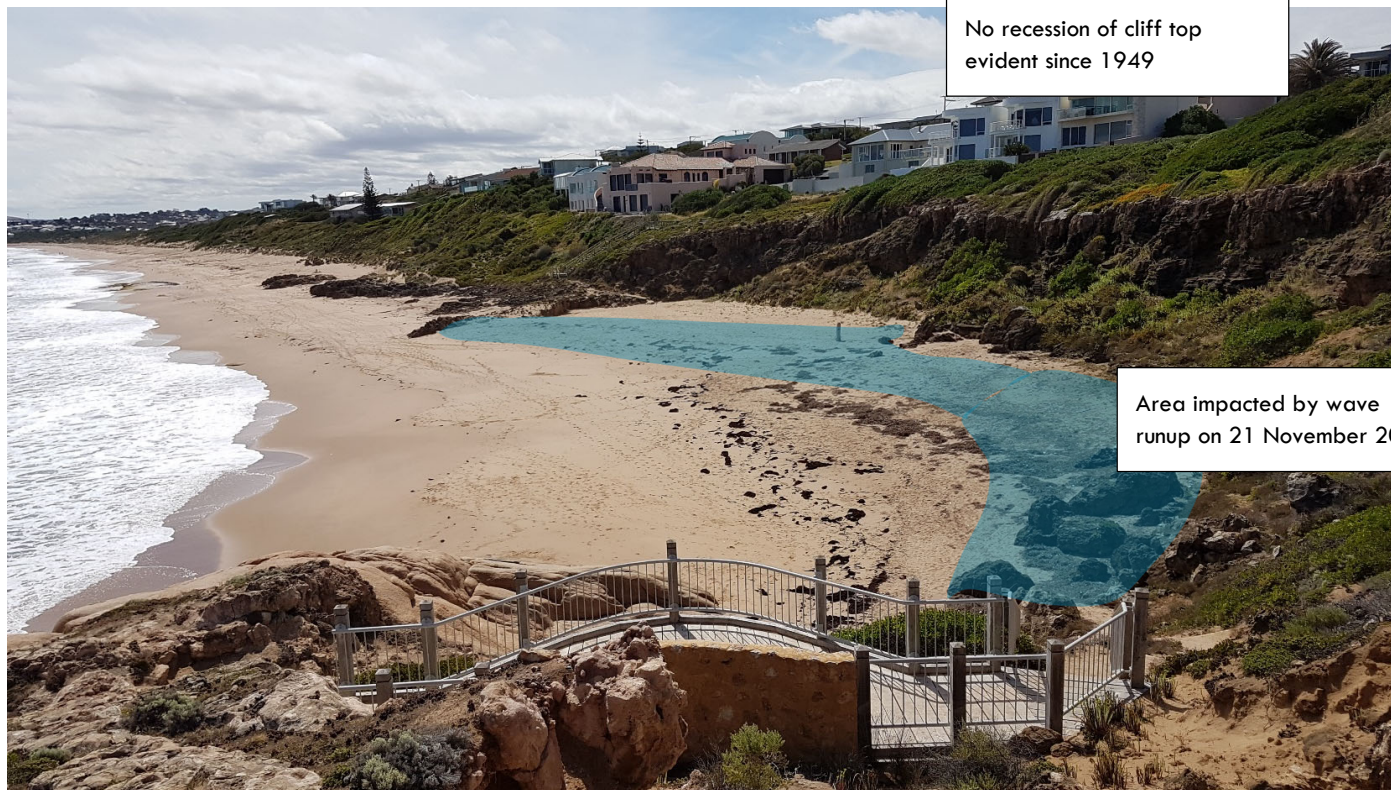
No recession of cliff top evident since 1949

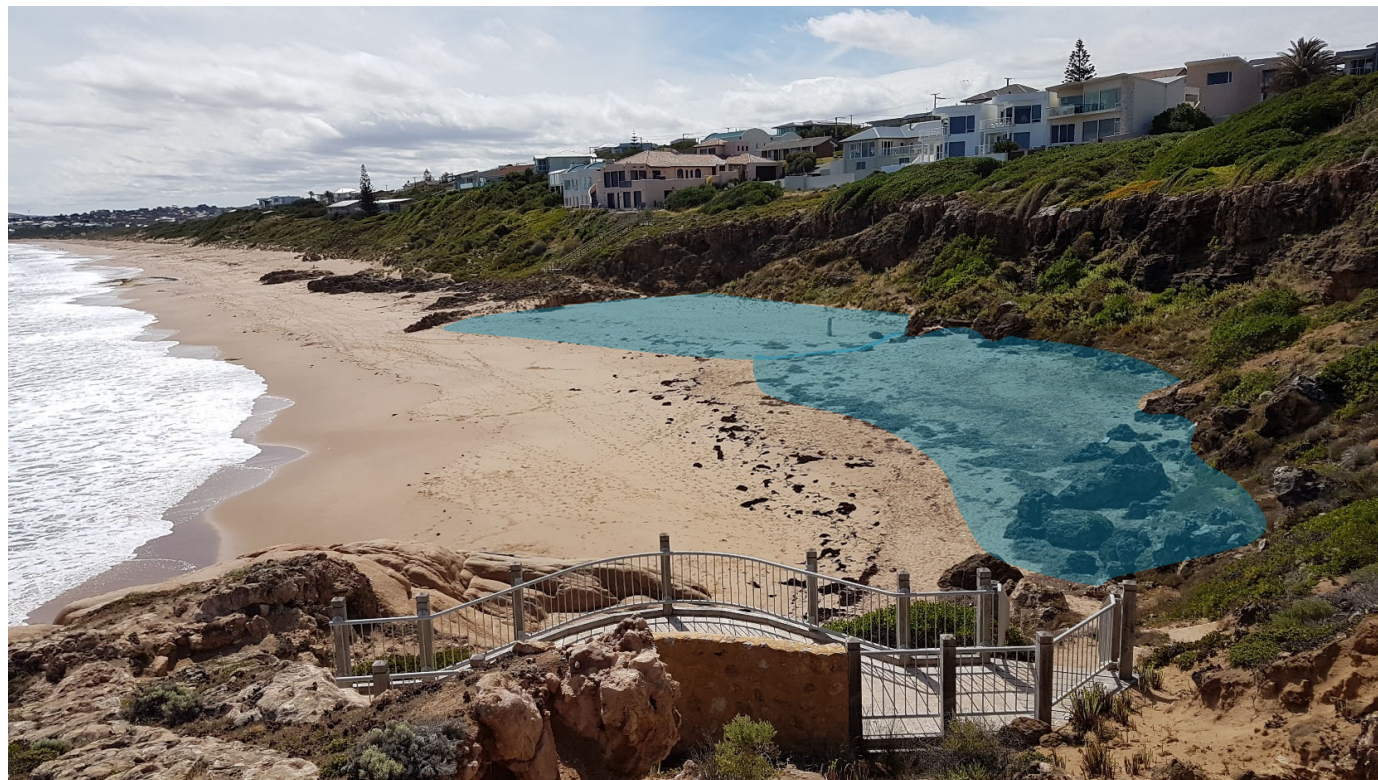
The modelling demonstrates that the impact would be higher on the eastern side of the bay.

The modelling shows that the backshore would be more significantly impacted by 2100 by storm events, but appears less significant with routine tidal action. However, it is important to note that modelling is conducted on current sand levels, and it isn't possible to establish the likely sand environment in 2100.

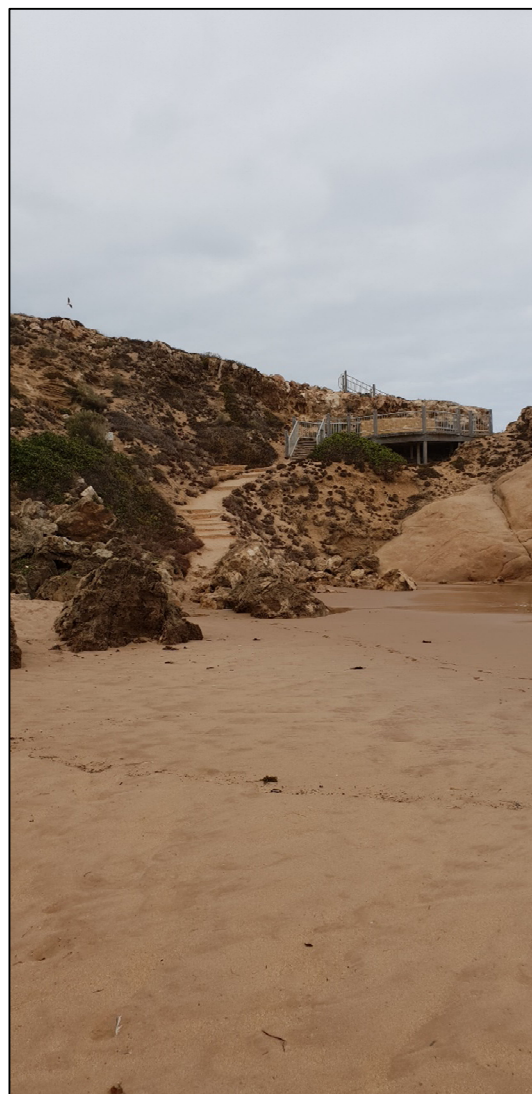
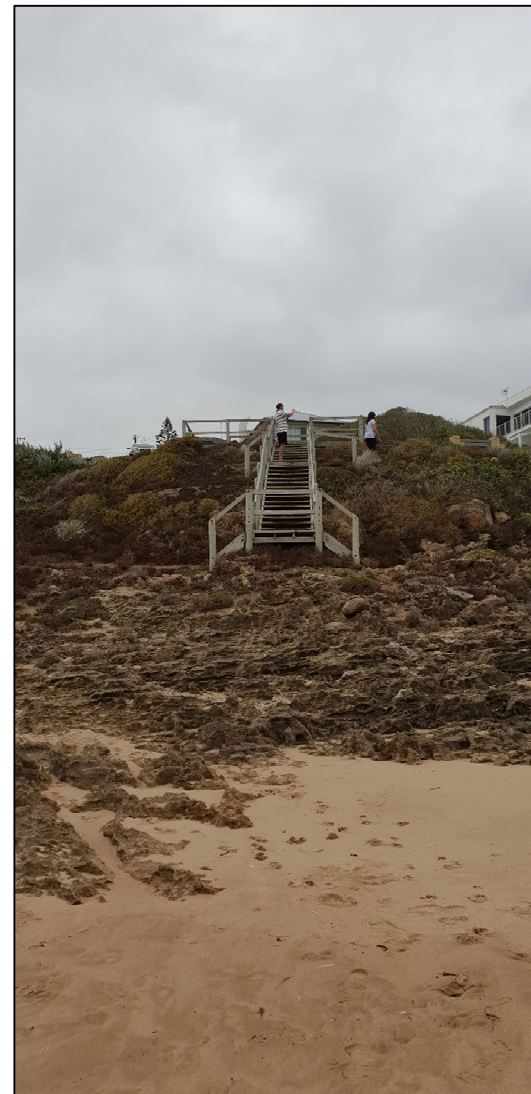
2. Merrilli Close

Access stairs culminate on top of a rocky outcrop and therefore free from any impacts from the sea.

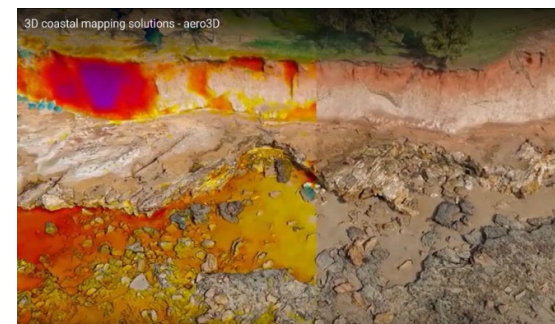
Figure: In a digital environment, software tools can be utilised to compare coastal change (Source: Aerometrex)

We have established a baseline in two ways: First, the capturing of the digital elevation model in 2018 provides a point in time baseline of the current form of the coast. In 5- or 10-years’ time (depending whether the coast is accreting or eroding), another digital elevation model could be captured and comparisons made between the two digital models (Figure).
