Coastal Adaptation Study
for Alexandrina Council

GOOLWA BEACH

Cells SF3 and SF4

Report to be cited as: Western, M., Bourman, R., Hesp, P (2019) Coastal Adaptation Study for Alexandrina Council (Cell SF3-4 Goolwa Beach) prepared by Integrated Coasts, South Australia.

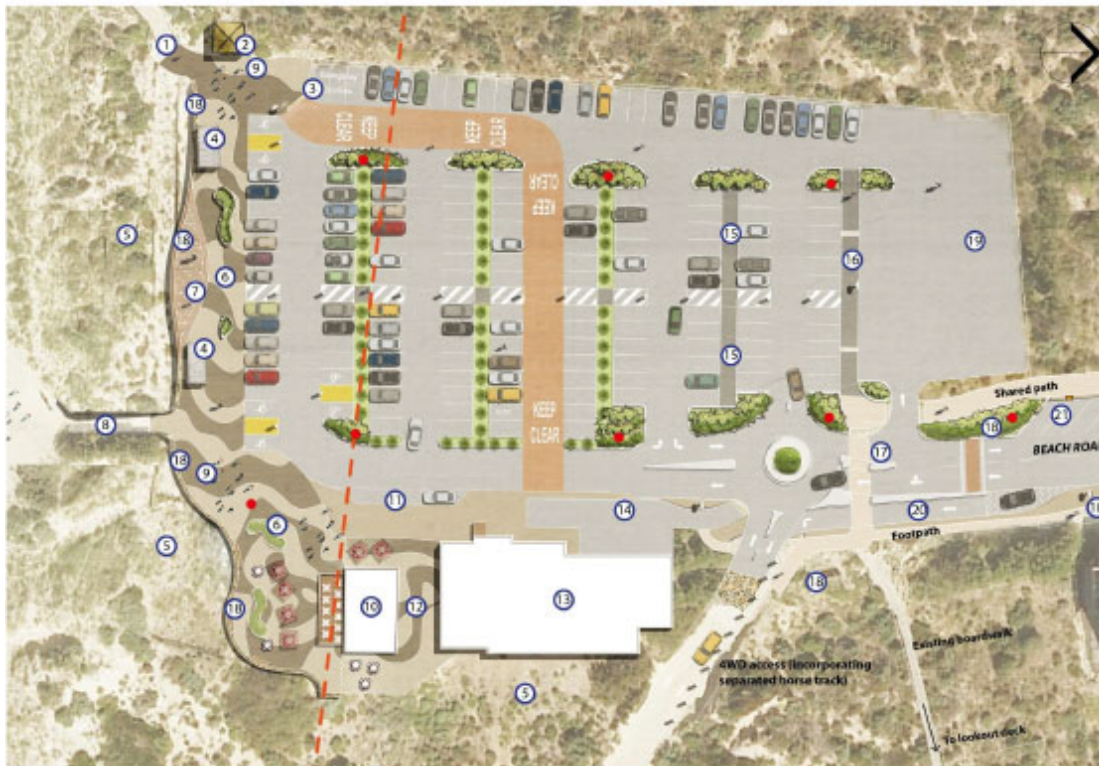
Based on advice from Coast Protection Board the masterplan has adopted ~60m of shoreline retreat by 2100 (Figure 4).

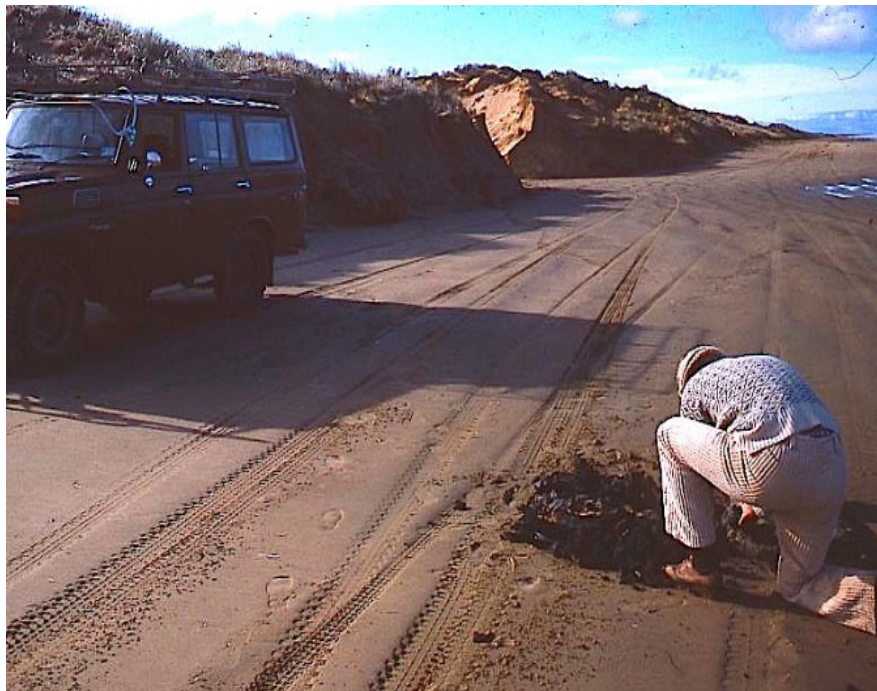
Figure 4: Back-barrier lagoonal sediments containing skeletons of rodents, shells and tree stumps dated at 7,000 to 4,500 years Before Present exposed on the modern beach from Goolwa Beach almost to the Murray Mouth. These sediments demonstrate that the dunes and the shoreline have moved landward at least 1 kilometre over the past 7,000 years at an average rate of 14 cm/yr.

There is evidence of longer-term coastal erosion at this locality. Black organic deposits, which would have originally formed in a back-barrier lagoon setting behind the modern coastal dunes, have been sporadically exposed after storms on the modern beach from Goolwa Beach almost to the Murray Mouth. Skeletons of rodents, shells and tree stumps contained in the back-barrier deposits, have been radiocarbon dated between 7,000 to 4,500 years BP (Before Present). These sediments demonstrate that the dunes and the shoreline have moved landward at least 1 kilometre over the past 7,000 years at an average rate of 14 cm/yr.

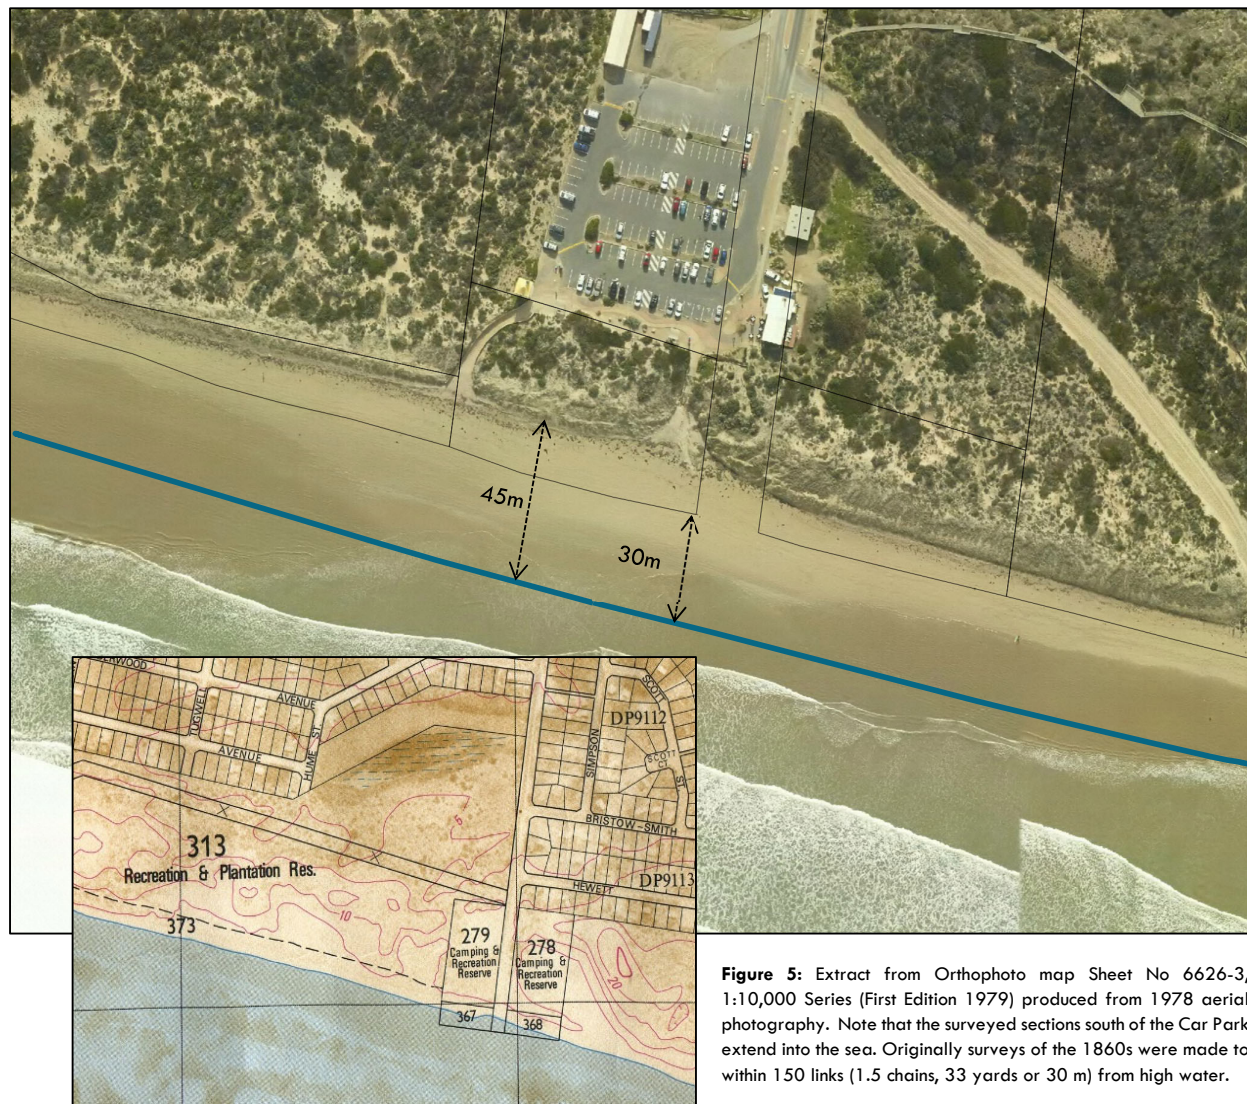
Figure 5: Extract from Orthophoto map Sheet No 6626-3, 1:10,000 Series (First Edition 1979) produced from 1978 aerial photography. Note that the surveyed sections south of the Car Park extend into the sea. Originally surveys of the 1860s were made to within 150 links (1.5 chains, 33 yards or 30 m) from high water.

Therefore, in this location, ~40-45m of erosion occurred between 1860 and 1950 at approximately 0.5m per year.

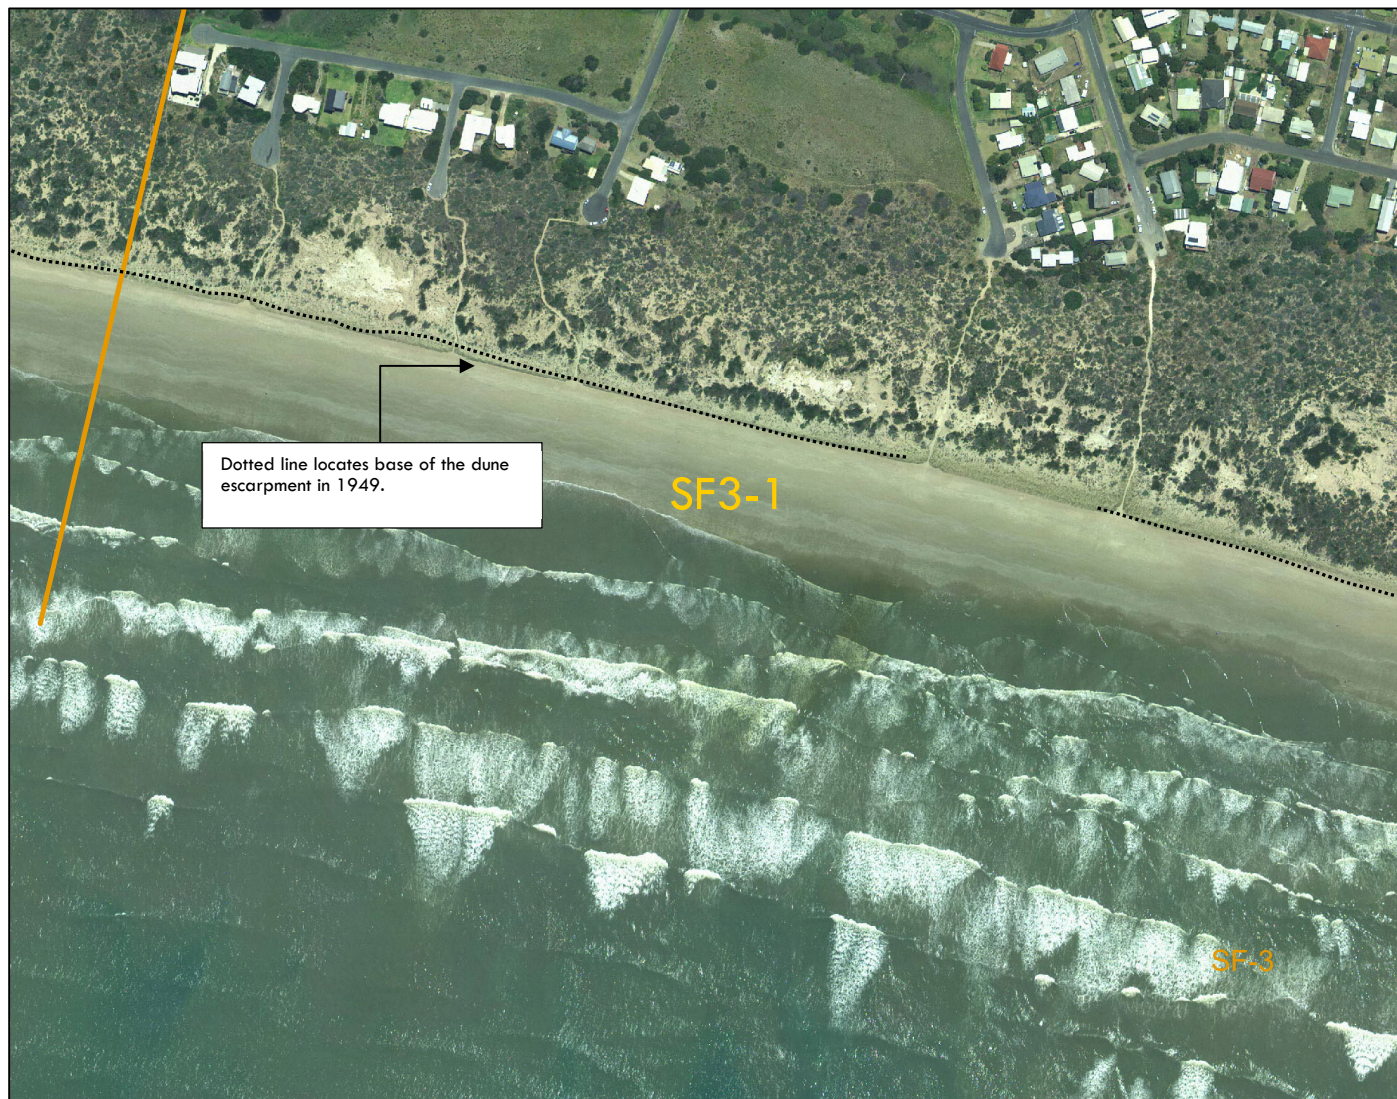
In cell 3.1, a comparison between 2006 and 2016 suggests minor accretion of the dune.

Most of the dune line in 2016 is in the same position as 1949.

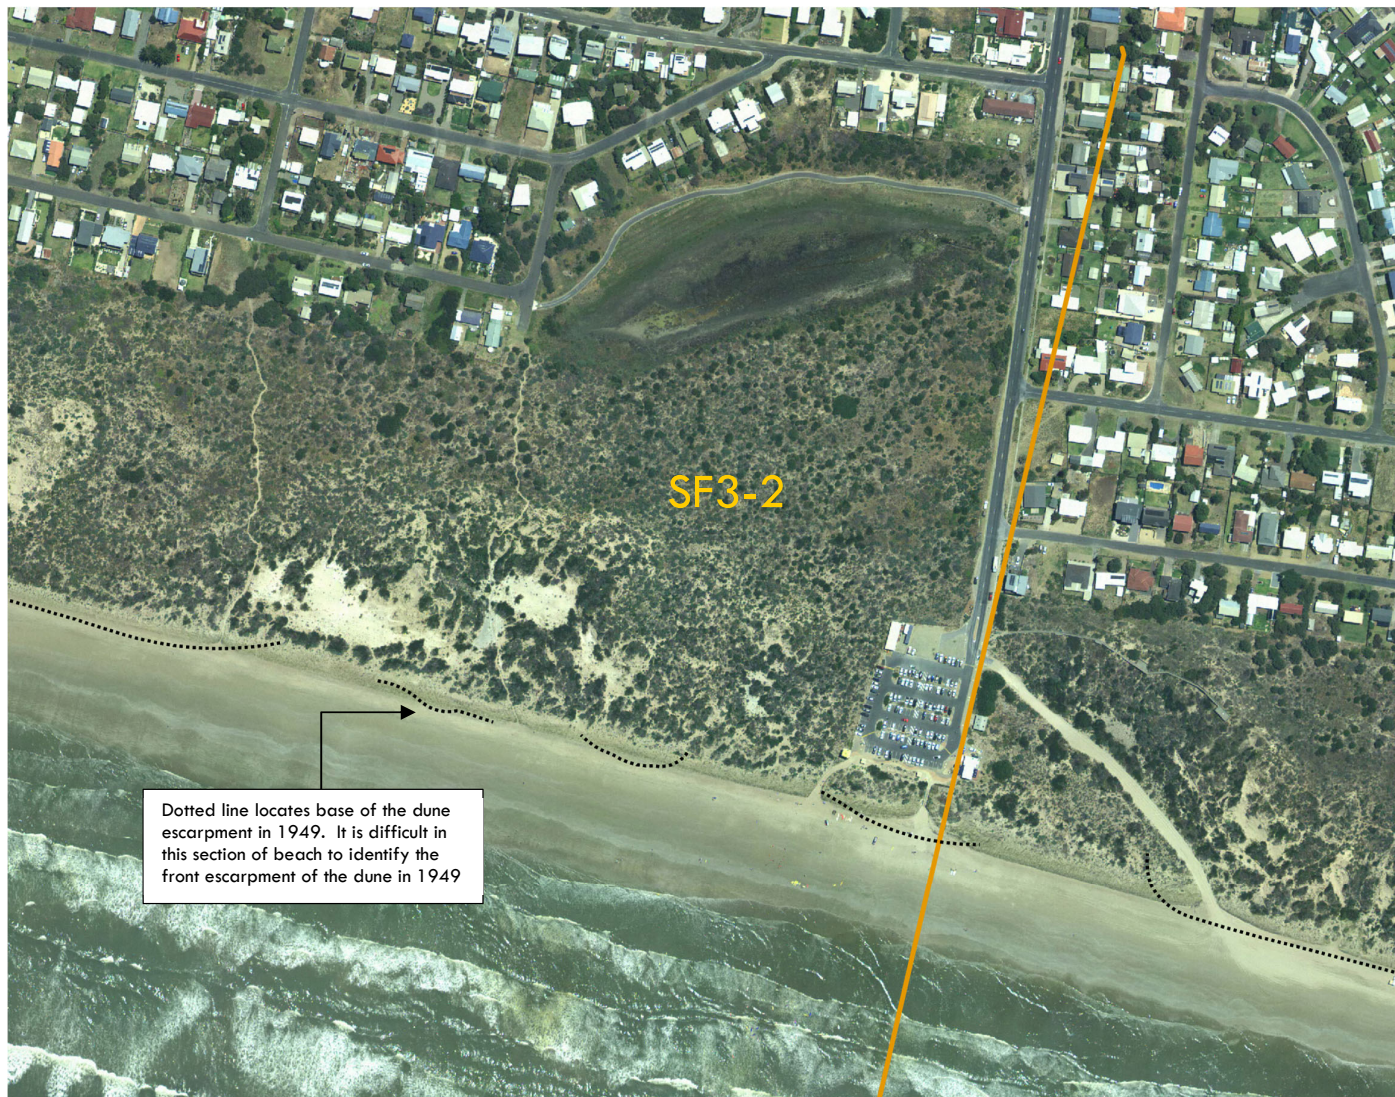
Dotted line locates base of the dune escarpment in 1949. It is difficult in this section of beach to identify the front escarpment of the dune in 1949

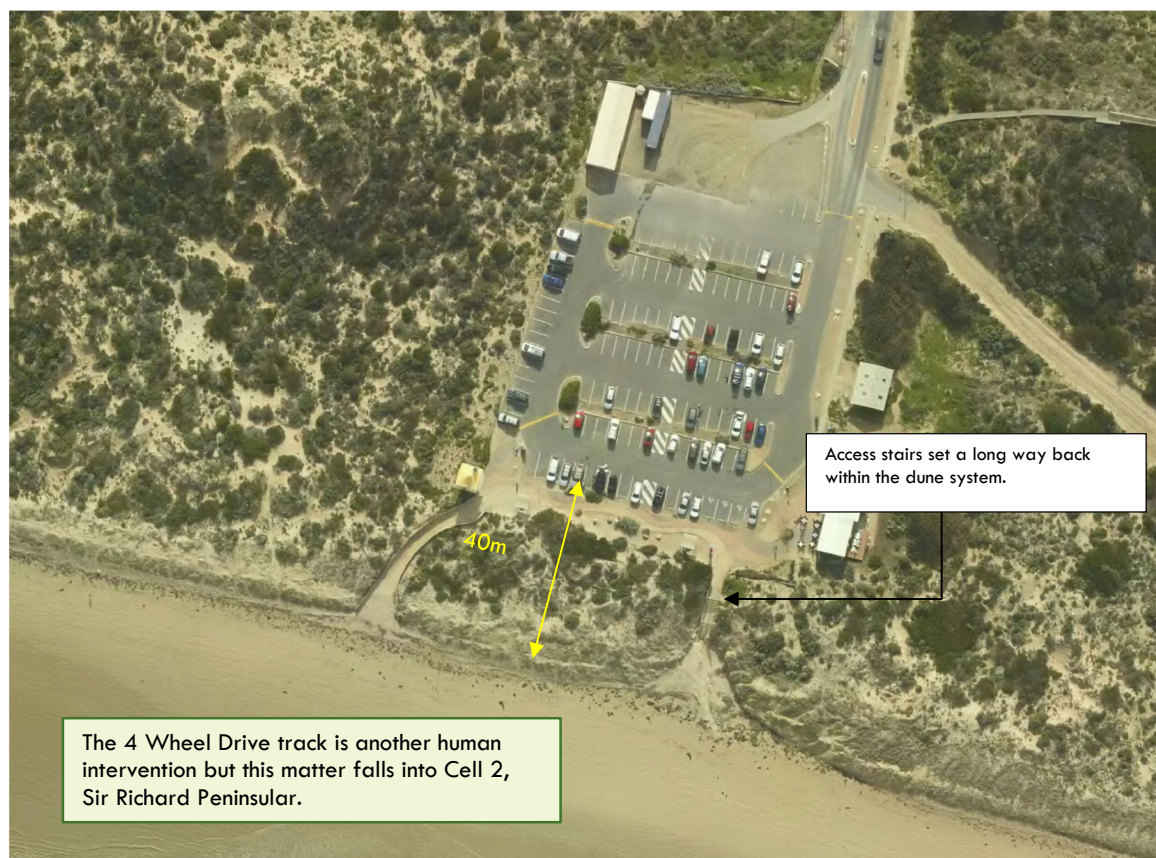
3. No dune fencing has been installed to the front side of the dunes, but the dune escarpment is quite steep at the beach level. Inspections revealed very little pedestrian activity within the foredune system.

4. Dune fencing has been installed to carpark side of the dunes to the left of the accessway, and a retaining system has been installed to the right hand side of the accessway. Both of these measures are designed to control sand drifting into the carpark area.

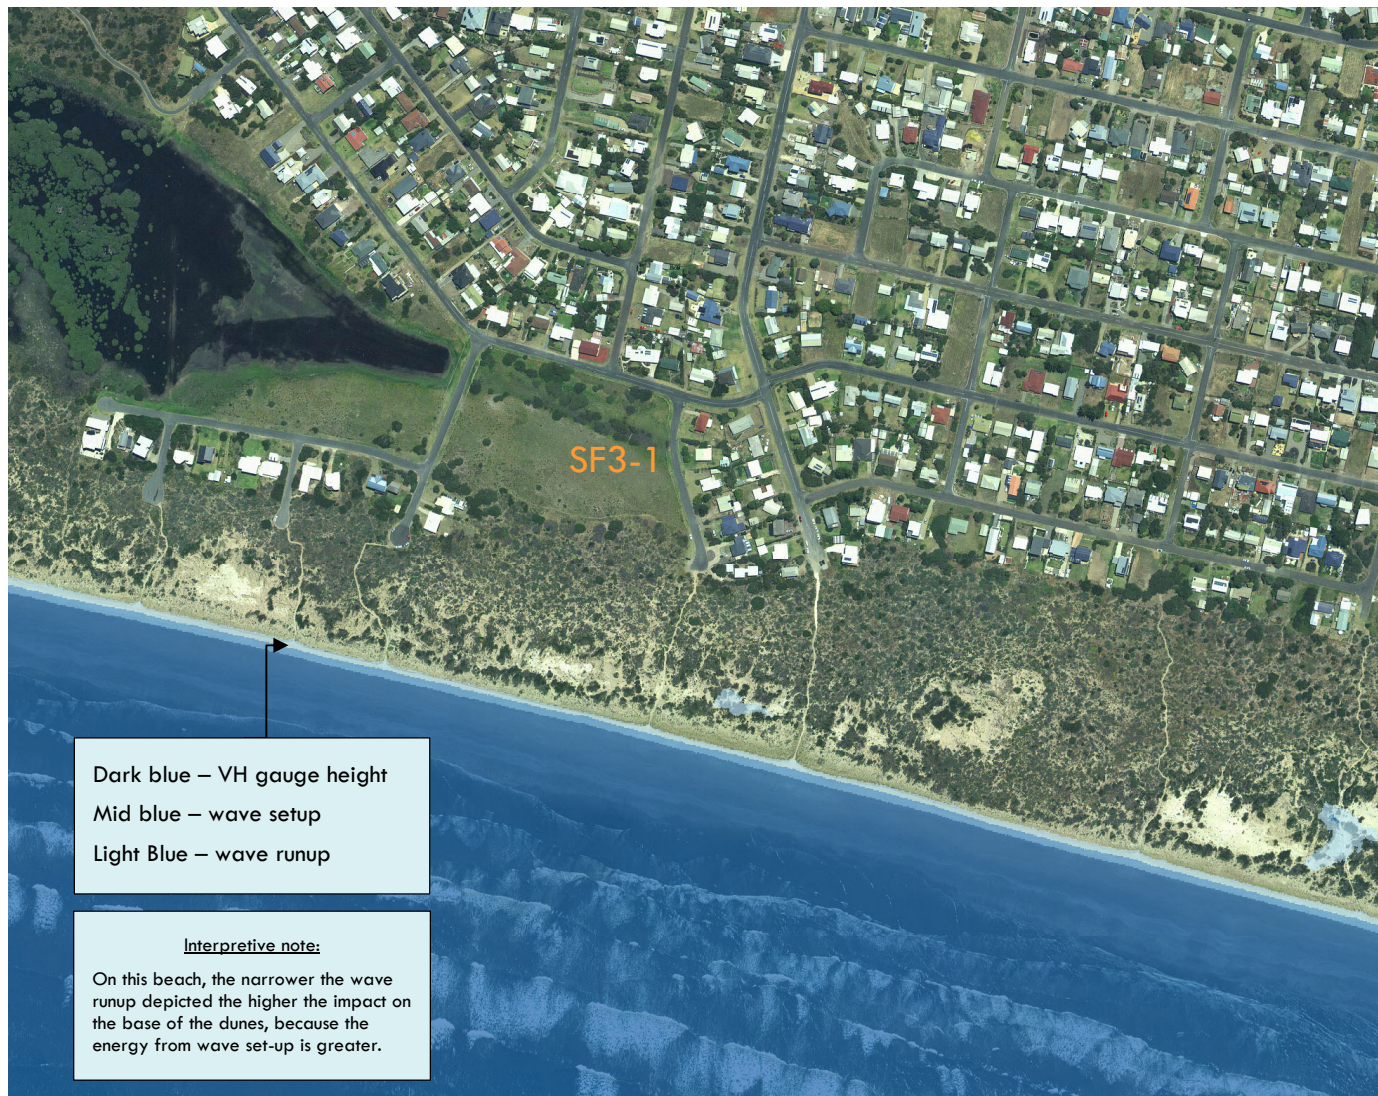
Dark blue – VH gauge height
Mid blue – wave setup
Light Blue – wave runup

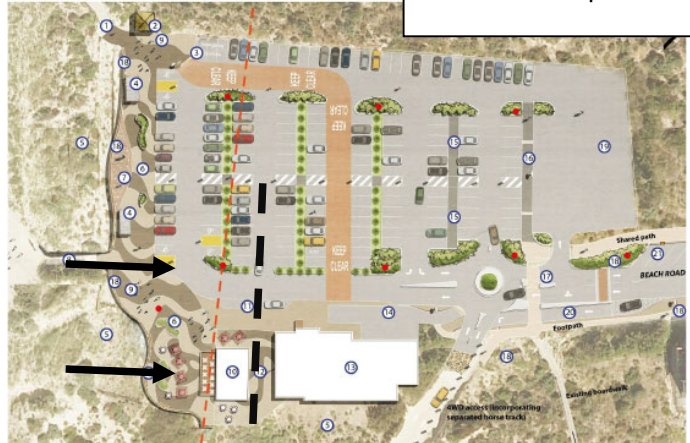
Recommendation to reinststate the dune system and reconfigure the access way as a ramp, culminating in smaller number of stairs that are buried into the sand to cater for expected erosion cycle. It may be possible to take this a ramp all the way to the beach.

1. Increase the buffer to the Goolwa Carpark and Surrounds proposal by 20m.
2. Reinststate the dunes to the main access point and install a ramp over the dunes with an exit to the beach. It is recommended that the end be buried down below current sand levels so that if the coast returns to an erosion mode that the infrastructure will not be left stranded by falling sand levels.

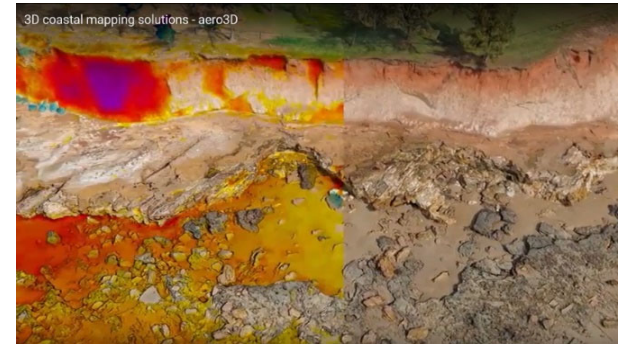
Figure: In a digital environment, software tools can be utilised to compare coastal change (Source: Aerometrex)

We have established a baseline in two ways: First, the capturing of the digital elevation model in 2018 provides a point in time baseline of the current form of the coast. In 5- or 10-years’ time (depending whether the coast is accreting or eroding), another digital elevation model could be captured, and comparisons made between the two digital models (Figure).

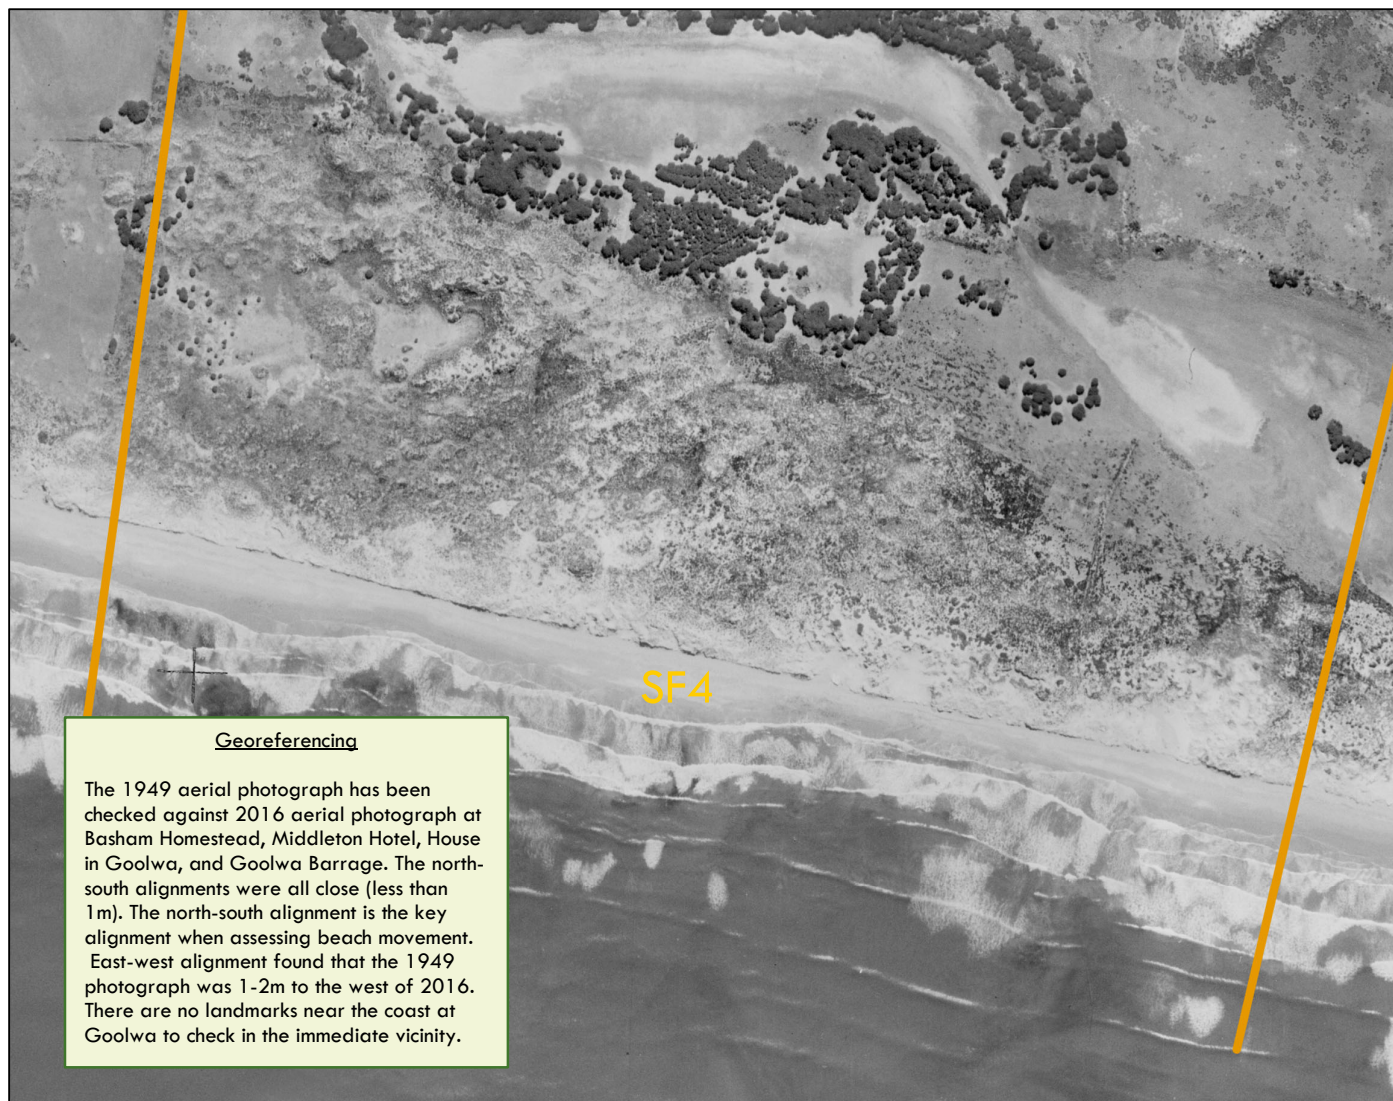
The 1949 aerial photograph has been checked against 2016 aerial photograph at Basham Homestead, Middleton Hotel, House in Goolwa, and Goolwa Barrage. The north-south alignments were all close (less than 1m). The north-south alignment is the key alignment when assessing beach movement. East-west alignment found that the 1949 photograph was 1-2m to the west of 2016. There are no landmarks near the coast at Goolwa to check in the immediate vicinity.

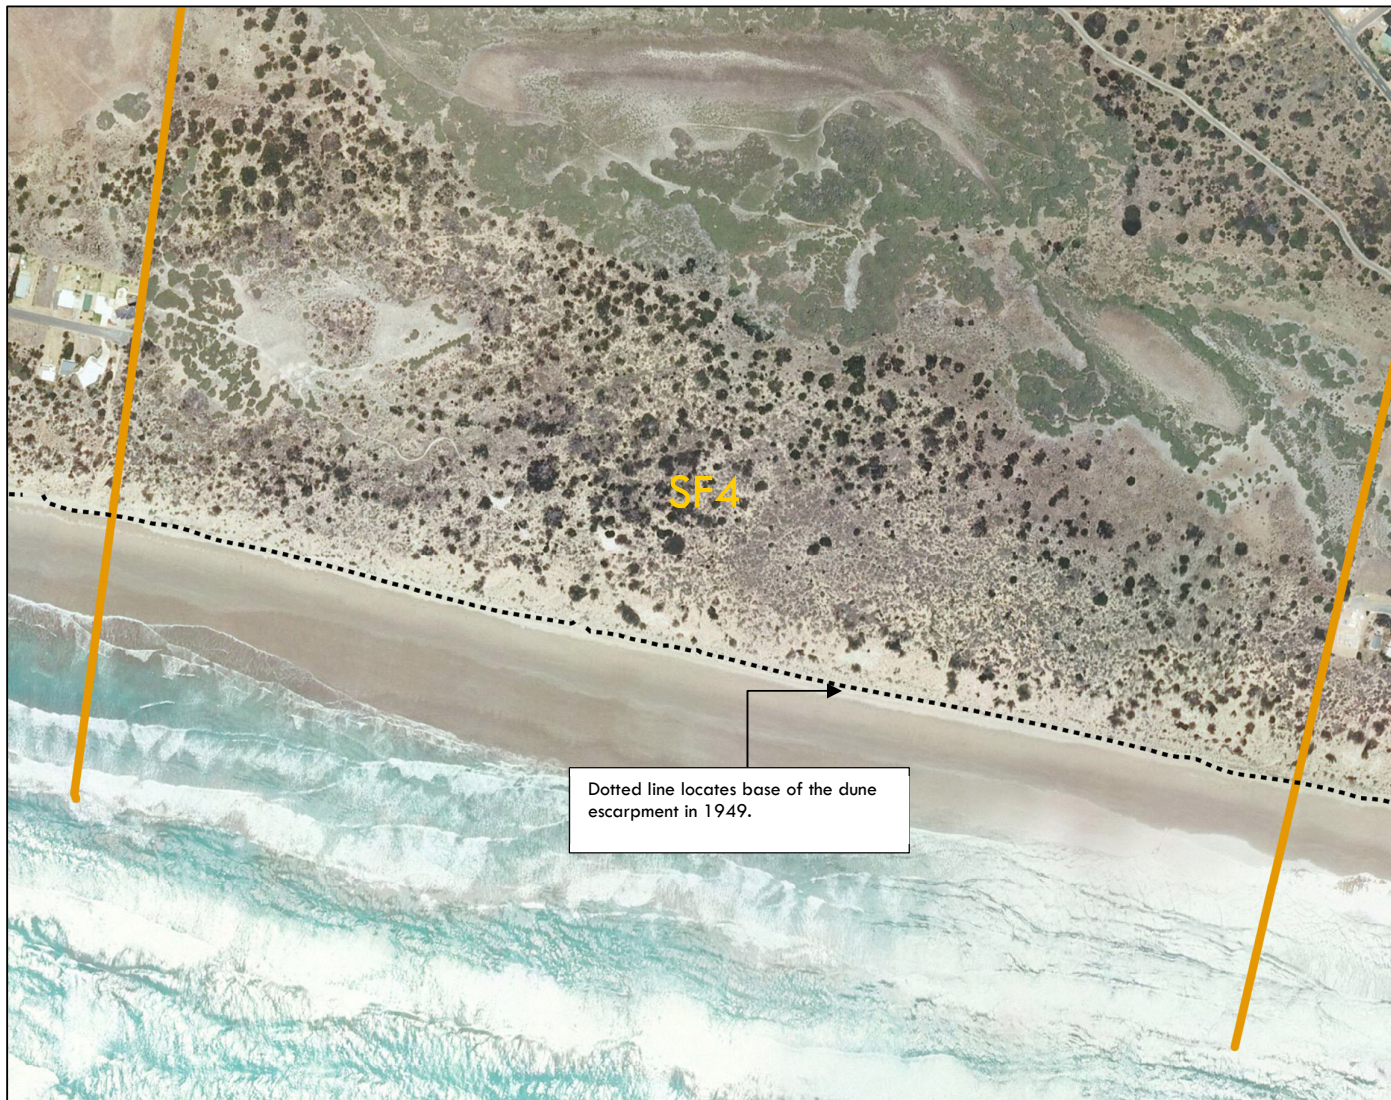
The line of the dune escarpment is located in the same position as 1949.

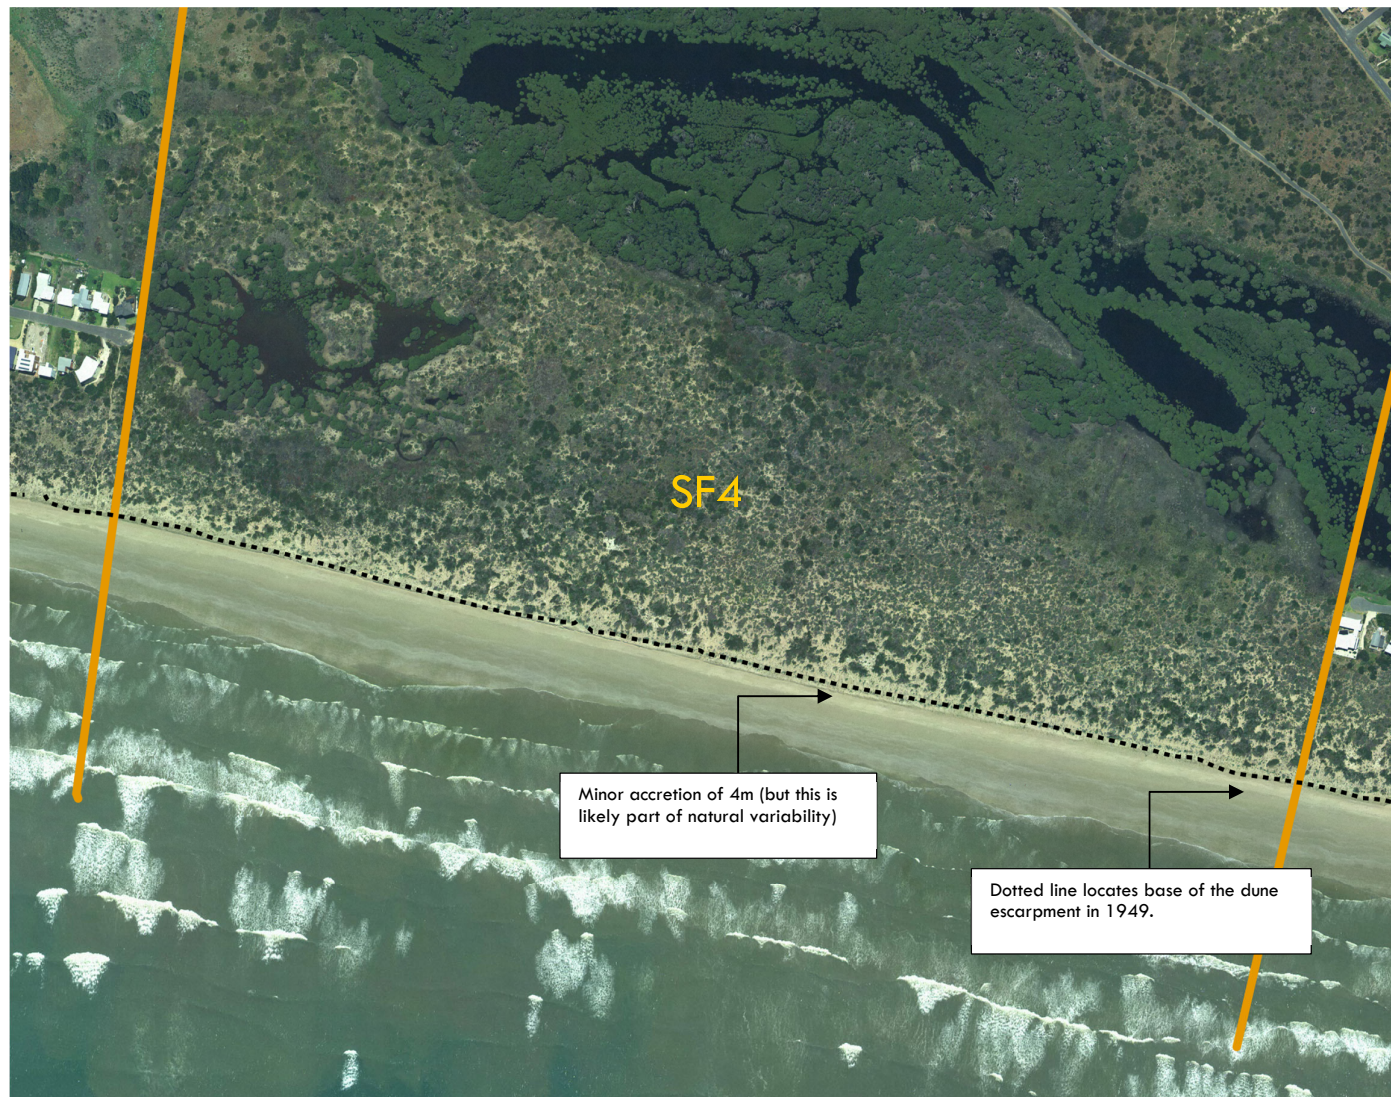
Assessment

The line of the dune escarpment is located in the same position as 1949. In some sections the line of the escarpment has accreted since 1949 by as much as 4m but this is likely related to natural variability rather than a trend.

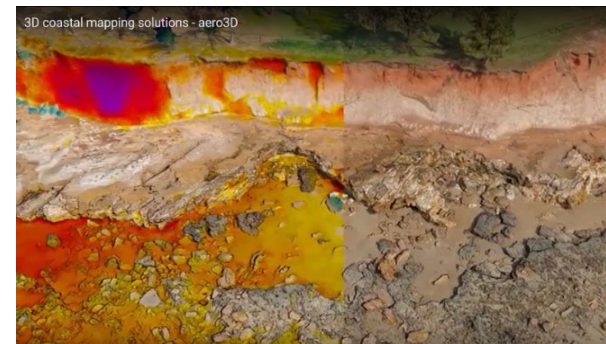
Figure: In a digital environment, software tools can be utilised to compare coastal change (Source: Aerometrex)

We have established a baseline in two ways: First, the capturing of the digital elevation model in 2018 provides a point in time baseline of the current form of the coast. In 5- or 10-years’ time (depending whether the coast is accreting or eroding), another digital elevation model could be captured, and comparisons made between the two digital models (Figure).
