Coastal Adaptation Study  
for Alexandrina Council  
**MIDDLETON BEACH**

Cell SF5

By Integrated Coasts: Western, Hesp, and Bourman (2019)

Report to be cited as: Western, M, Bourman, R., Hesp, P (2019) Coastal Adaptation Study for Alexandrina Council (Cell SF5 Middleton Beach) prepared by Integrated Coasts, South Australia.

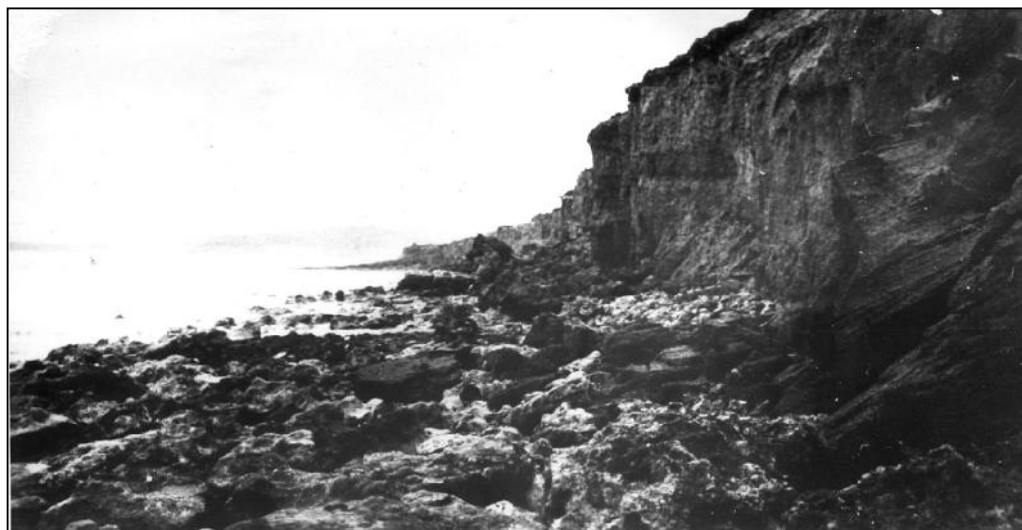
Figure 3: The aeolianite cliffs at Surfers Beach have a long history of active erosion. This photo was taken in the 1950s (Dr R Bourman)

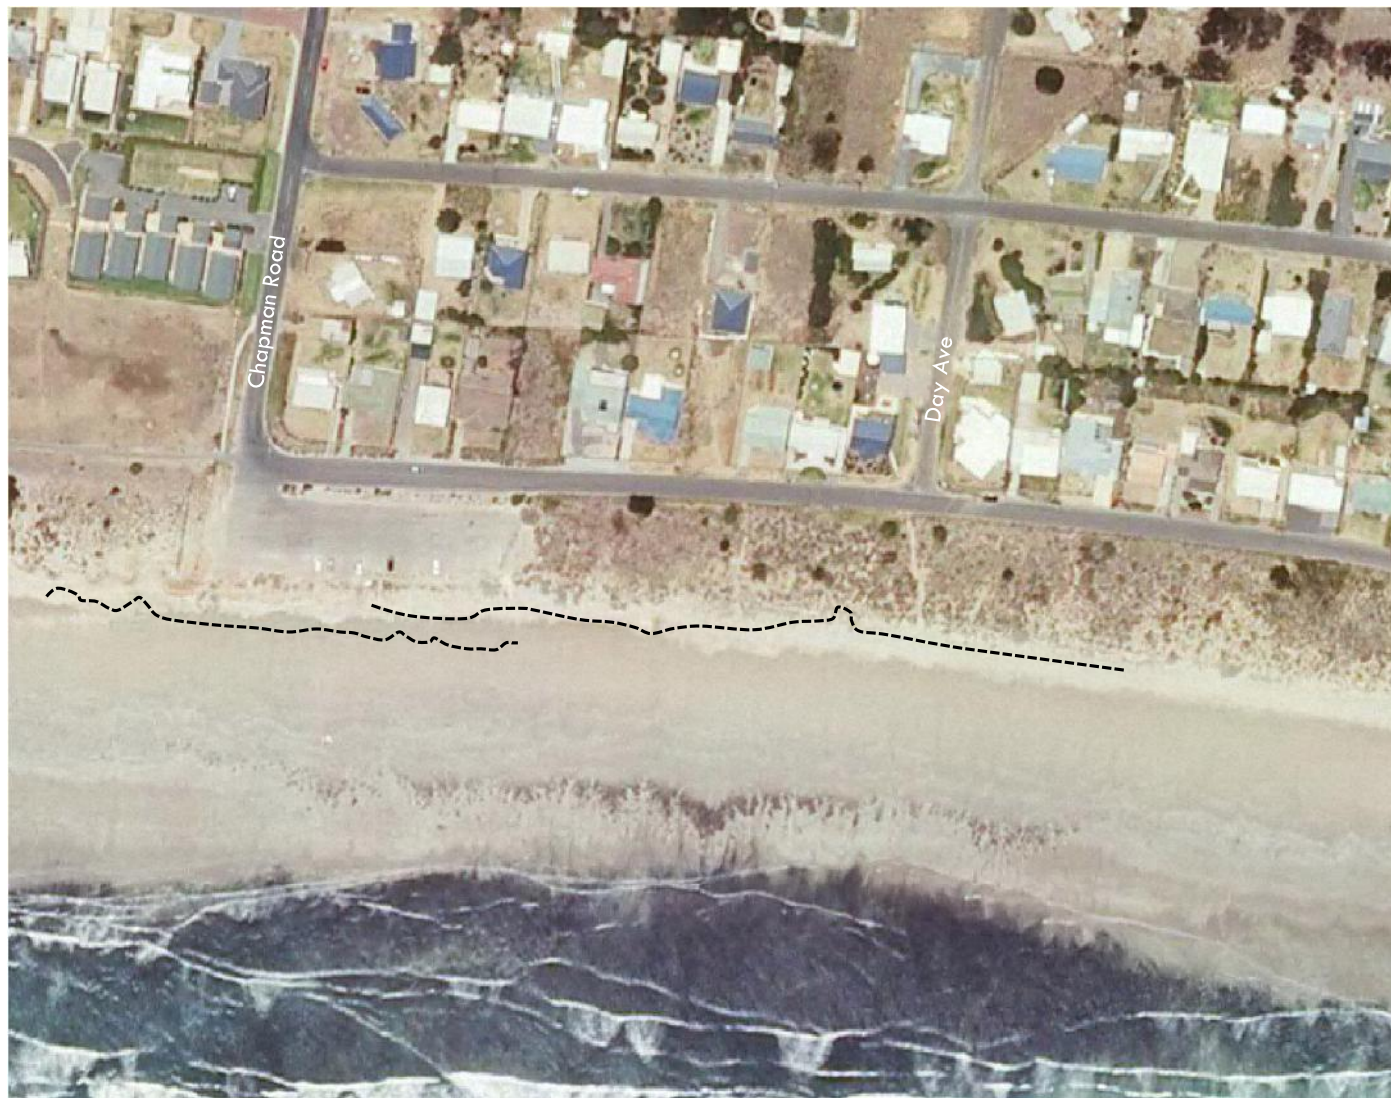
Comparison to 1949, demonstrates 8-10m recession in vicinity of Chapman.

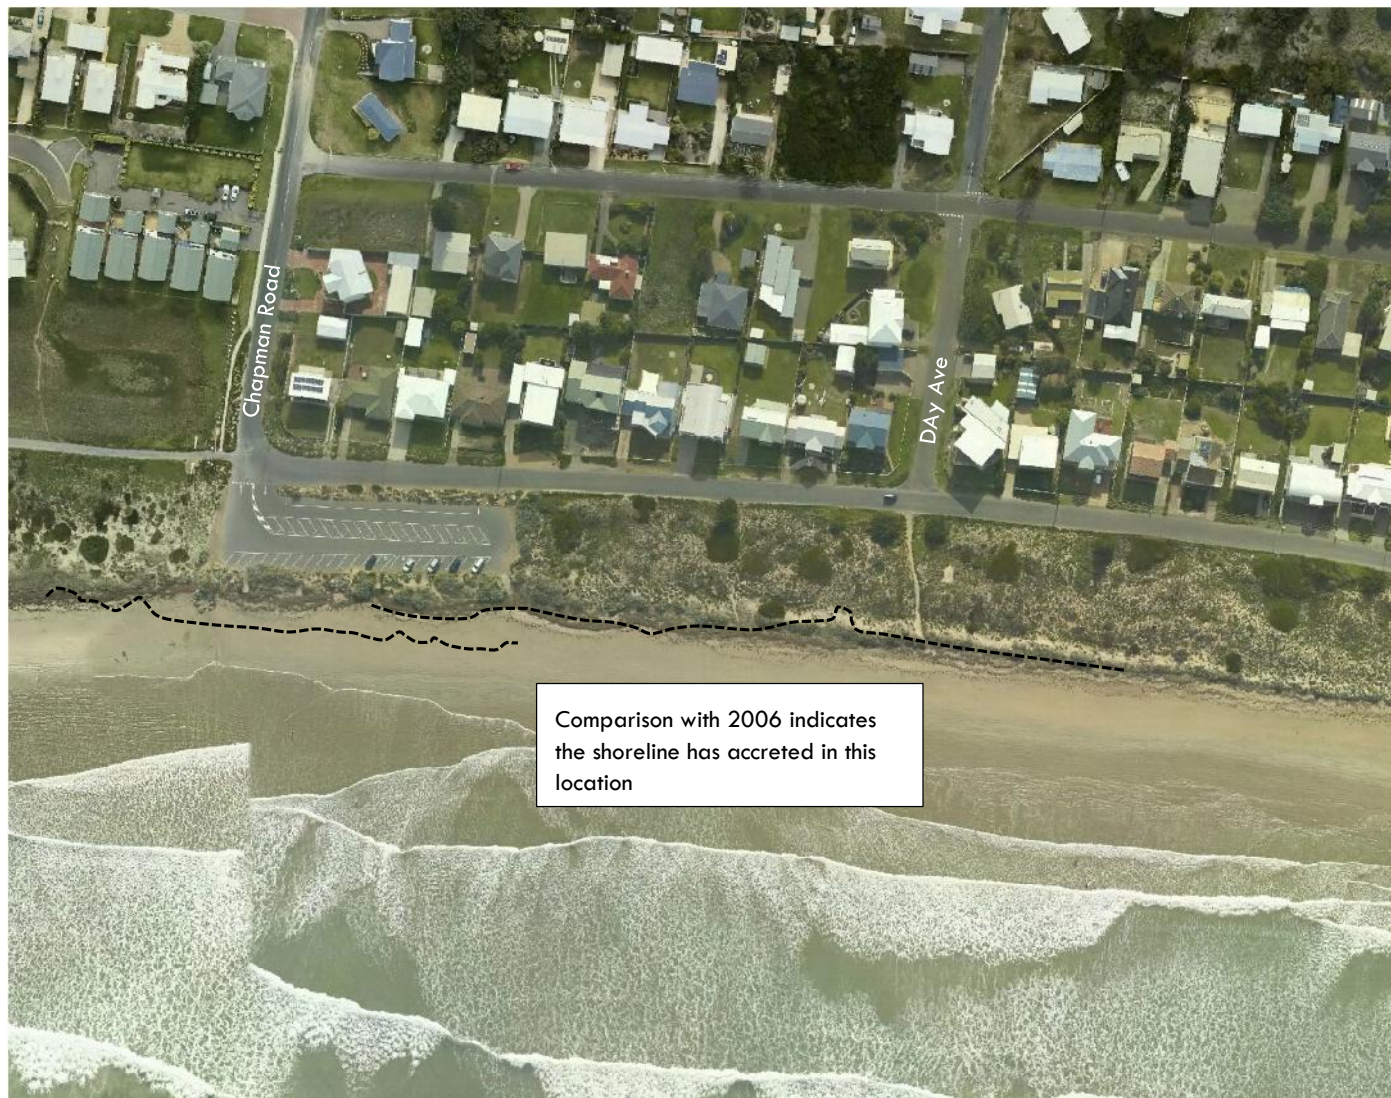
Comparison between 2006 and 2018, demonstrates additional erosion of ~2m in vicinity of Chapman Road carpark.

Note also that the location of the frontal dune is the same as 1949 to the east of the carpark.

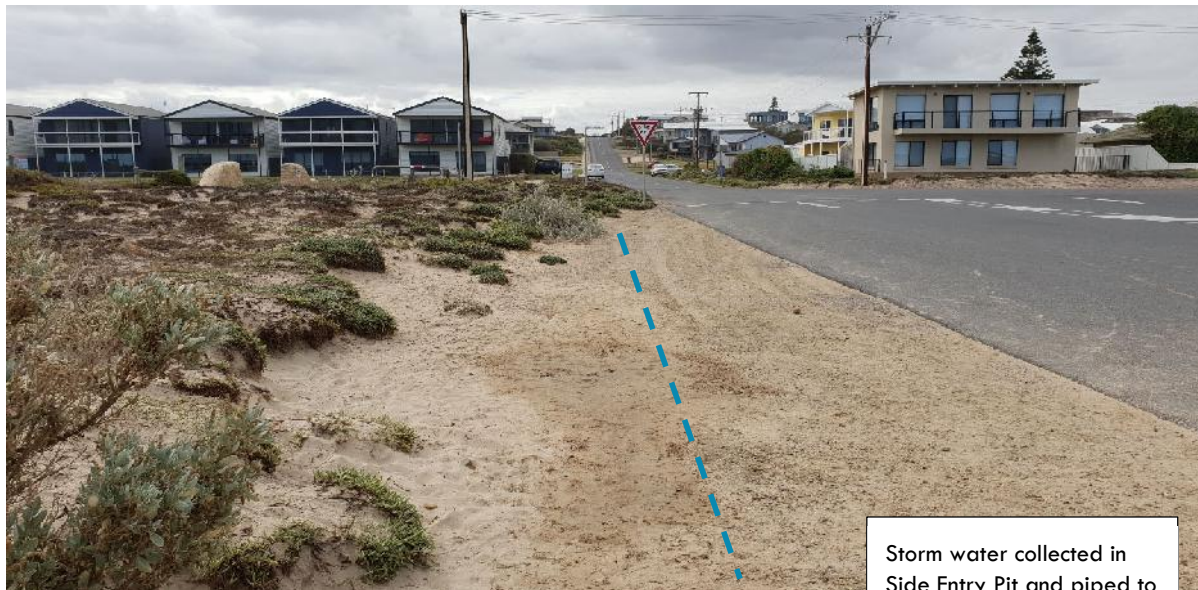
Storm water is collected in a side entry pit on Chapman Road and then is piped to the foreshore (presumably with water collected from higher up within the settlement as well).

Note sand levels around the outlet on the beach.

Storm water collected in Side Entry Pit and piped to foreshore (outlet blocked).

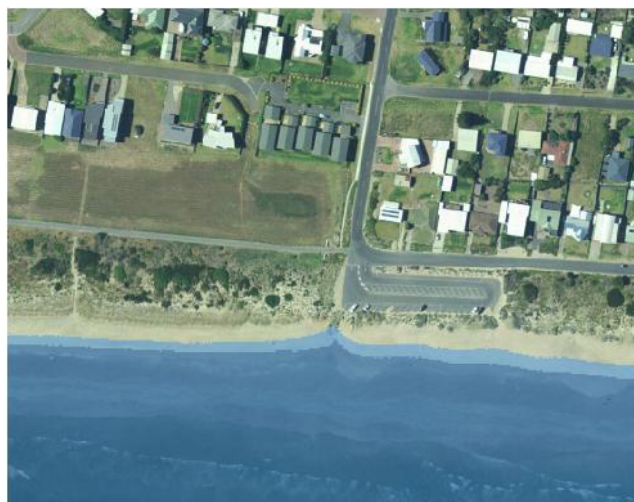
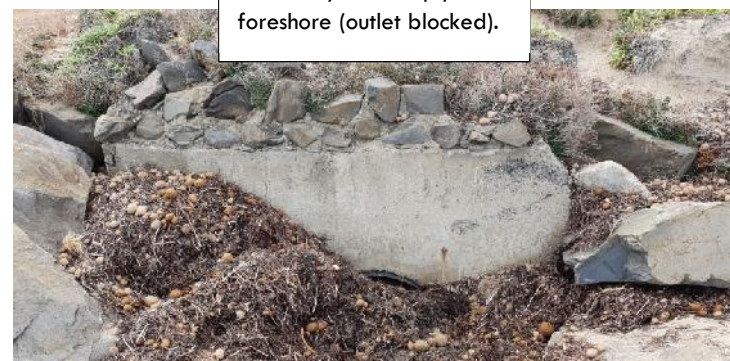
Left: Note the scouring from storm water outflow (DEM 2018). Impacts from storm effects will be greater in locations where the beach has been lowered. Sea level rise will exacerbate the problem.

Consider construction of detention or retention system to reduce storm water flows to the beach

Replenish the beach sand to the area adjacent the current stormwater outlet. Sand shall be locally sourced via beach scraping.

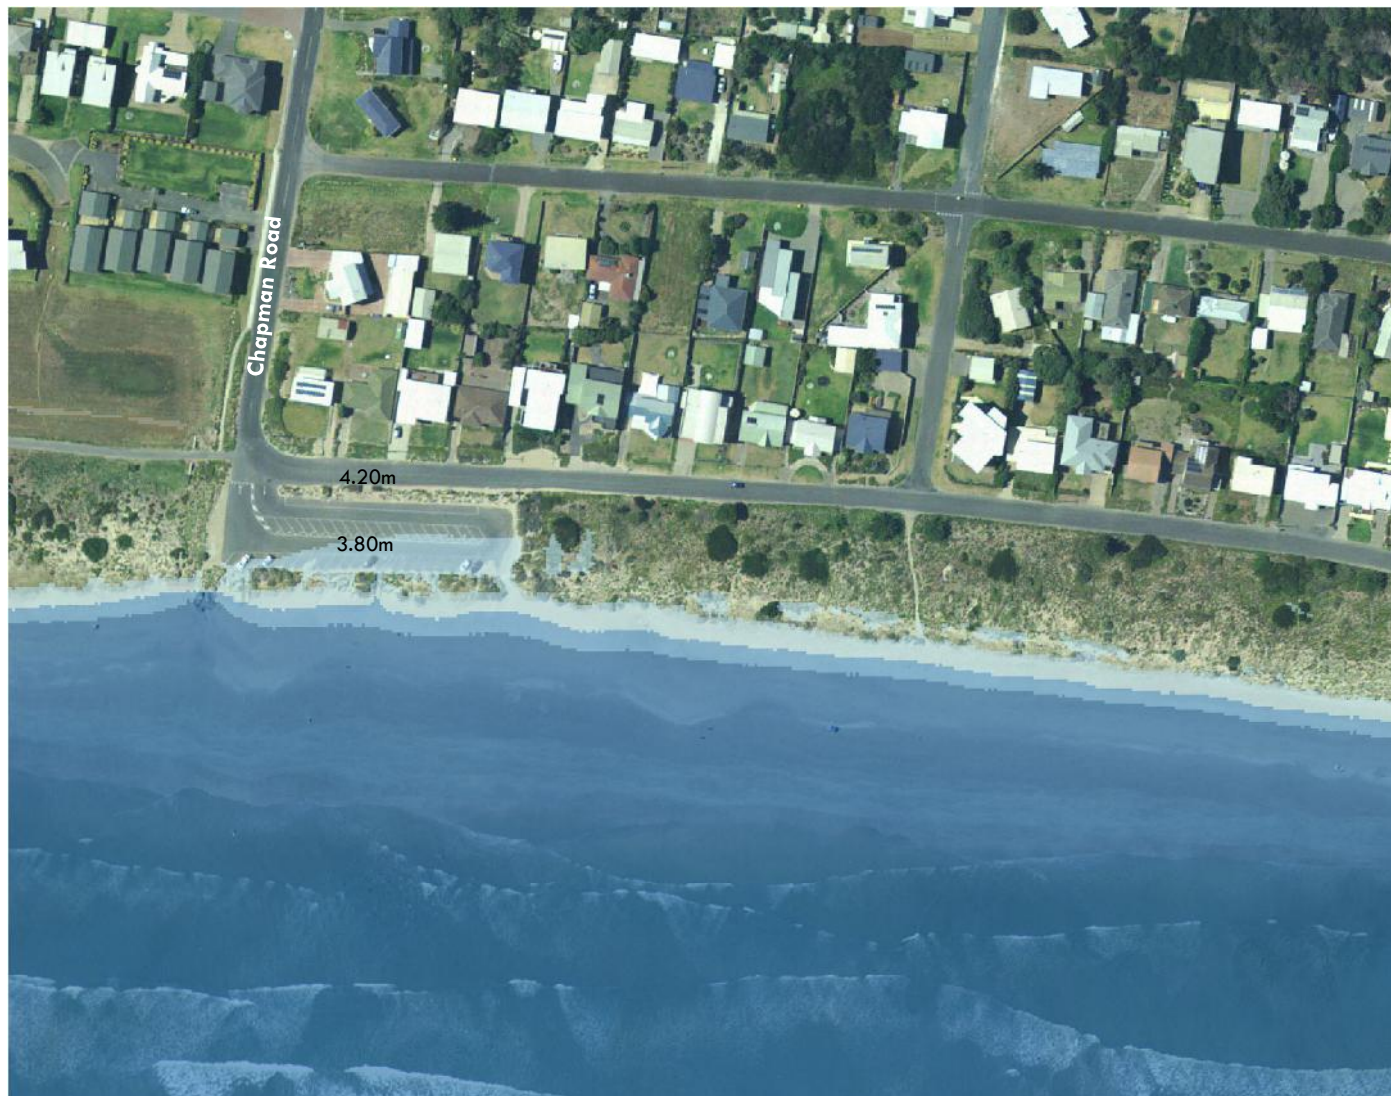
Scenario modelling demonstrates that wave-set up would almost be at the base of the dunes. The impact of this event on the current dunes would be very high.

Water would likely enter carpark at Chapman.

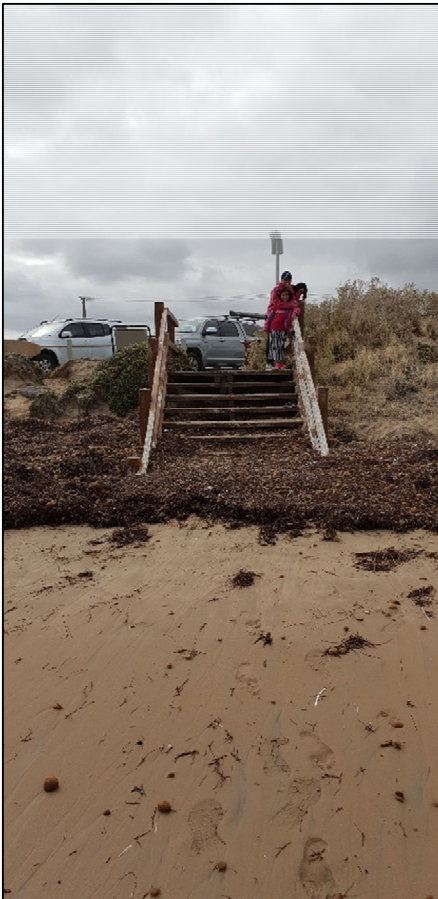
**Chapman Road**

Sand has accumulated at about 0.6m since installation of the stairs. Currently not at risk.

On upgrade, consider removing one set of stairs and consolidate into one larger set in the middle. Also consider alternative slope to ramp (identify a way to prevent storm surges coming through the gap).

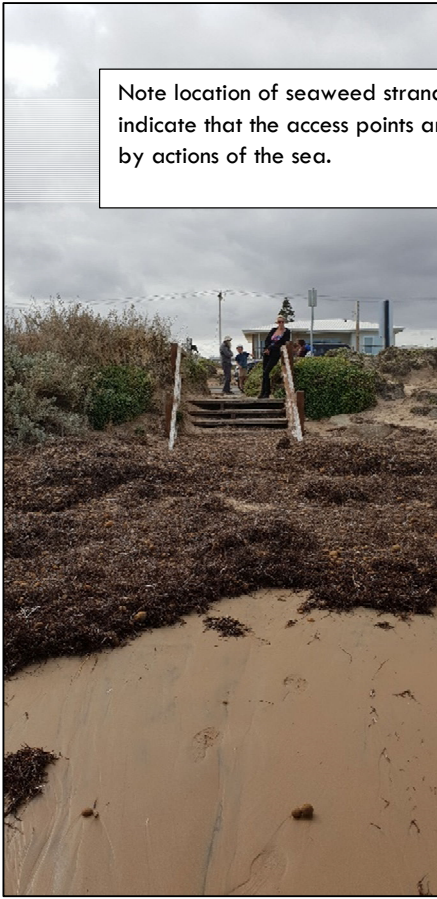
**Chapman Road**

Note location of seaweed strands at entrance points. These indicate that the access points are routinely being impacted by actions of the sea.

Sand has accumulated at about 0.8m since installation of the stairs. Currently not at risk.

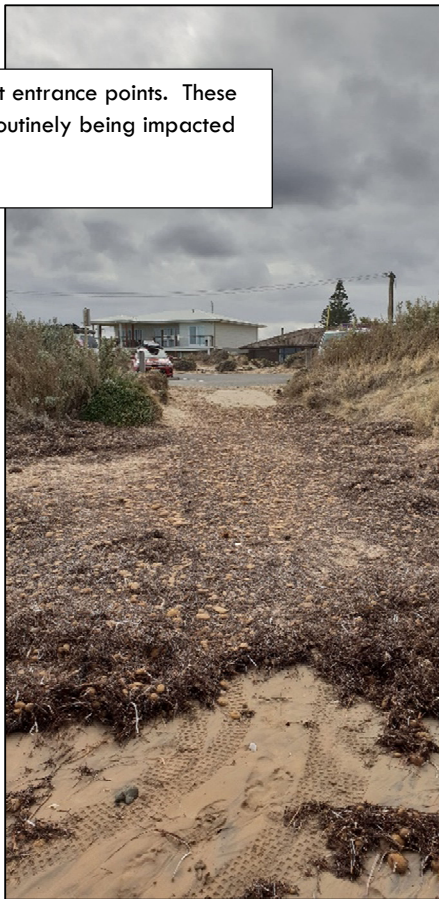
**Chapman Road**

Provision for vehicular access. Not at risk, but does provide access point for the flow of water in extreme events (see modelling)

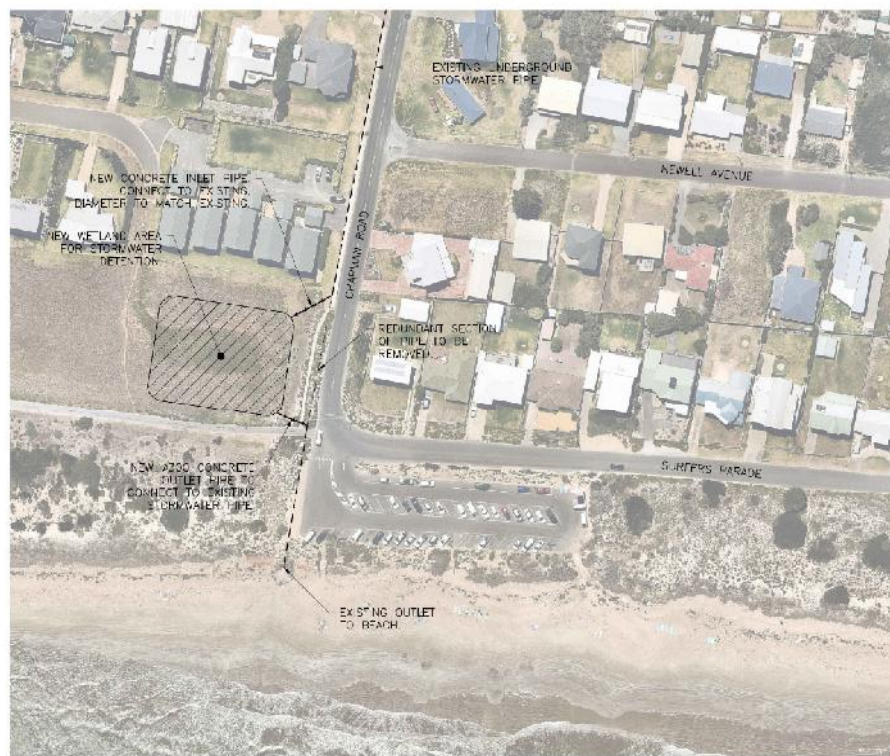
CHAPMAN ROAD CARPARK – MIDDLETON  
SCALE: 1:1000

Refer drawing 18084-19 for details on the above.

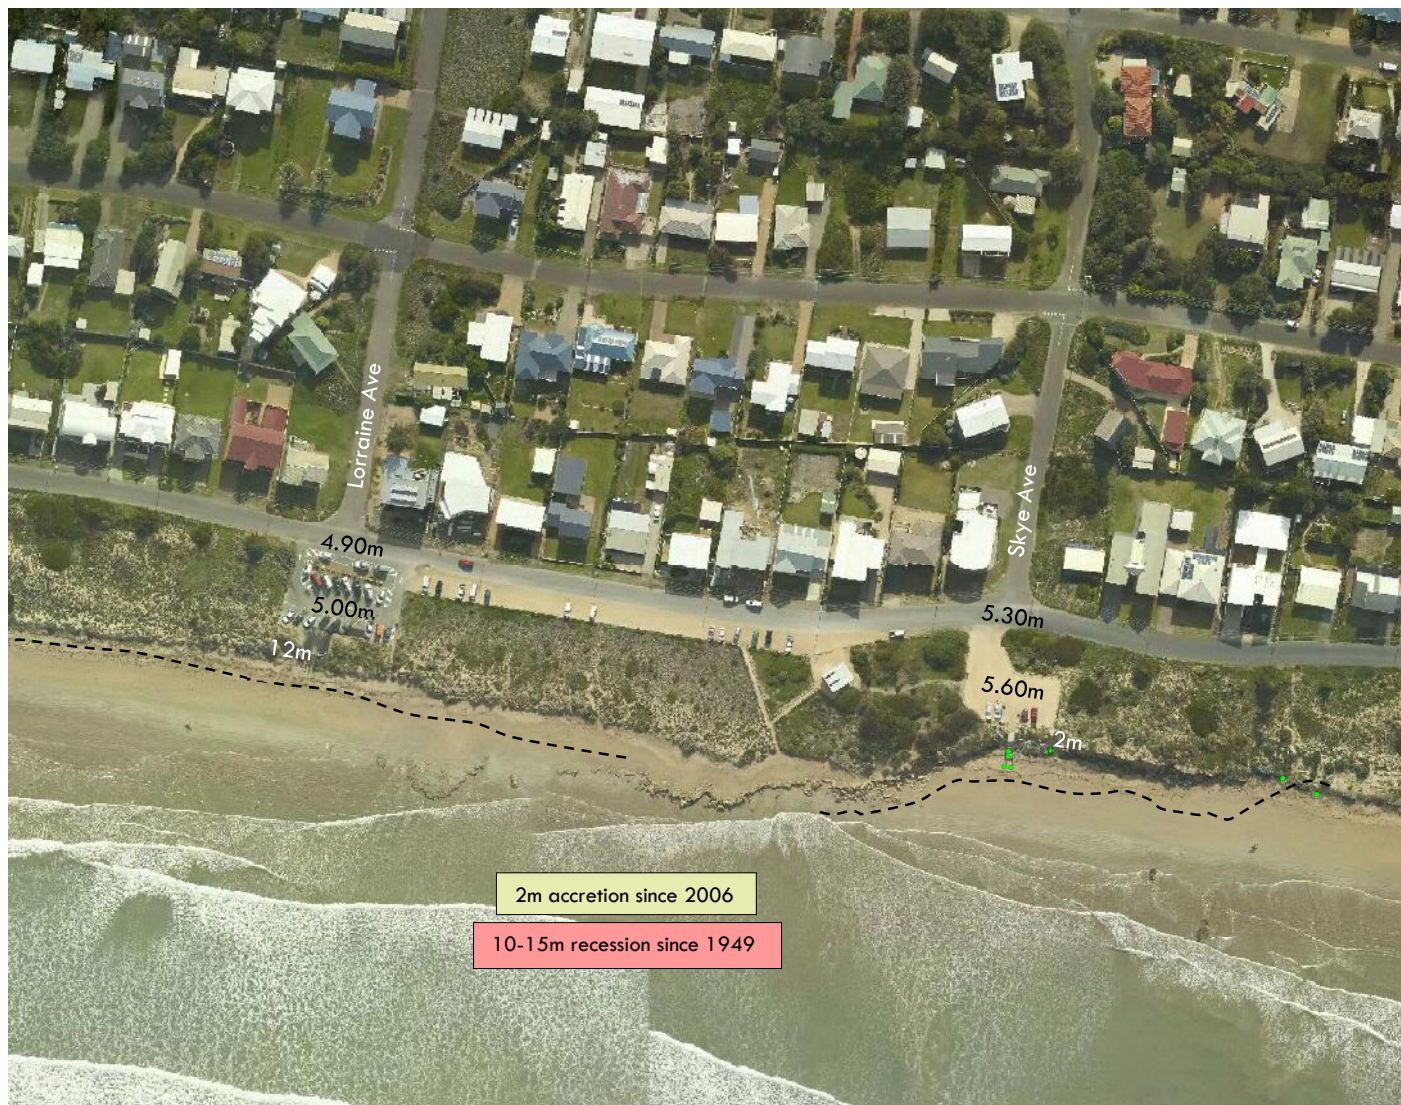
Works associated with installation of stairs at Skye Avenue appear to have moved the coastline seaward by ~1-2m.

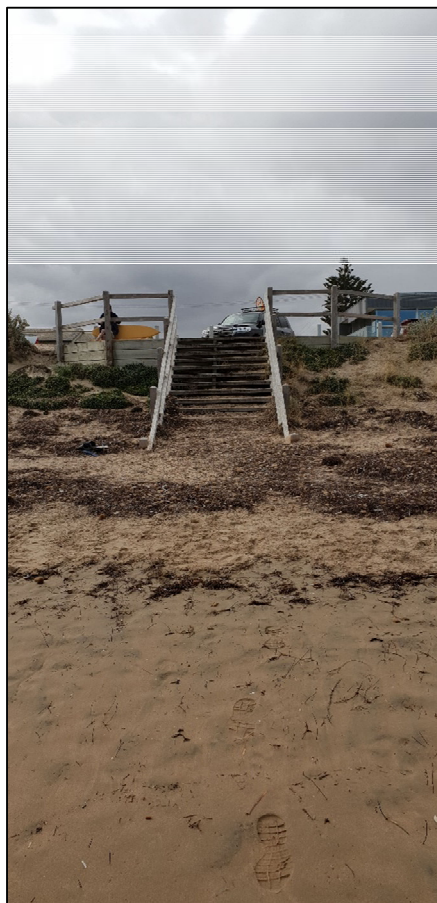
Lorraine Ave

Sand has accumulated at about 0.8m since installation of the stairs. Currently not at risk.

On upgrade, consider removing one set of stairs and consolidate into one to reduce access points to the beach. The larger set pictured could be located further back from the front of the dune.

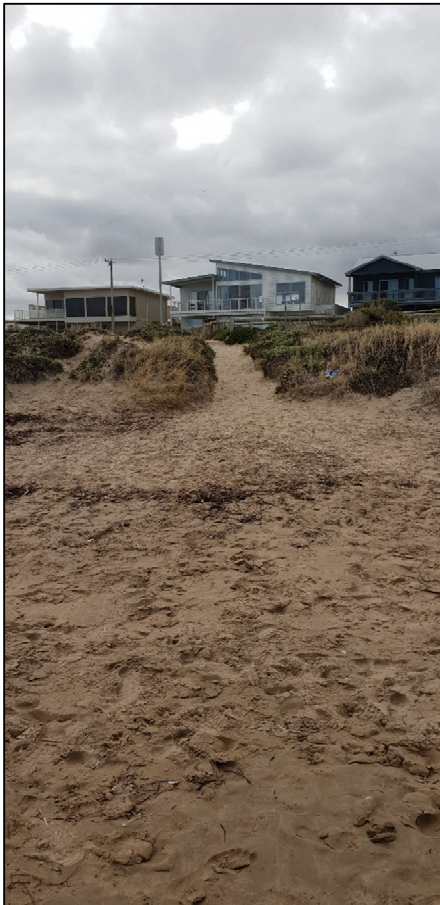
**Skye Ave**  
 Beach access point on western side of the amenities block.

On upgrade, consider removing one set of stairs and consolidate into one larger set in the middle. Also consider alternative slope to ramp (identify a way to prevent storm surges coming through the gap).

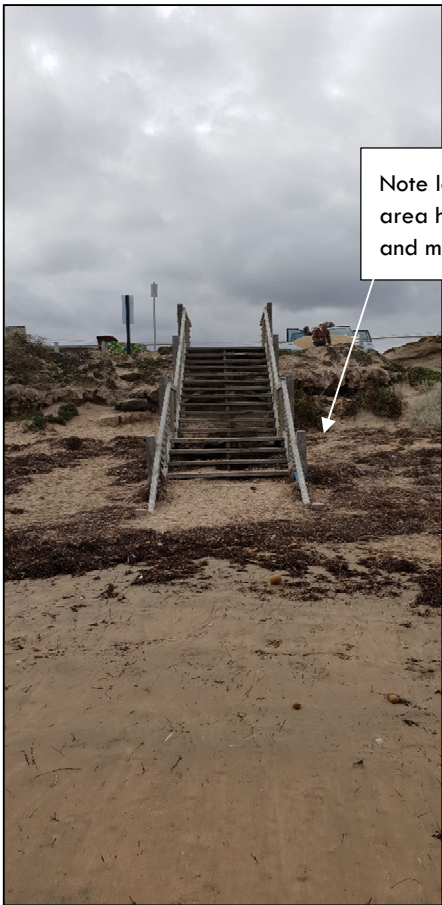
Note location of seaweed. This area has been actively eroding and may threaten the carpark

**Skye Ave**  
 Access stairs from Skye Ave carpark. Note seaweed strands in proximity of rock ledges. This area has been eroding.

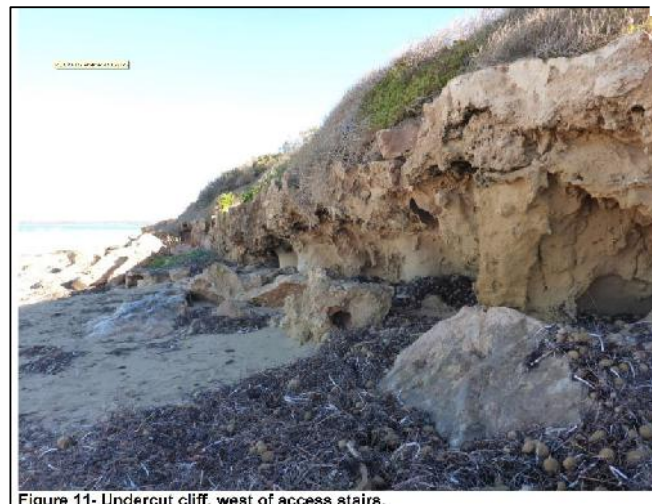
Figure 11- Undercut cliff, west of access stairs.

The cliffs east of the access stairs were severely undercut, particularly at the eastern end with approximately 1.6m overhang. Some large pieces of sandstone were on the beach at the base of the cliff, presumably fallen from the cliff. There is minimal erosion to the base of the cliff, hence the overall cliff appears stable.

It was reported that people (in particular children) often sit under the overhanging sections of cliff, which poses a high safety risk if the cliff was to collapse. In our opinion the cliffs west of the access steps are higher priority, as erosion may continue to develop as a result of wave action at the base of the cliff.

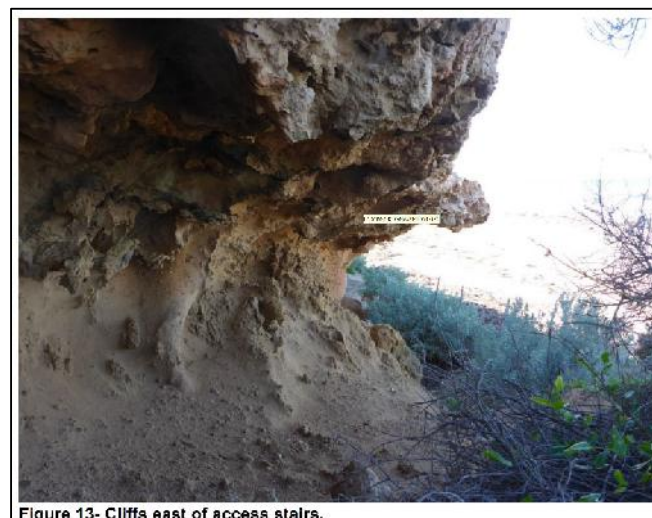
Figure 13- Cliffs east of access stairs.

The following adaptation strategies are recommended to be undertaken to the cliffs east of the access stairs:

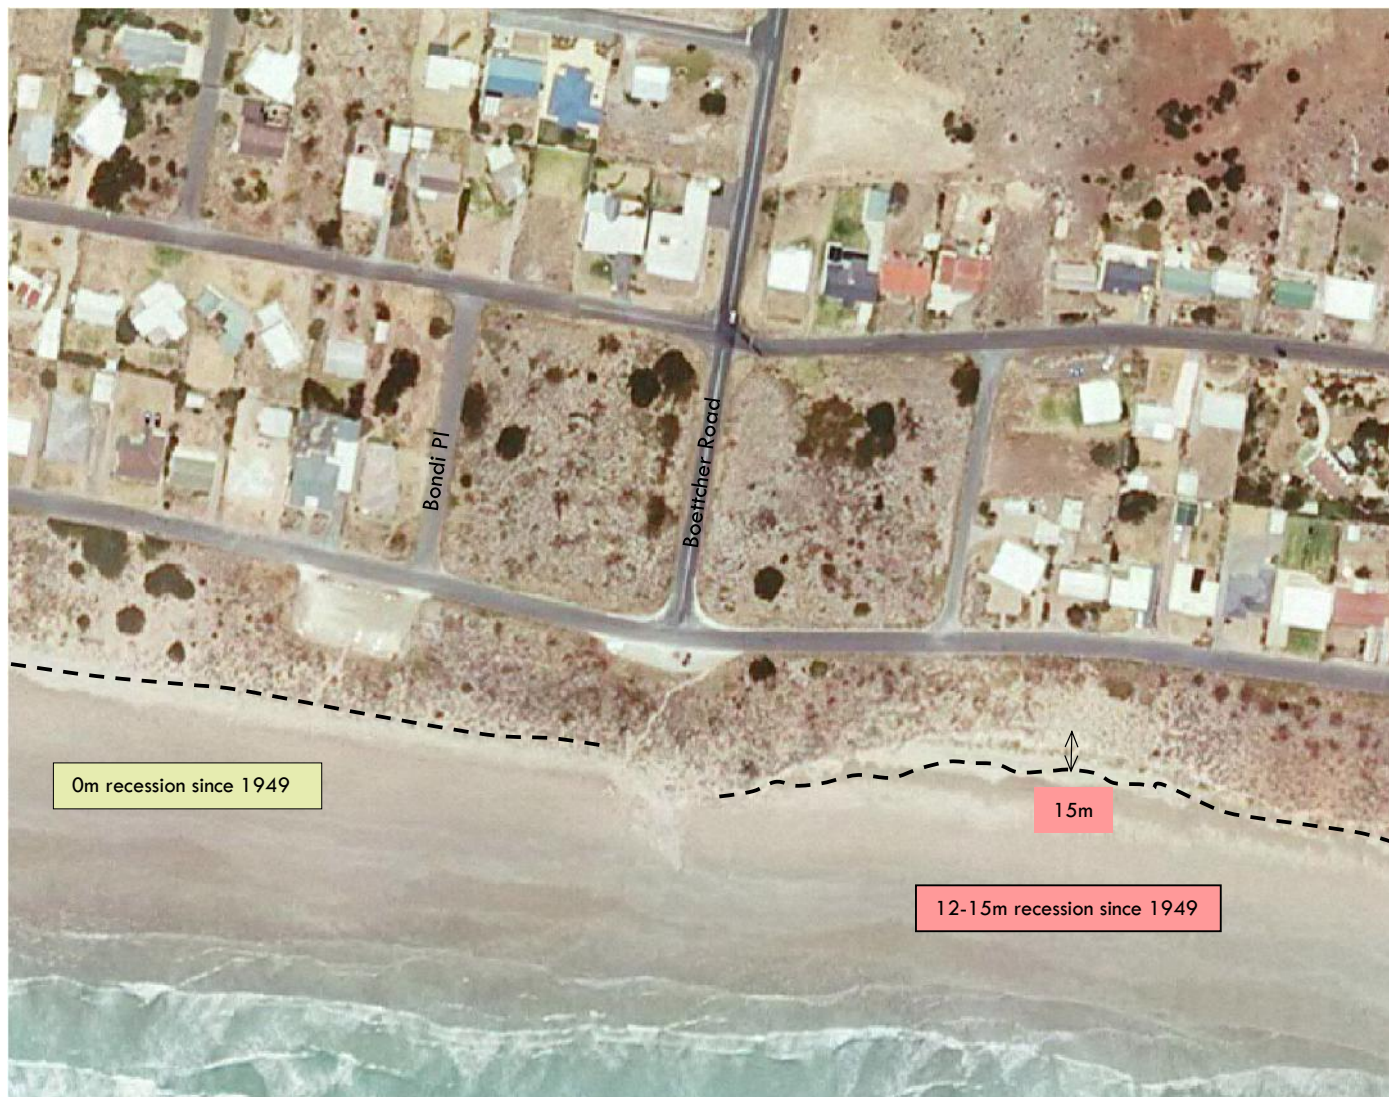
The coastline in the vicinity of Bondi Place and Boettcher Road carparks has not shown any measurable recession since 1949.

However, the area immediately to the east of the Boettcher Road carpark has receded between 12 and 15m since 1949.

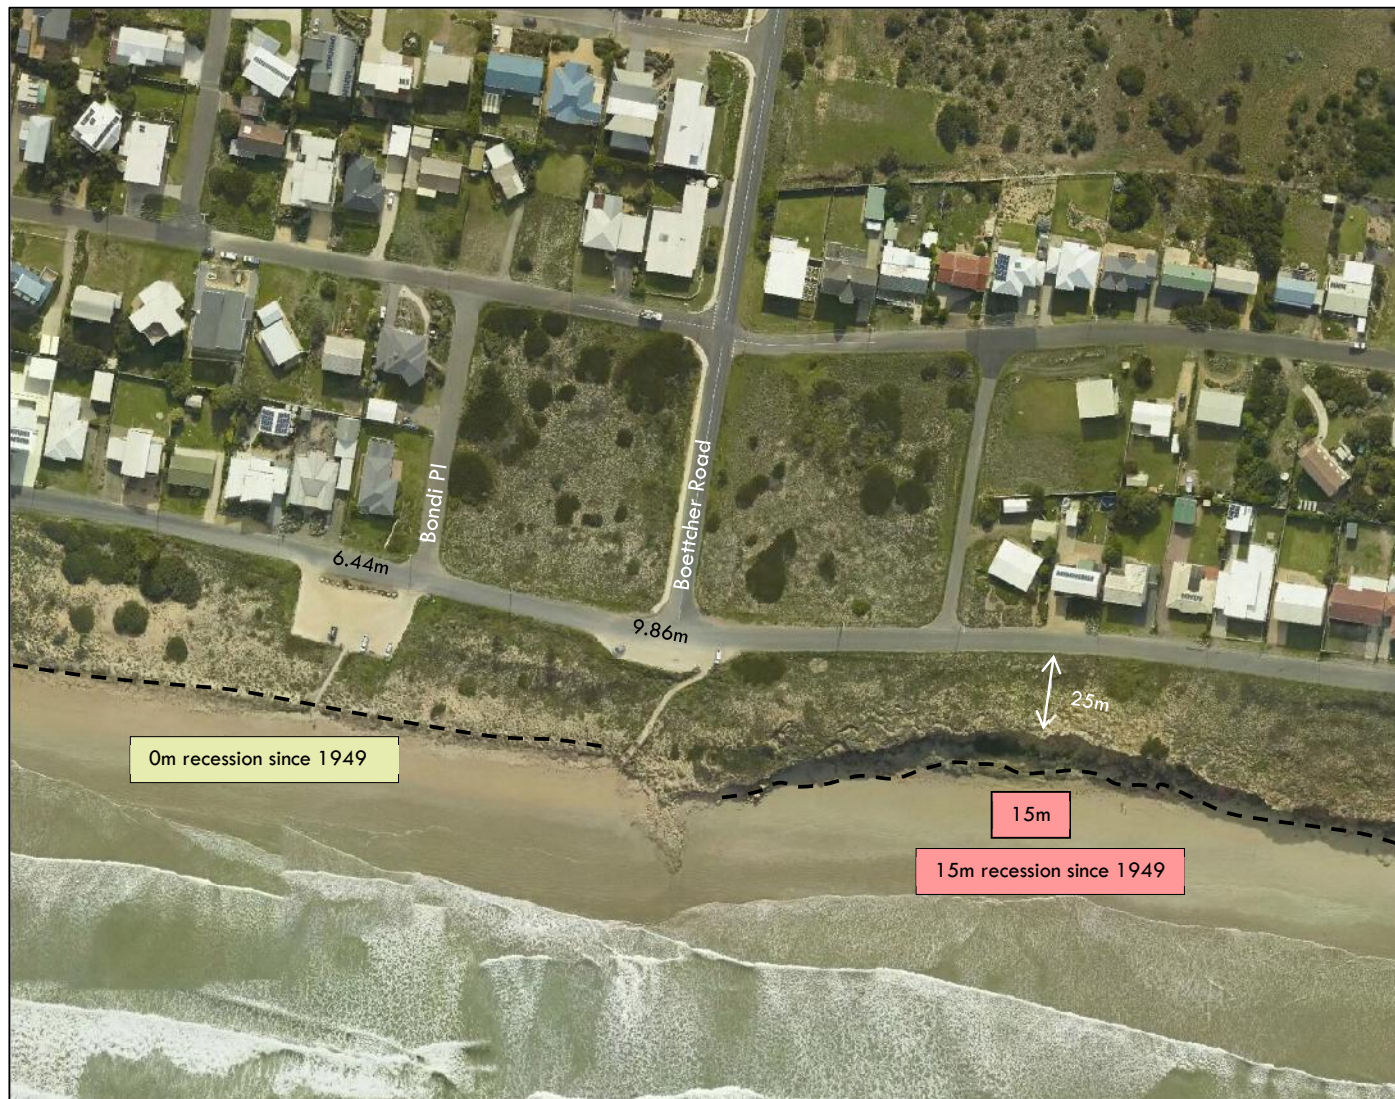
The cliff top to the east of Boettcher has receded up to 15m since 1949. A small dune has built at the base of the cliff.

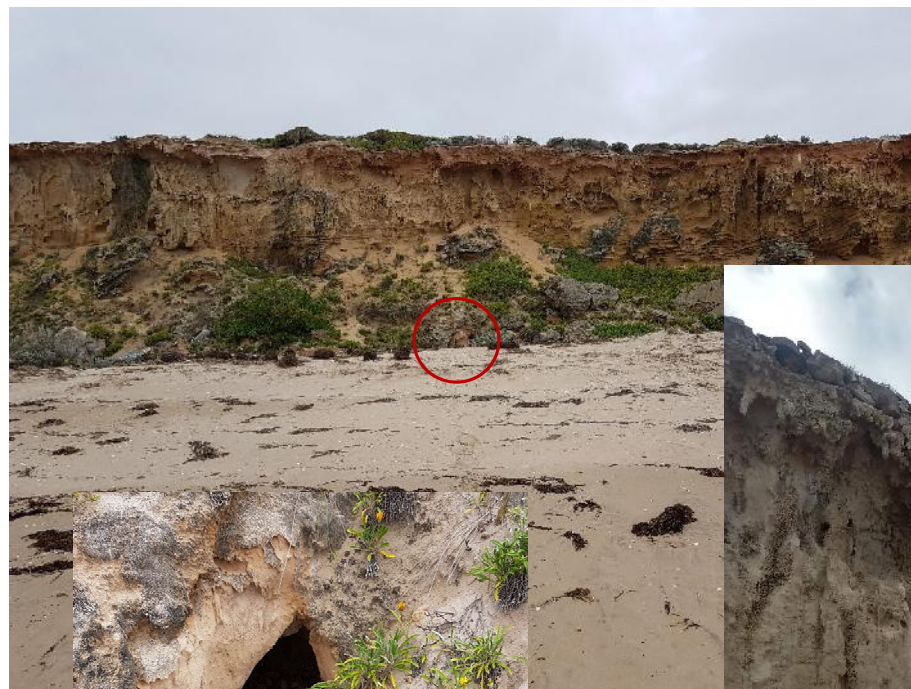
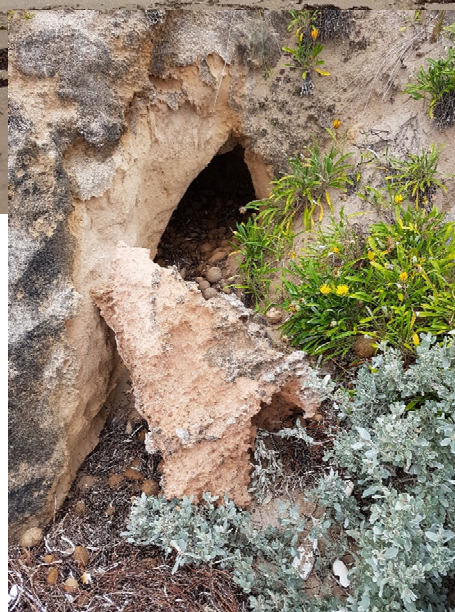
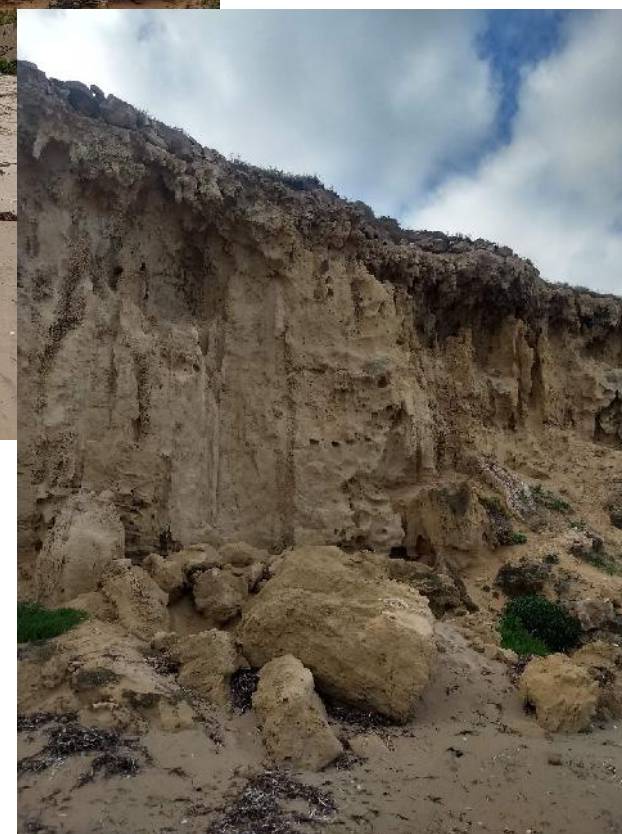
Recent block falls from cliffs demonstrate ongoing erosion potential (Photograph: M Hillman)

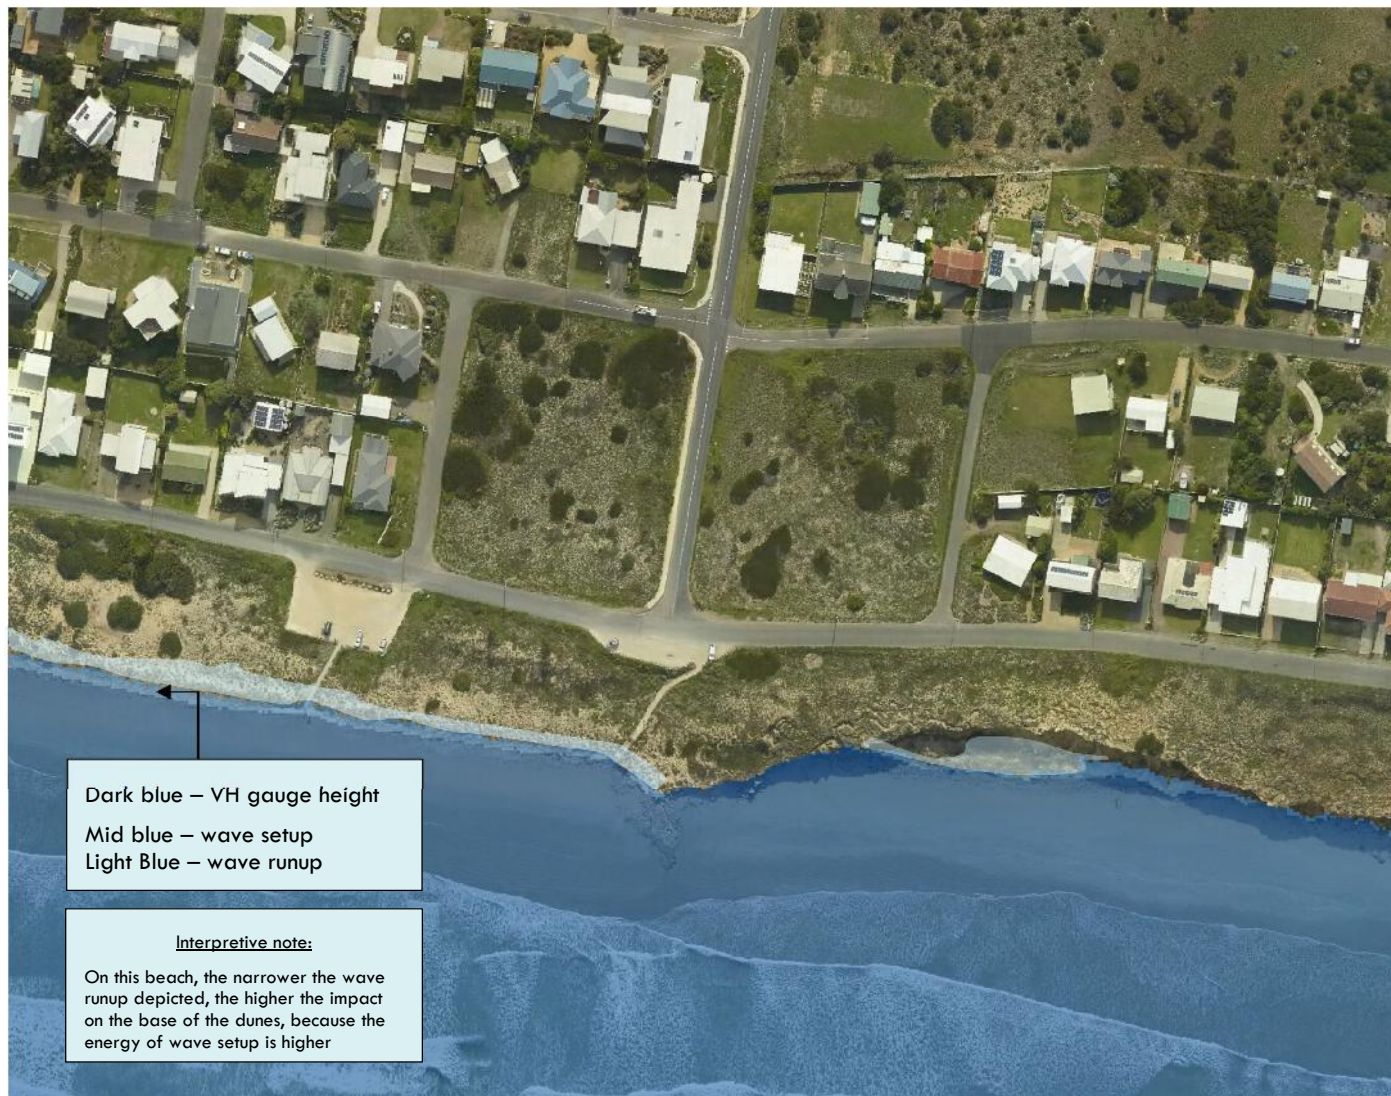
Dark blue – VH gauge height  
Mid blue – wave setup  
Light Blue – wave runup

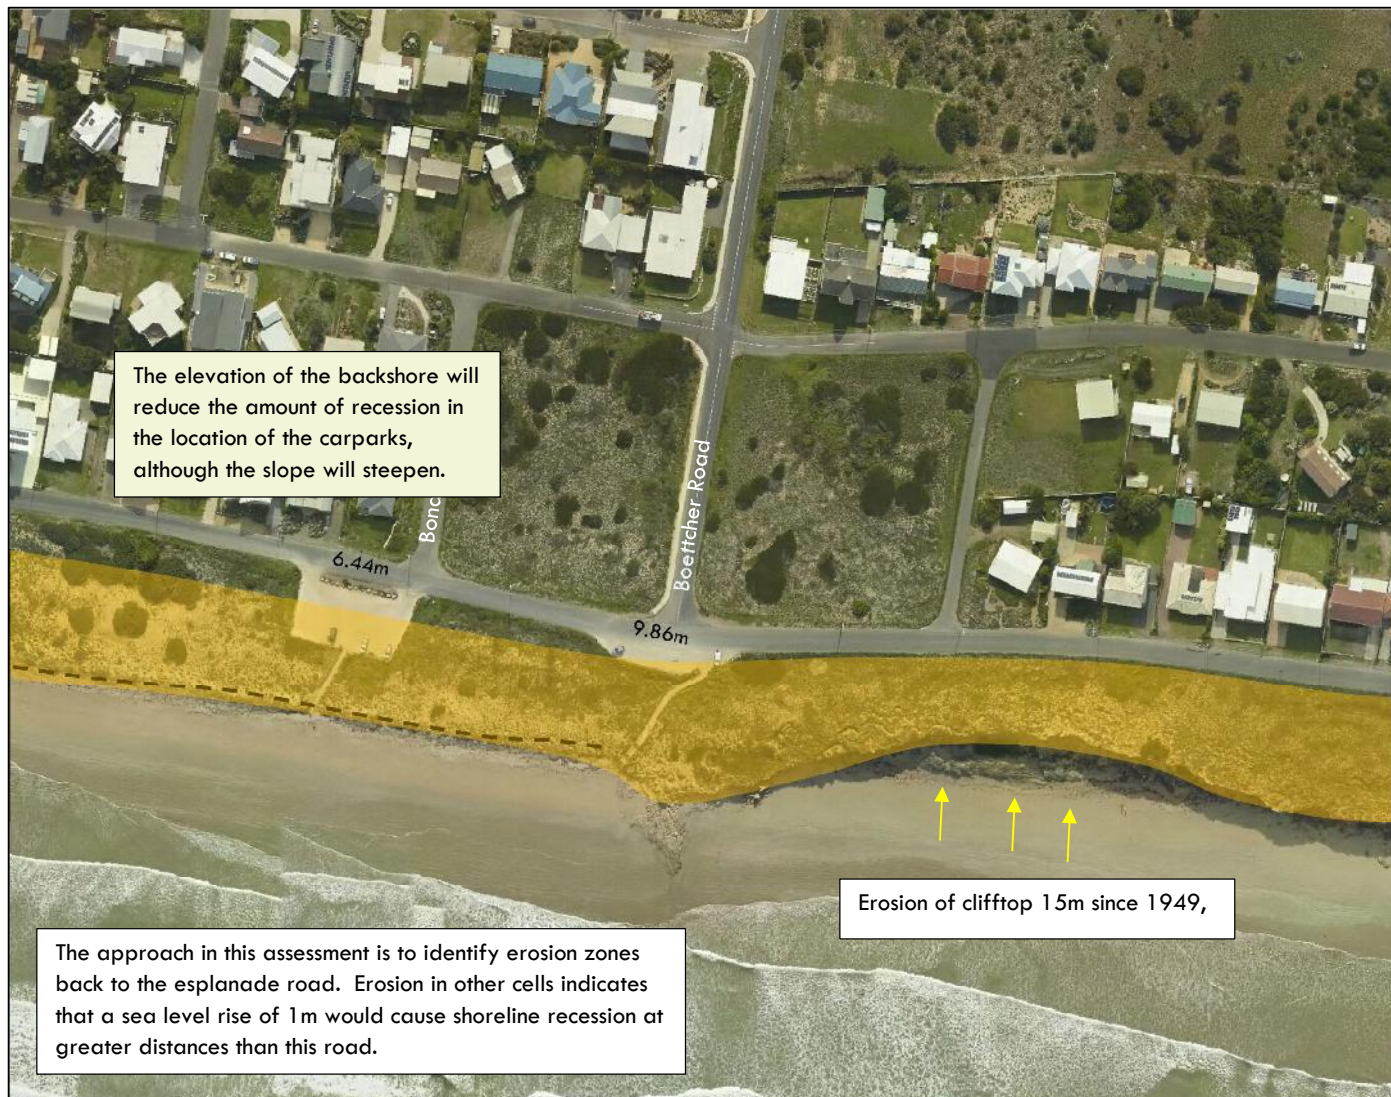
The elevation of the backshore will reduce the amount of recession in the location of the carparks, although the slope will steepen.

Erosion of cliff top 15m since 1949,

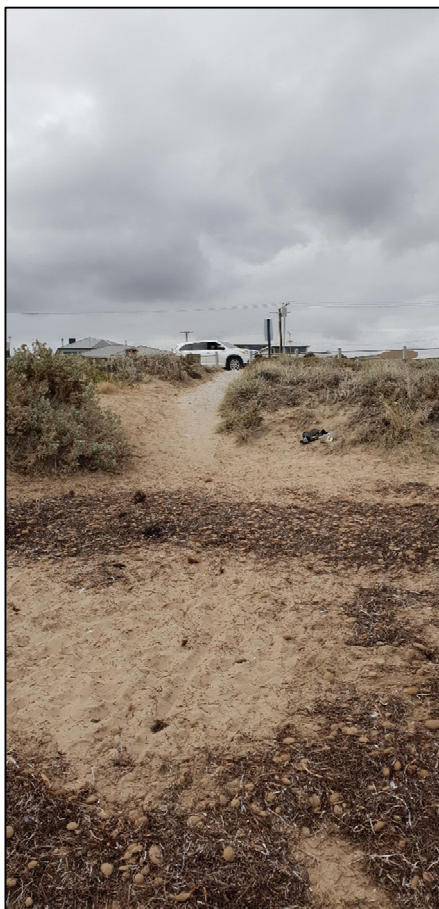
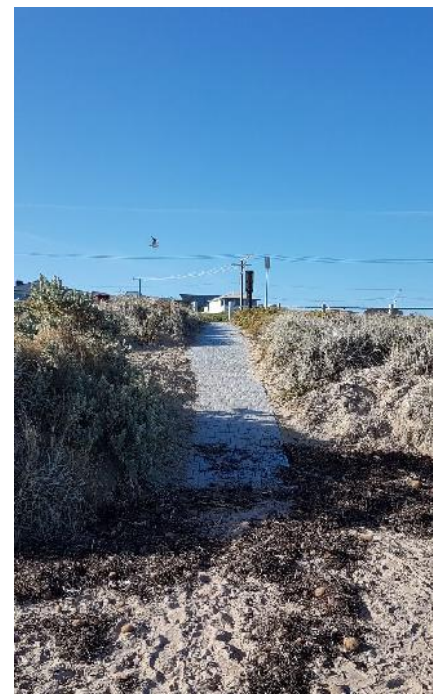
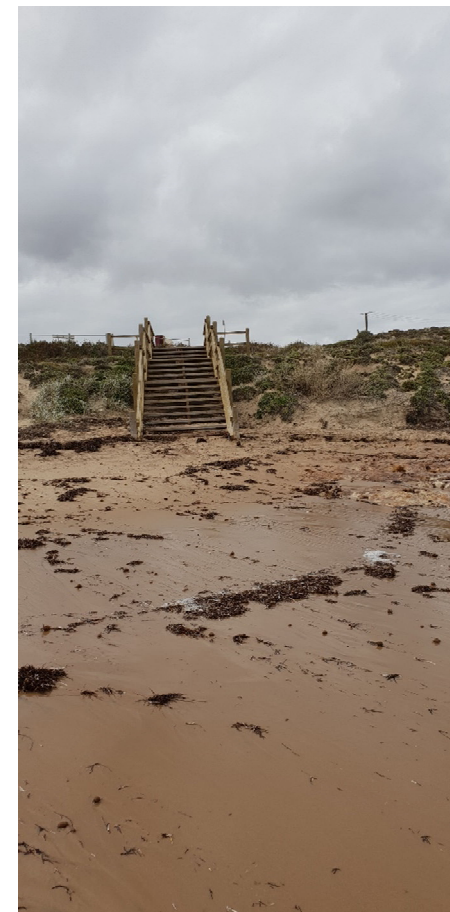
Wooden access stairs culminate in approximately in location of current wave run-up zone. On upgrade these could be positioned further landward.
