Coastal Adaptation Study  
for Alexandrina Council  
**MIDDLETON BEACH**

Cell SF5

By Integrated Coasts: Western, Hesp, and Bourman (2019)

Report to be cited as: Western, M, Bourman, R., Hesp, P (2019) Coastal Adaptation Study for Alexandrina Council (Cell SF5 Middleton Beach) prepared by Integrated Coasts, South Australia.

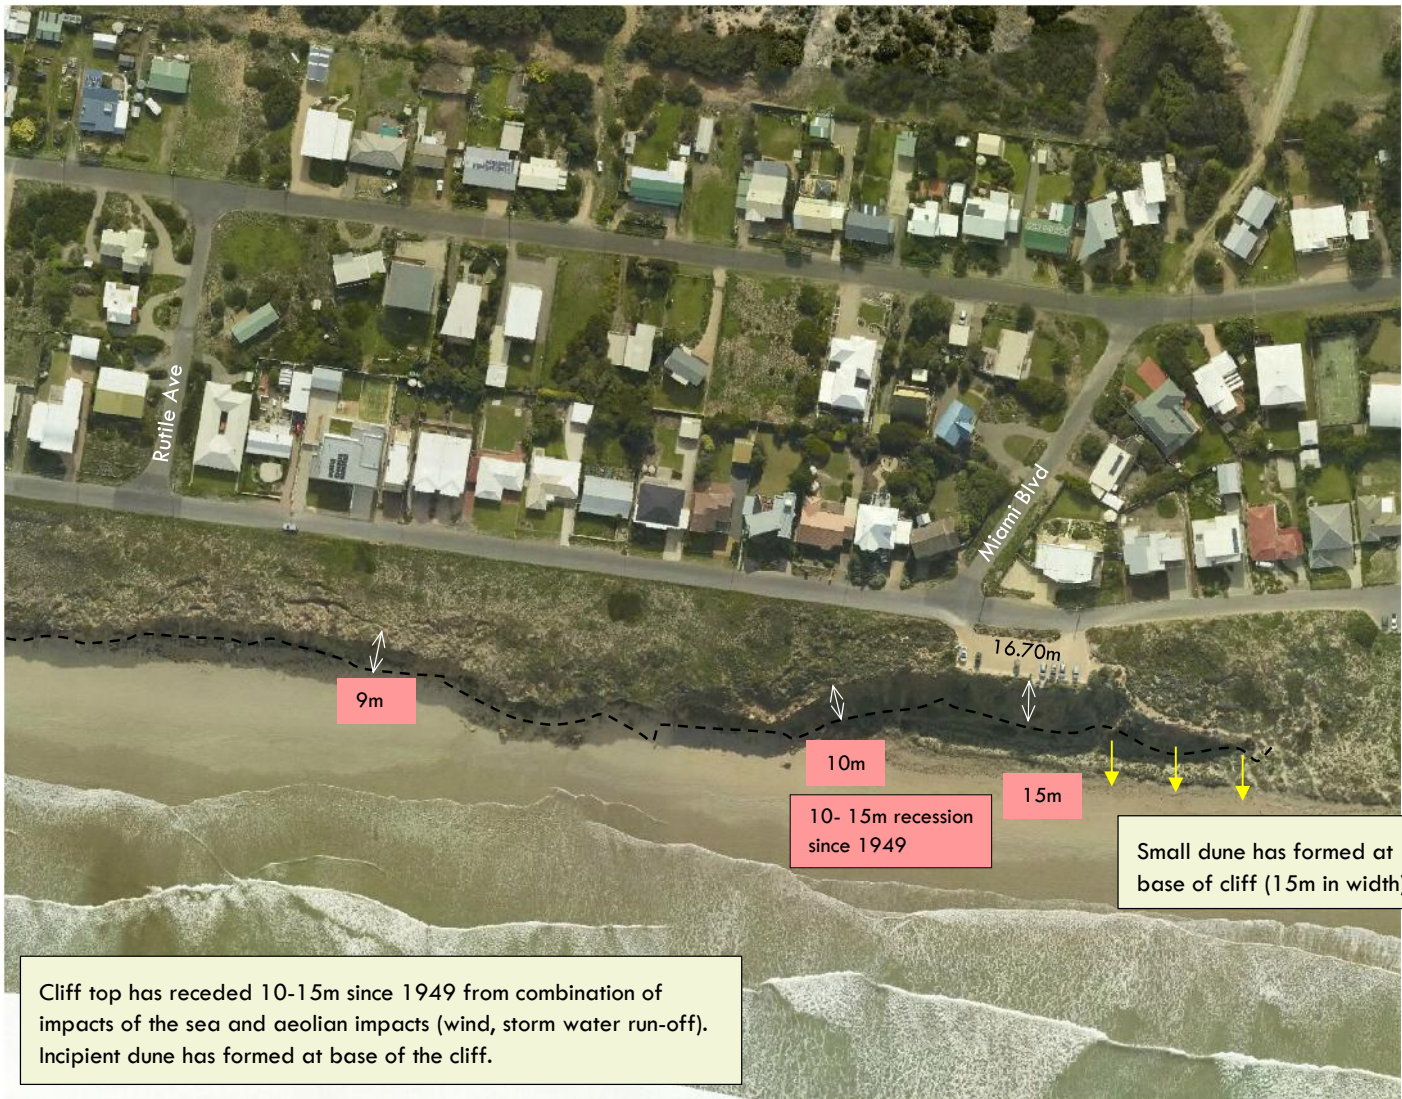
Cliff top has receded 10-15m since 1949 from combination of impacts of the sea and aeolian impacts (wind, storm water run-off).  
 Incipient dune has formed at base of the cliff.

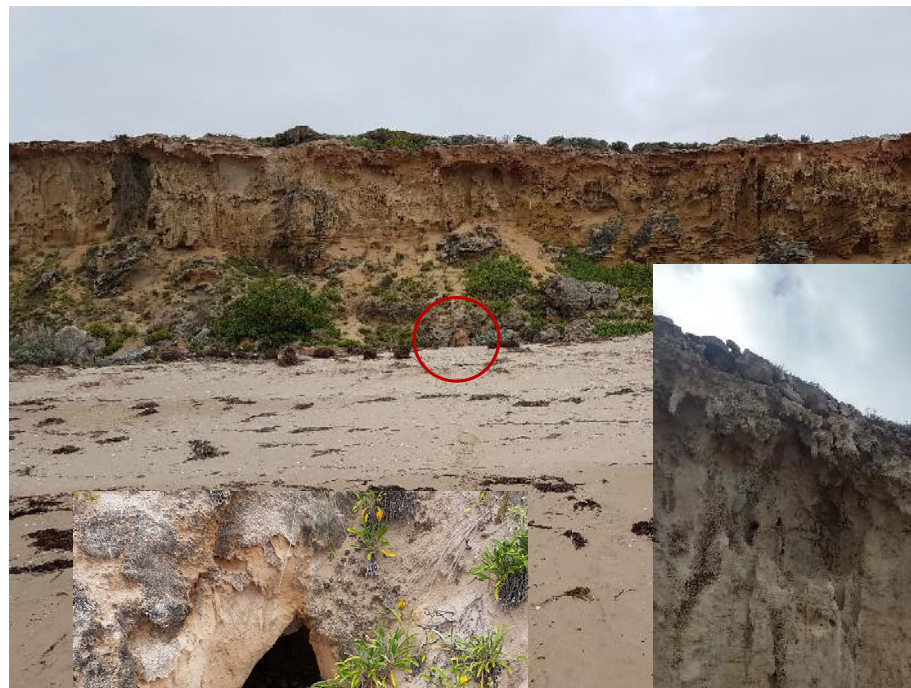
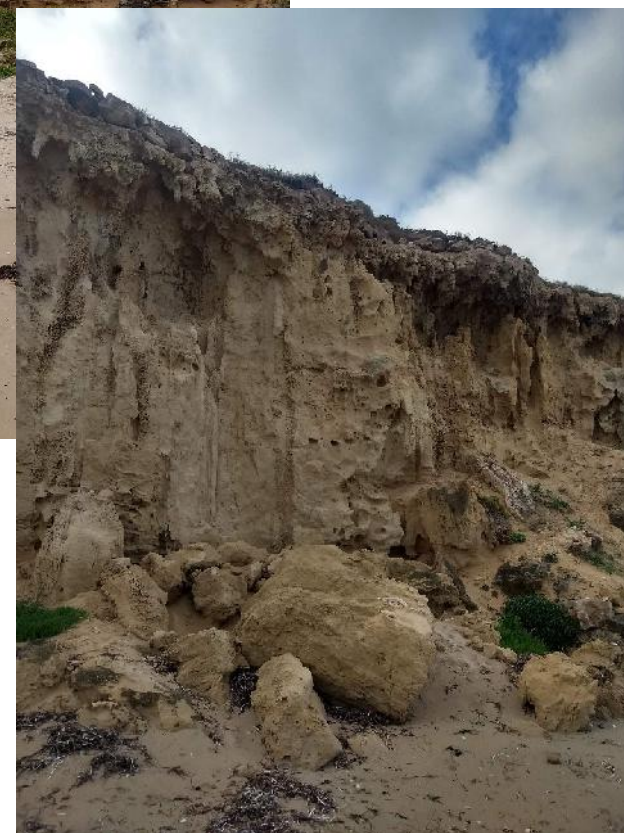
Recent block falls demonstrate ongoing erosion of cliffs.  
(Photograph: M. Hillman)

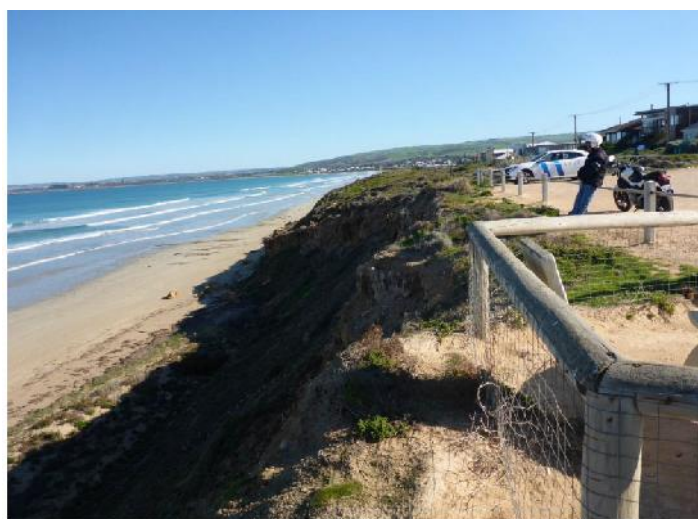
Figure 16- Existing cliff

The cliff adjacent the carpark may continue to erode gradually over time, however in our opinion there is no immediate risk to the carpark. It is recommended to monitor the erosion and if it develops, consideration should be made to move the carpark extent/fencing to the north. This will prevent vehicles encroaching on the edge of the cliff, and greatly minimise associated risk.

The top of the cliff is a risk to public safety, hence council should continue to restrict access to the edge of the cliff.

Predicted future water levels may increase erosion and risk. This should be re-assessed in the future.

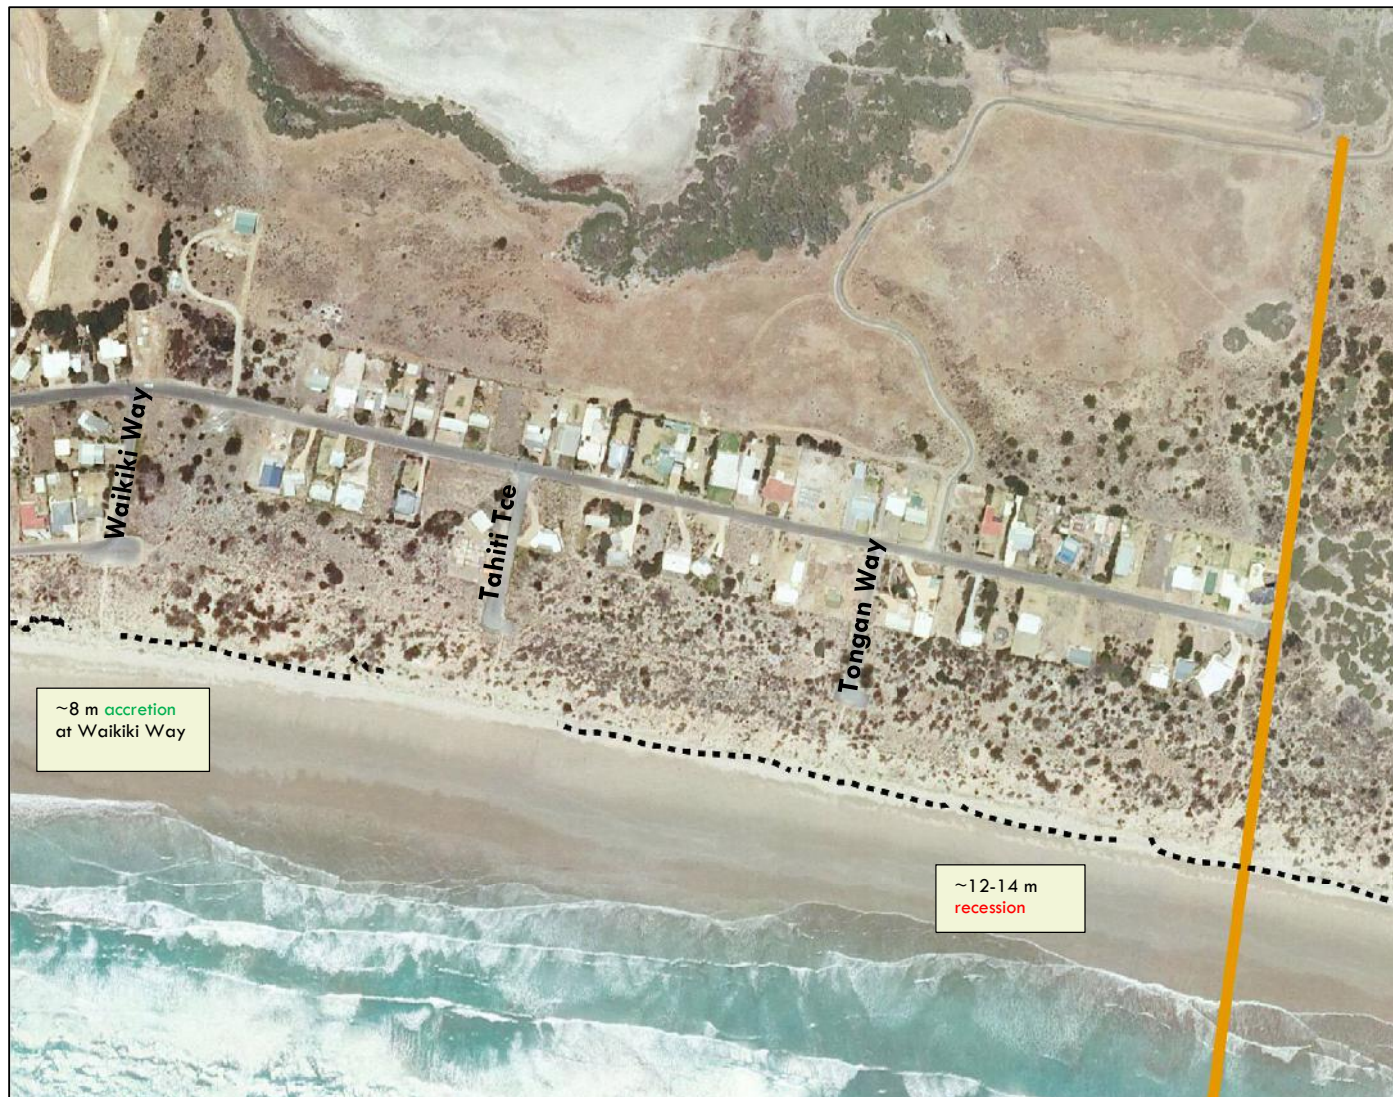
Comparison of 1949 to 2006, demonstrates 8-10m accretion at Waikiki Way, and 12-14 recession near the eastern cell border.

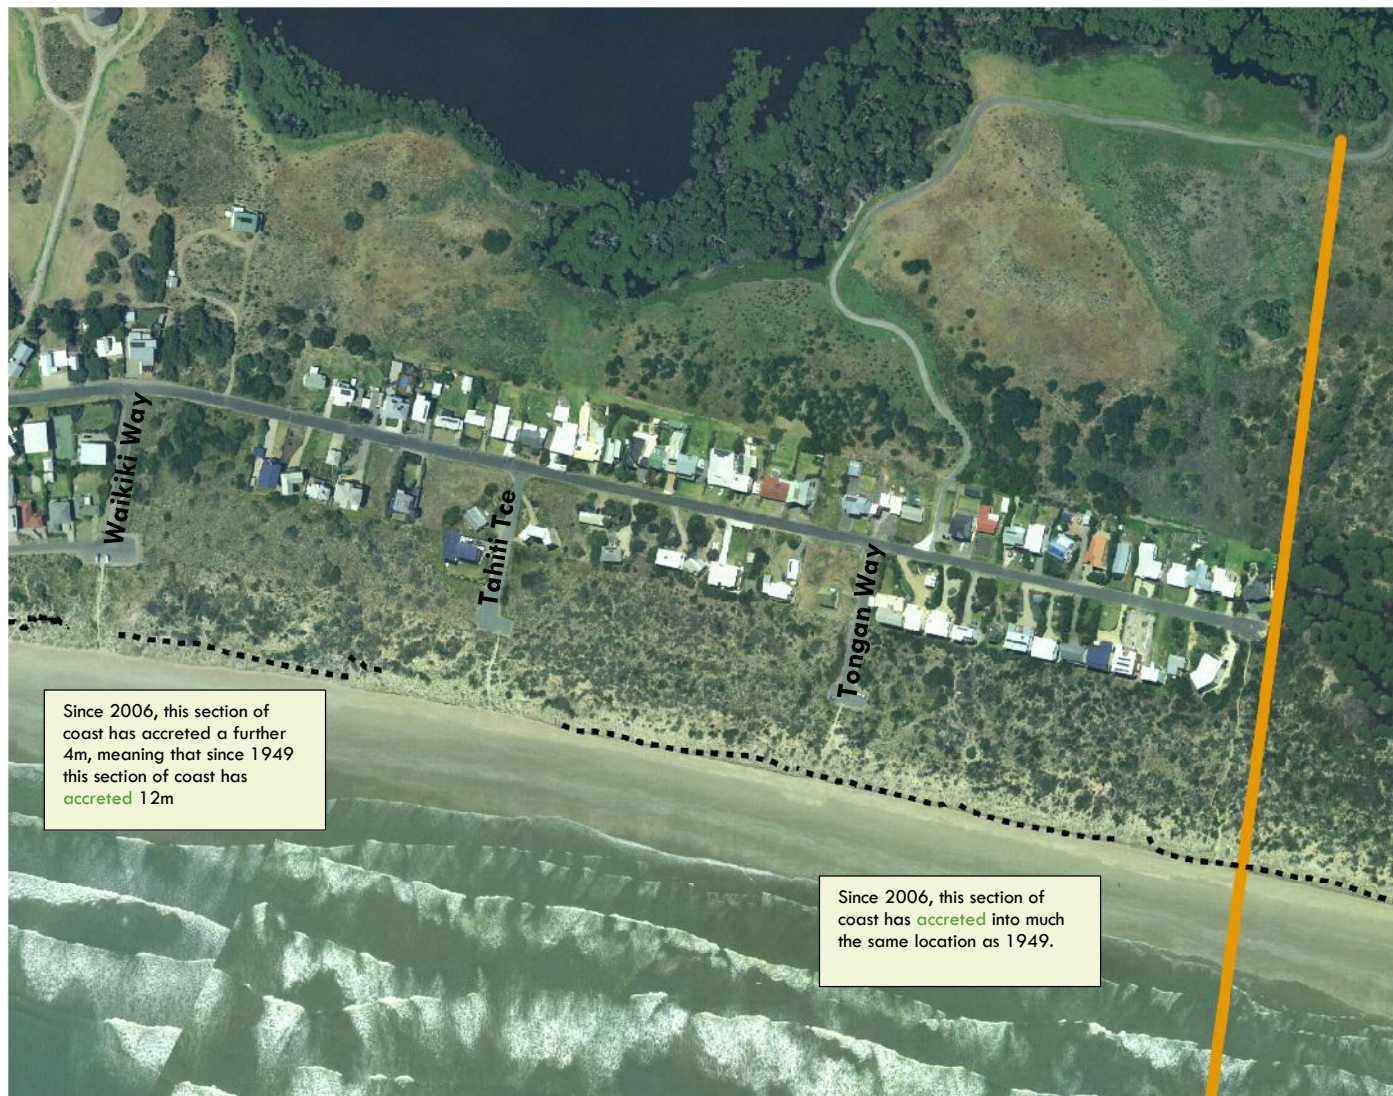
Since 2006, this section of coast has accreted a further 4m, meaning that since 1949 this section of coast has accreted 12m

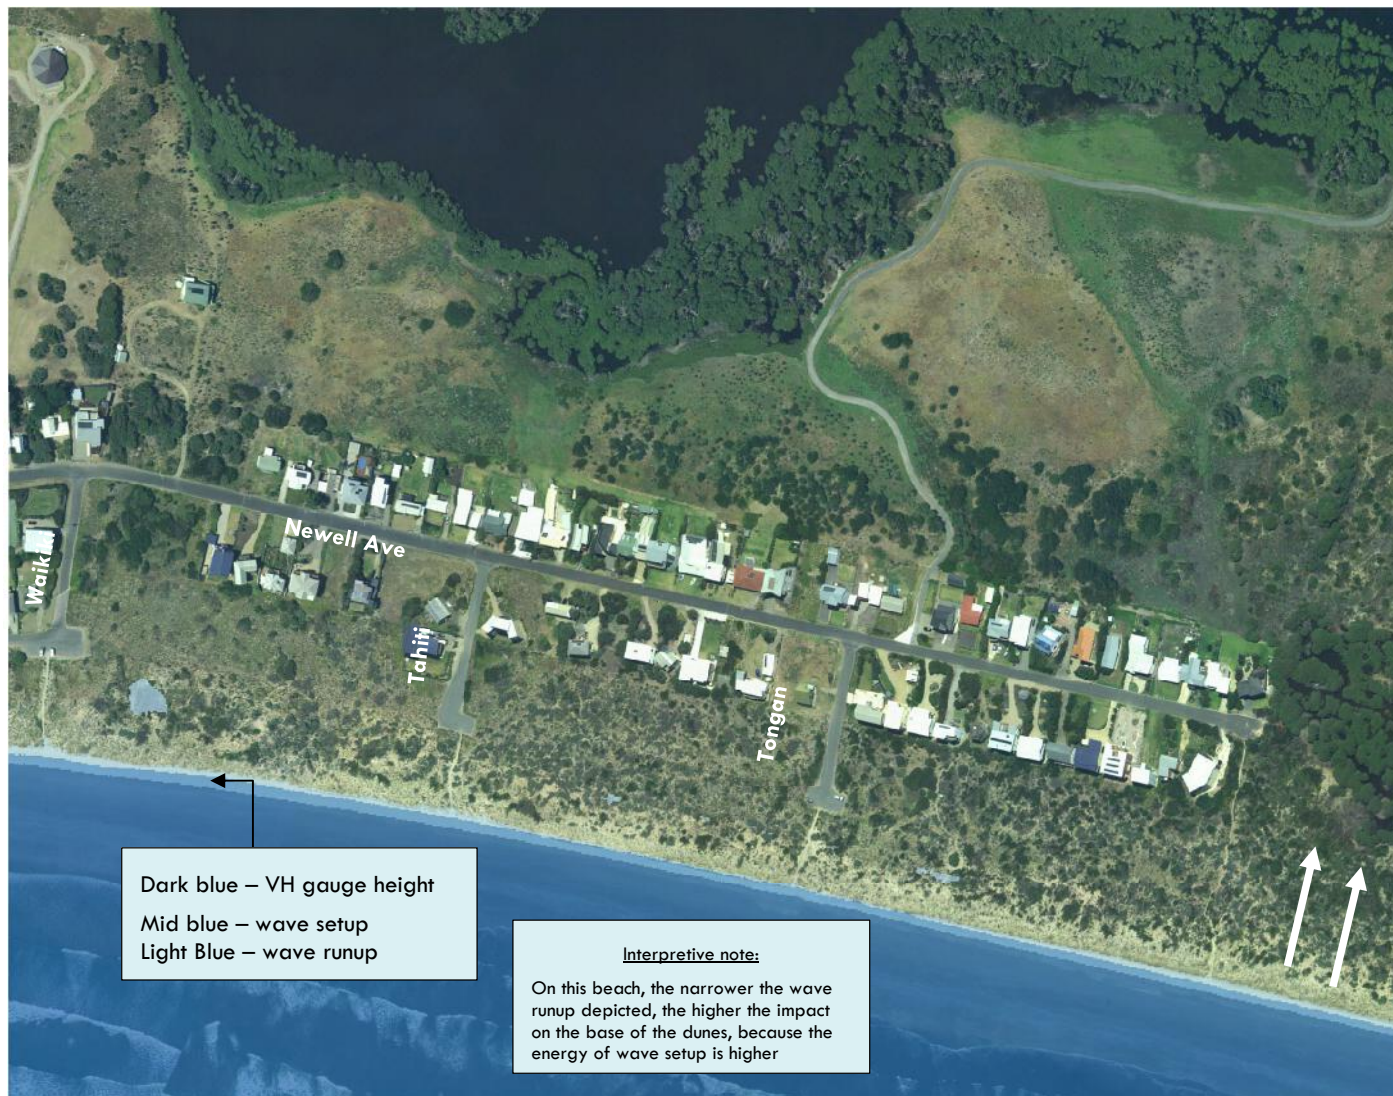
## Future exposure — storm surge (2050)

### Storm surge

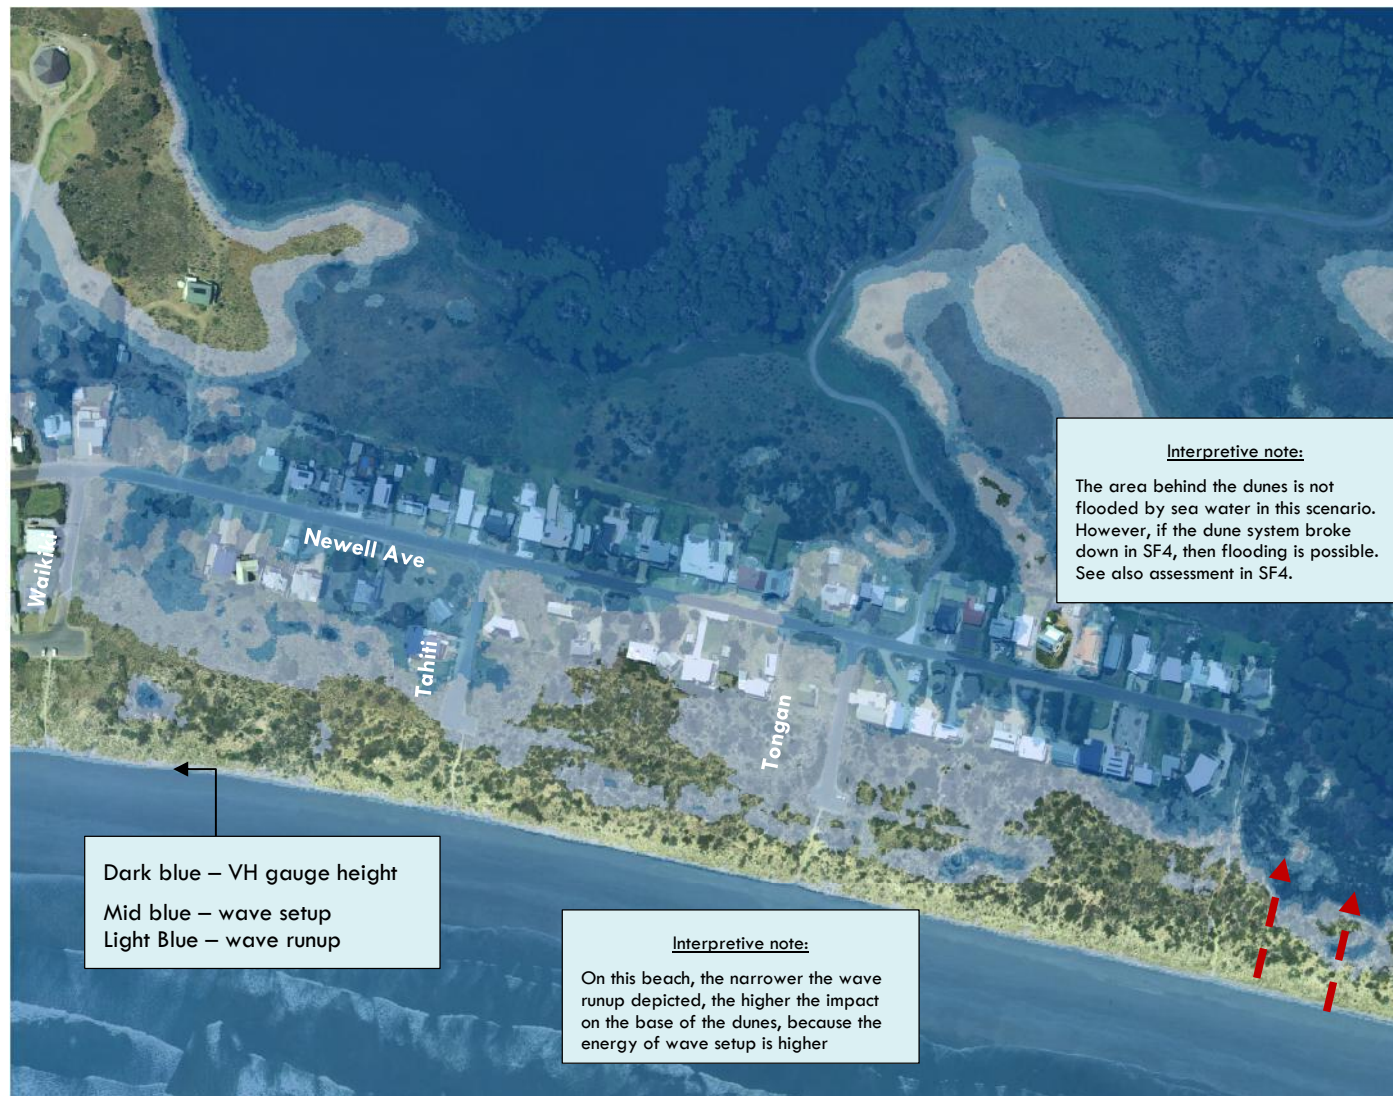
## Future exposure — storm surge (2100)

### Storm surge

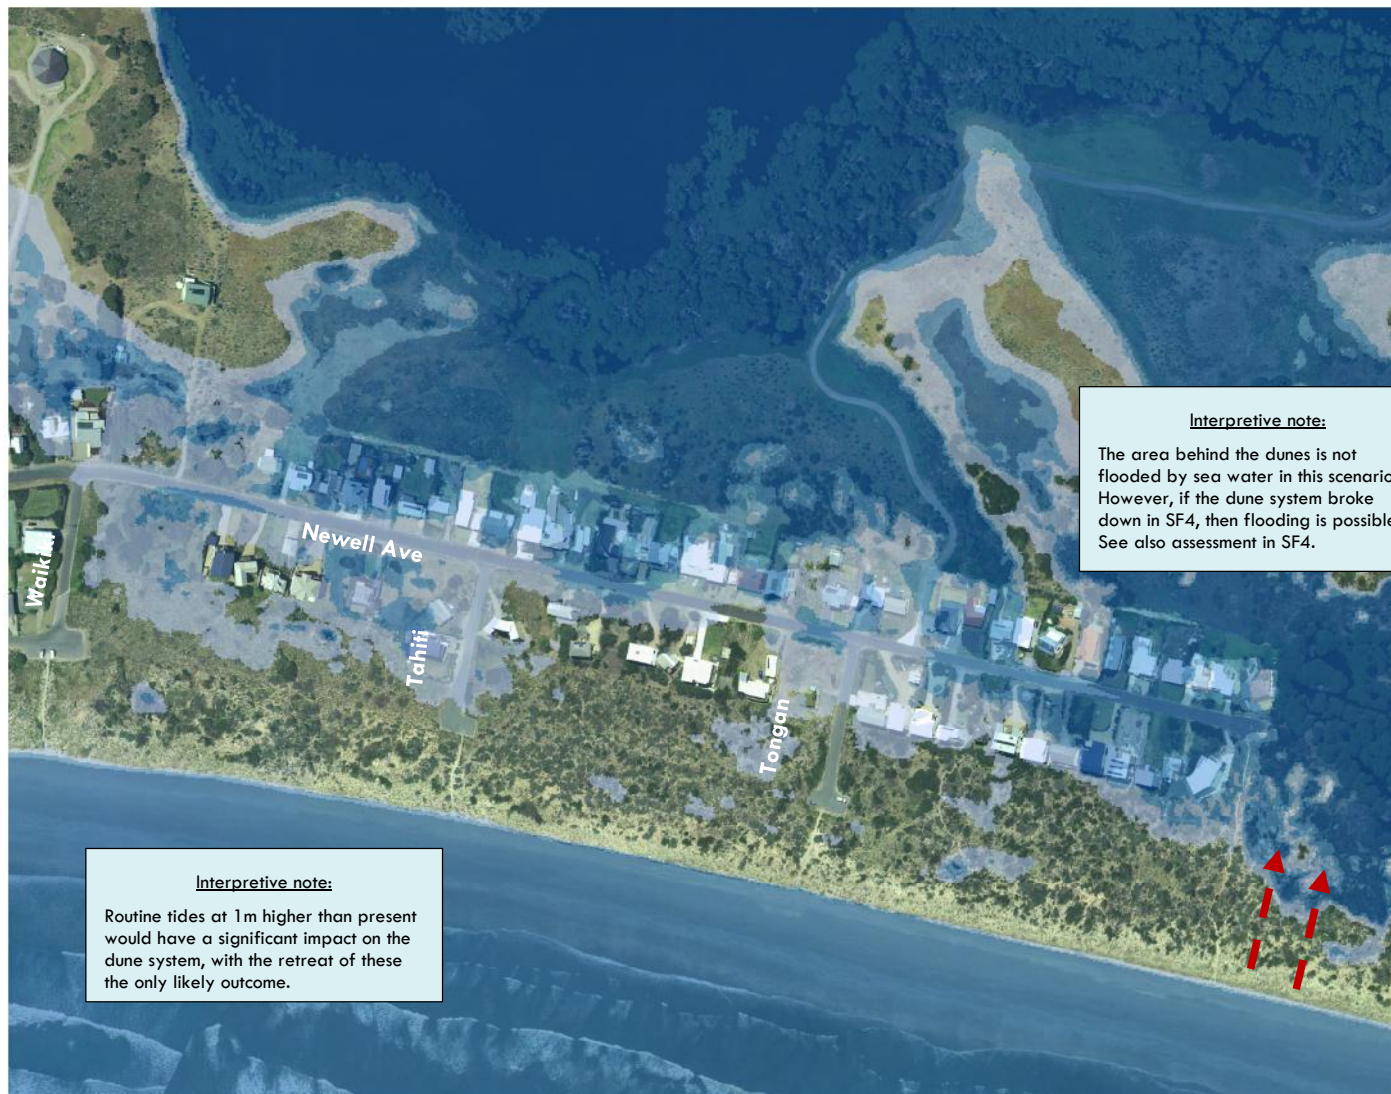
## Future exposure – monthly high water (2100)

### Monthly high water

#### Interpretive note:

The area behind the dunes is not flooded by sea water in this scenario. However, if the dune system broke down in SF4, then flooding is possible. See also assessment in SF4.

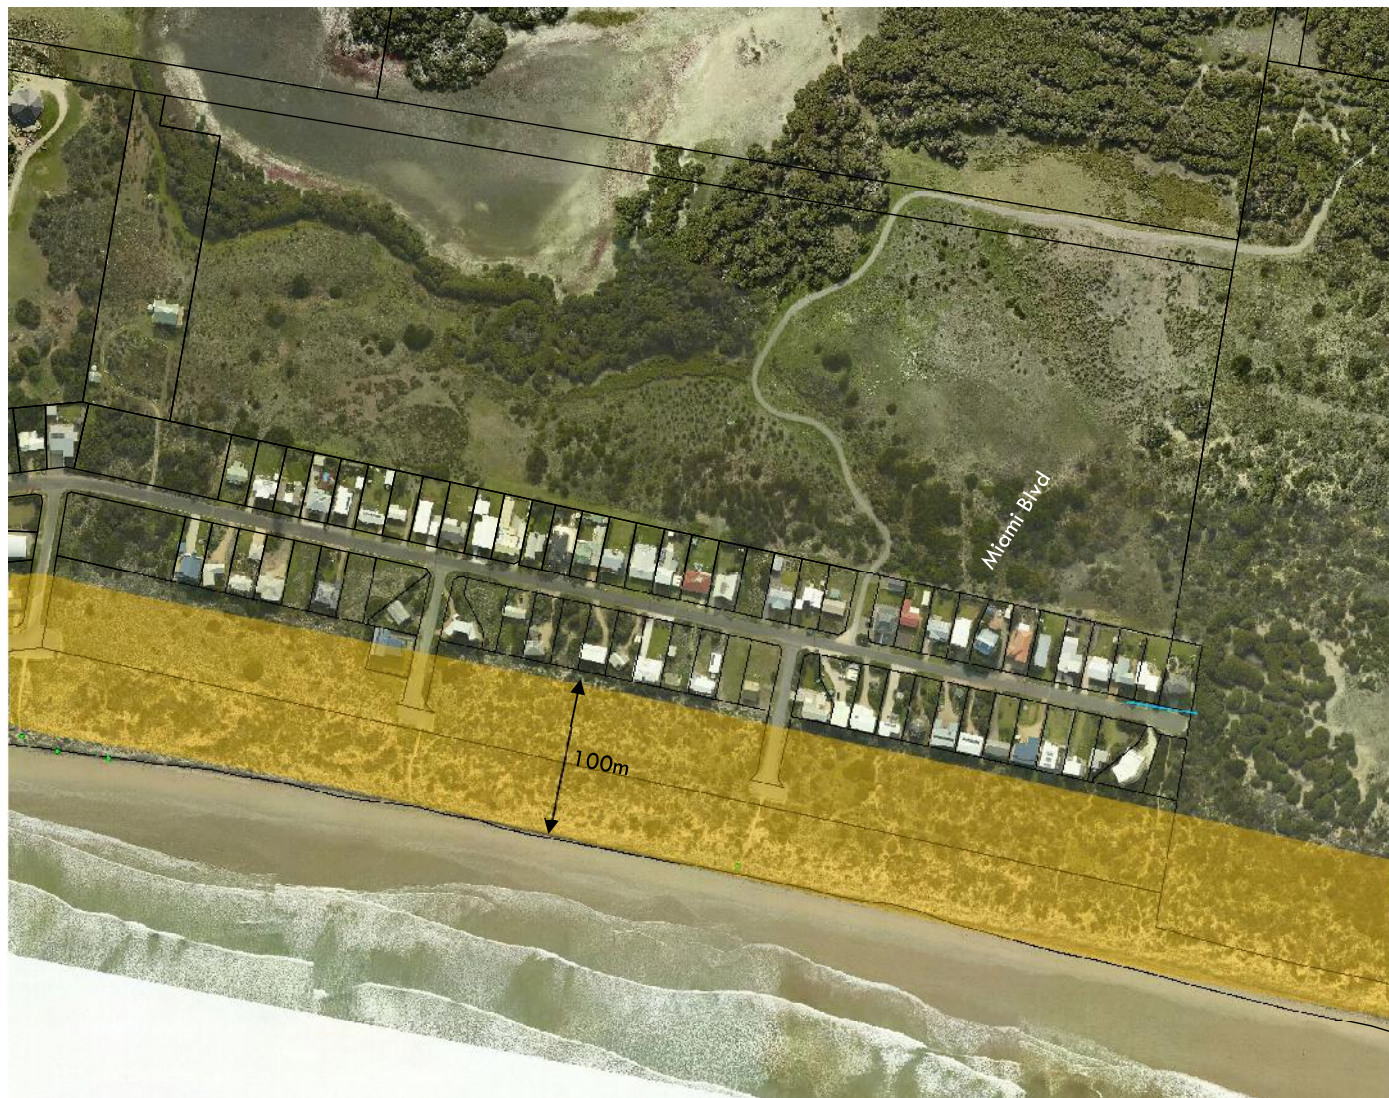
### Assessment

On a dissipative beach with sandy backshores, the shoreline will be dictated by the swash zone of wave run-up. The 2100 routine tidal map demonstrates that should seas rise as projected, then the shoreline will retreat.

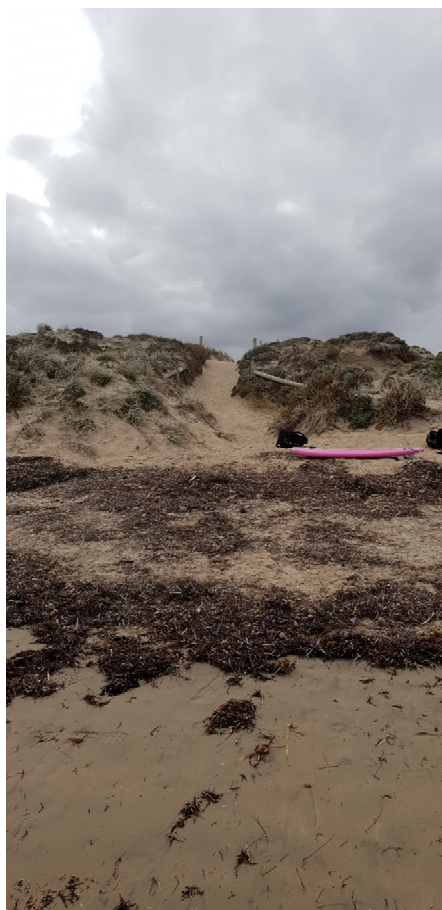
**Beach access ways.**

The beach access ways at Waikiki, Tahiti and Togan Way are constructed informally.

**Waikiki Way**  
 Natural path from Waikiki Way to the beach. No evidence of erosion of the entrance and seaweed strands further away from the entrance.

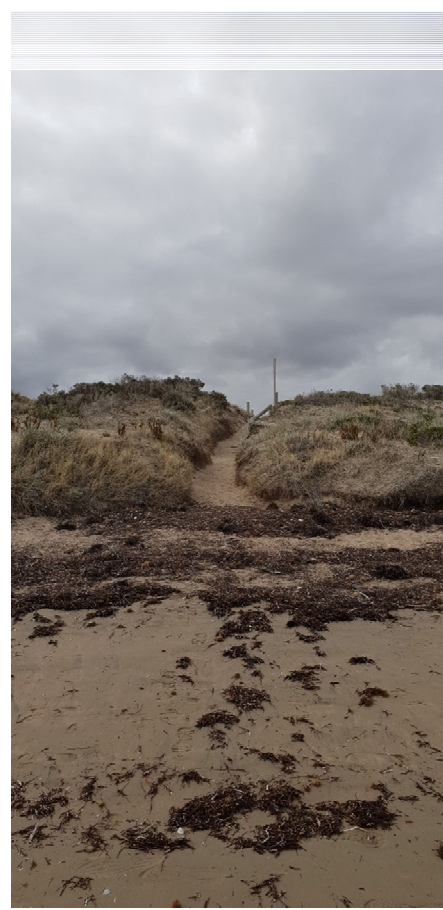
**Tahiti Road**  
 Wooden slat/ log walkway in poor condition at termination point. Seaweed strands appear in close proximity to the exit point.

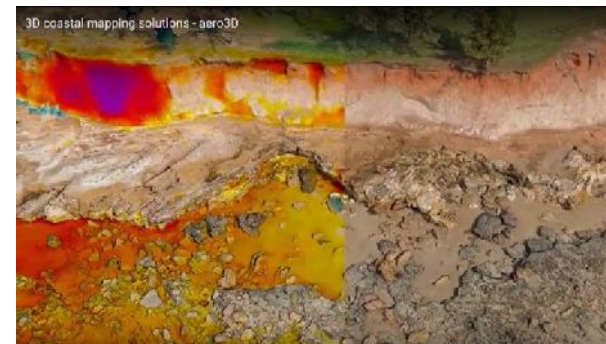
Figure: In a digital environment, software tools can be utilised to compare coastal change (Source: Aerometrex)

We have established a baseline in two ways: First, the capturing of the digital elevation model in 2018 provides a point in time baseline of the current form of the coast. In 5- or 10-years’ time (depending whether the coast is accreting or eroding), another digital elevation model could be captured, and comparisons made between the two digital models (Figure).

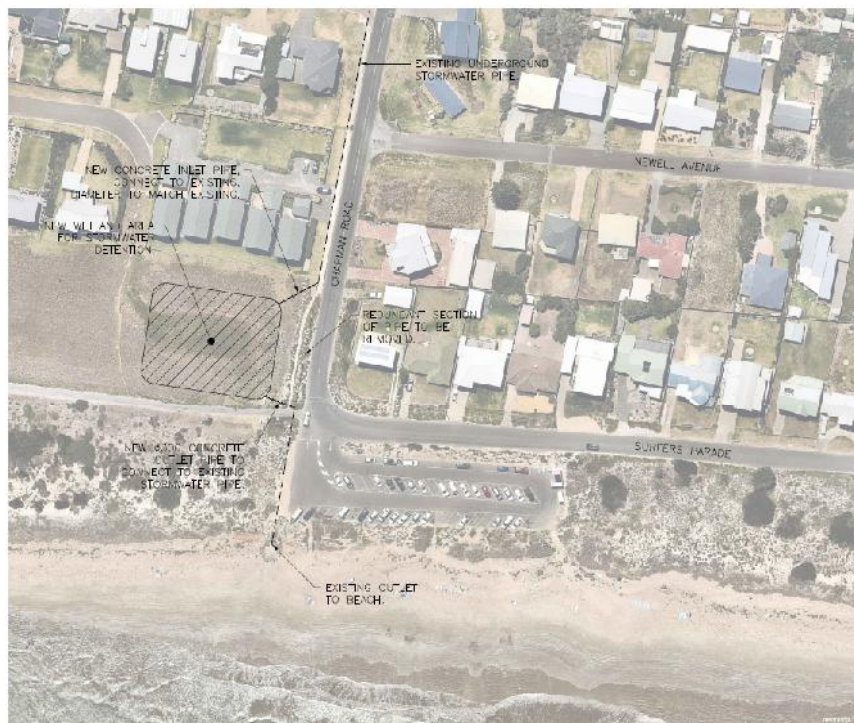
**CHAPMAN ROAD CARPARK – MIDDLETON**  
SCALE 1:1000

Magryn Engineering provided preliminary design and costing for:

- Reconfiguration of storm water outflow to beach at Chapman Road (including detention pond)
- Collapse overhanging section of cliff and install protection to carpark at Skye Ave carpark (not pictured)
